Project 147041.10 – Perimeter Pile Upgrade, 301 Mission Street, San Francisco, CA

Re: Monitoring Report

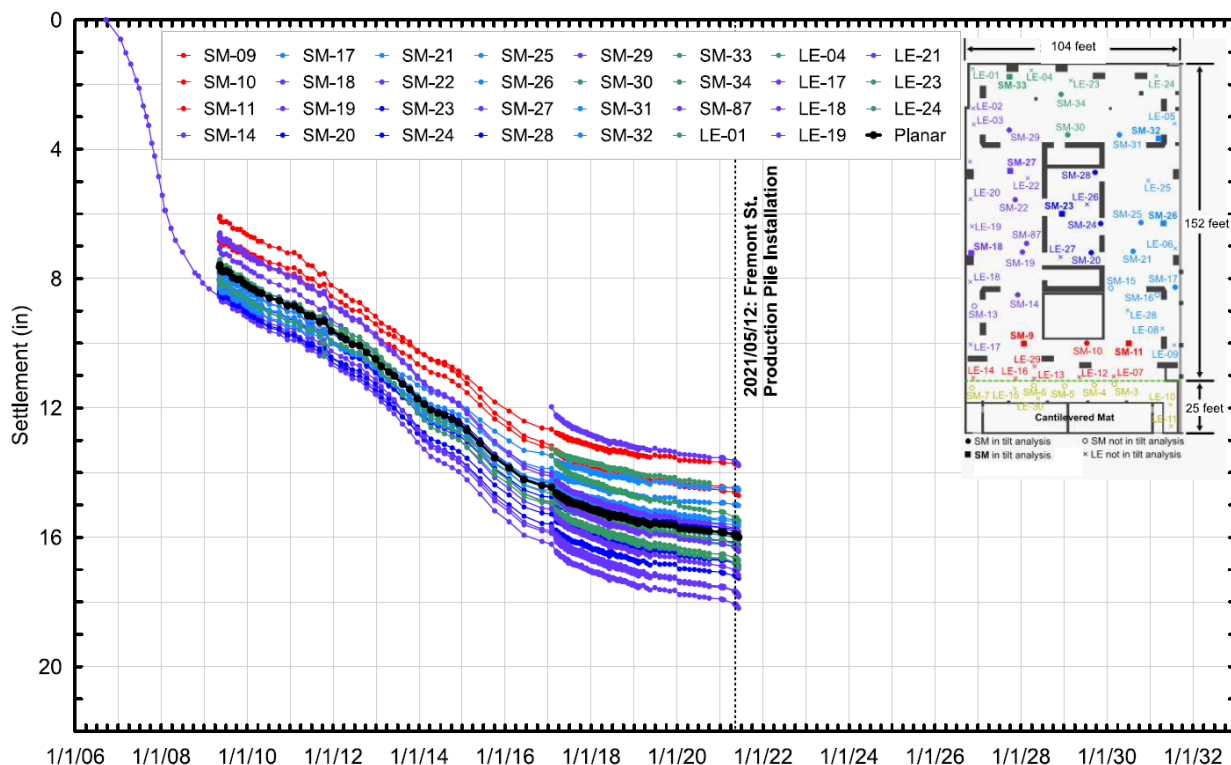
Figure 1 - Settlement History (Slate 17 June 2021)

Figure 1, above, extracted from Slate Monitoring Report 006 shows the building settlement history as measured by a series of settlement markers mounted in the tower's basement. Also shown on this figure is an interpolated plot of planar building settlement. This plot shows that on average, building settlement (as indicated by the planar interpolation) has remained relatively stable throughout the construction period to date, and in line with prior months behavior. However, beginning in early May of this year, and coinciding approximately with installation of the 36 in. casings, somewhat increased settlement has occurred along the building's west side. Along with

this settlement, increased tilting of the building roof towards the west has also occurred. As explained in the attached 18 June memo from John Egan, we interpret this behavior as resulting from disturbance and compaction of the Colma Sands, associated with production pile installation along Fremont Street. We anticipate that now that this installation is complete, the west side of the building will return to historic settlement rates. We do not anticipate that installation of the 24 in. diameter casings and rock sockets will affect this, as installation of the 24-inch casings will not disturb the Colma formation.

As reported by Slate, as of 17 June, the building roof had tilted approximately 2-1/2 in. further to the west, since initiation of construction in November 2020, with total tilt to the west, as of 17 June, being approximately 17 in. Egan projects that total settlement to the west, now that installation of the 36 in. casings along Fremont Street is complete may be about 18 in. Future monitoring reports should confirm this. The projected tilting is well within the settlement cases analyzed by us to investigate the building's safety under future settlement and does not present a structural concern.
