**MEMORANDUM**

TO: Vision Winter, Esq., O'Melveny and Myers LLP  
FROM: Patrick O. Shires, Cotton, Shires and Associates, Inc.  
RE: **Millennium Tower Shoring Wall Exploration August 9 through 17, 2017**  
DATE: August 24, 2017

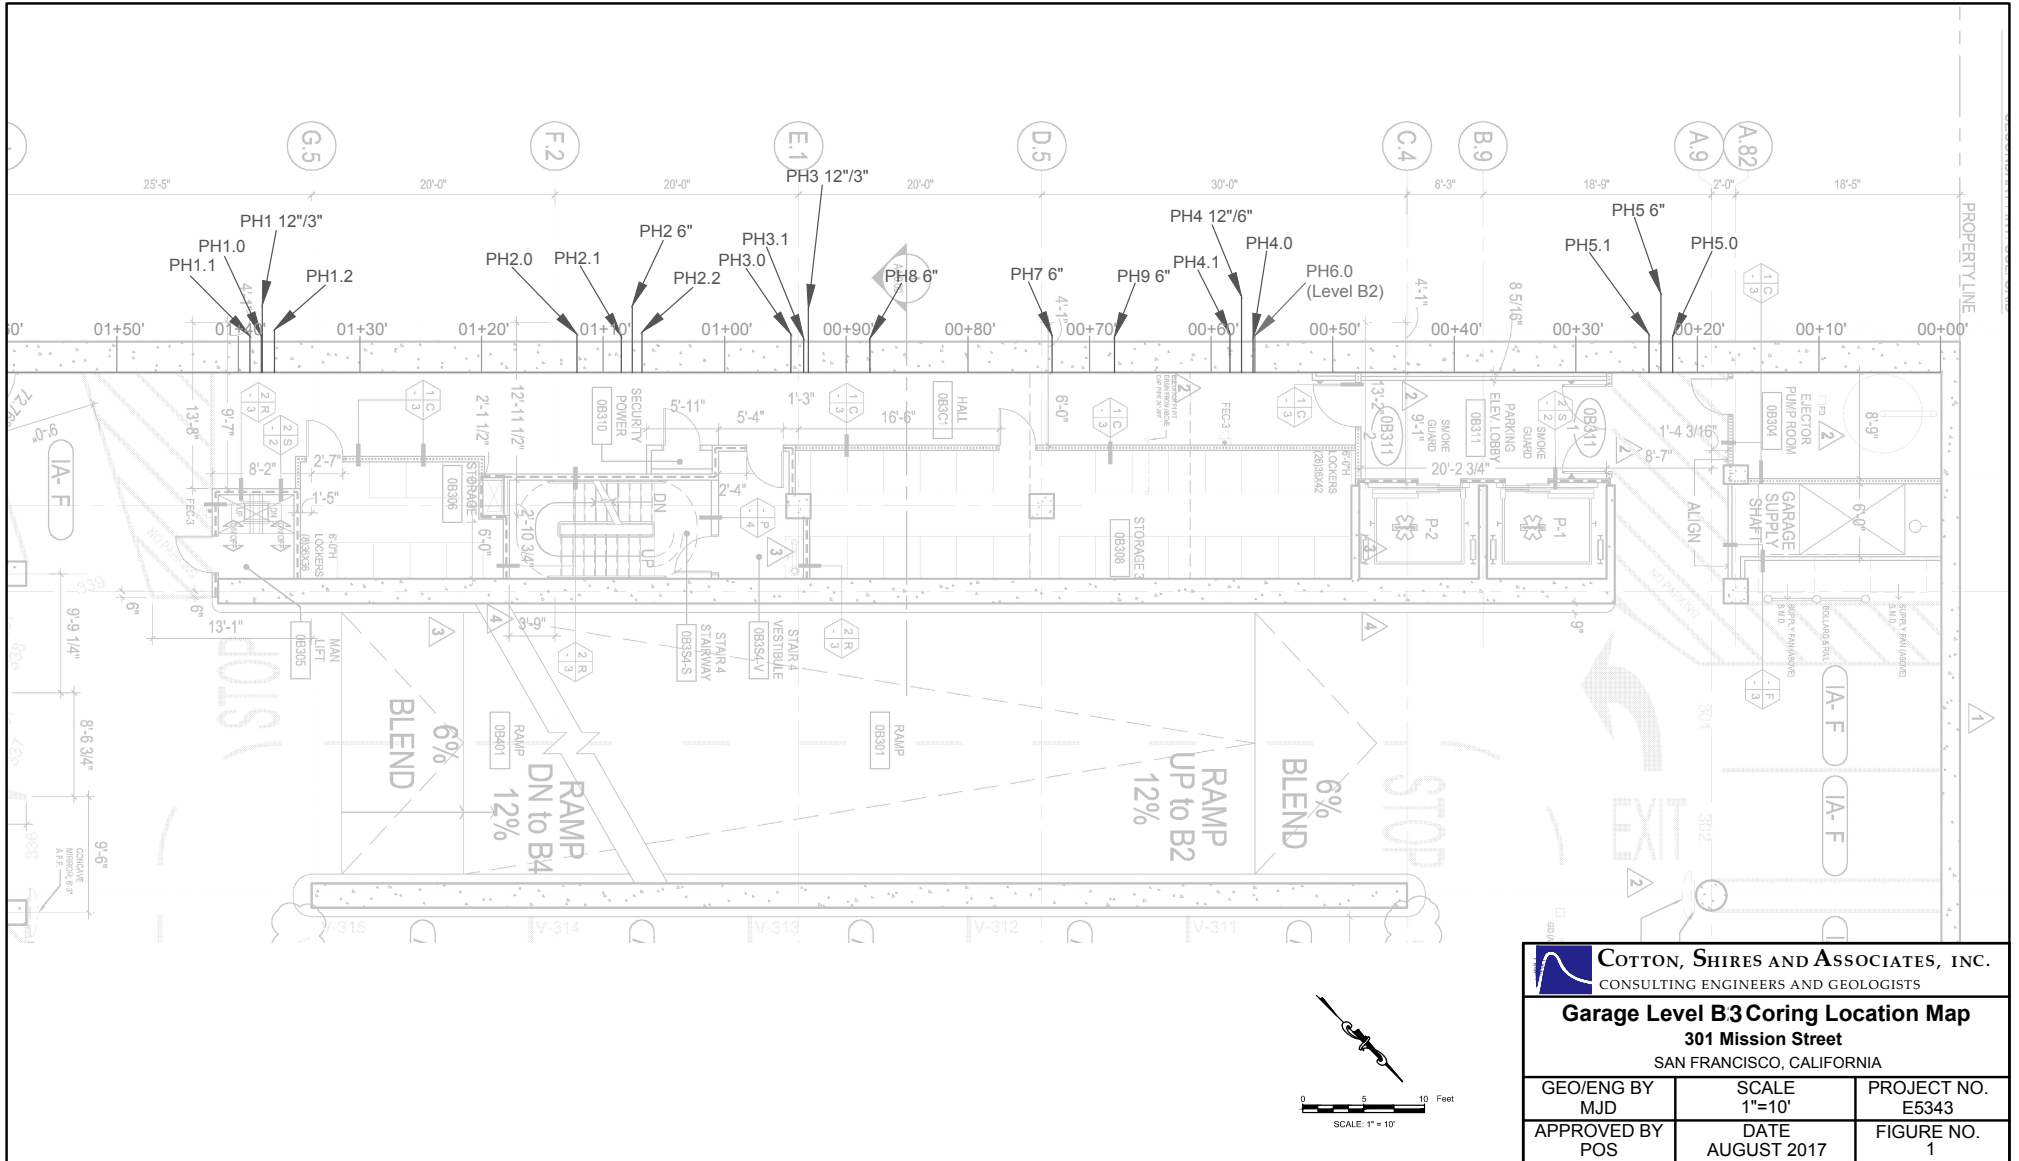
From August 9 through 17, 2017, the westernmost wall of the podium parking garage Level B3 at 301 Mission Street was cored to explore between the top of the shoring wall behind the garage wall in the area just below the base of the Tower pile cap. Smaller diameter drain holes were drilled below larger diameter exploration holes (where needed) at nine exploration locations (PH-1 through PH-9, with PH-6 being the only location on Level B2 to explore the garage wall to pile cap section) – see attached Figure 1, Garage Level B3 Coring Location Map, for location of cores.

Attached is Figure 1, Garage Level B3 Coring Location Map (which depicts the locations of the exploratory core holes as well as the depth of coring and also shows the location of the core in garage Level B2) as well as CSA's field logs of core/core holes and photographs of the core/core holes.

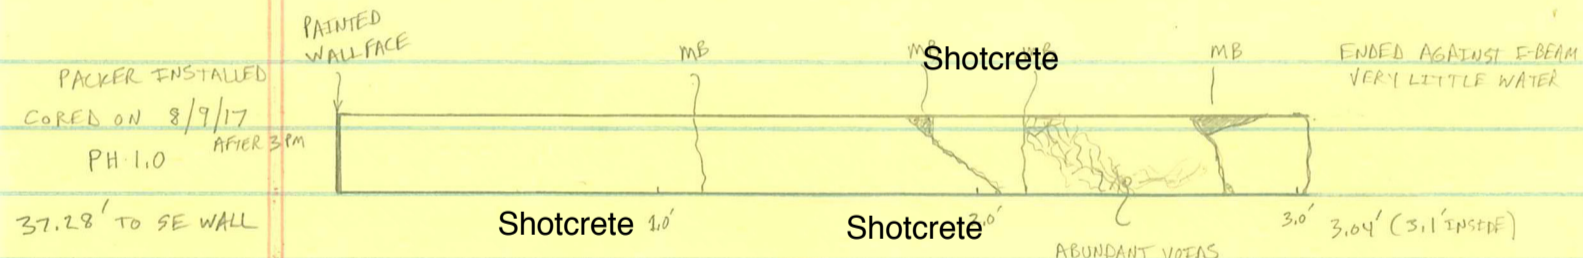
# PH1.0: 3" Diameter Core Log

**PH1 Location:** Penhall Concrete Services (Penhall) cored 3-inch diameter PH1.0 at the end of the day on Wednesday, August 9, 2017. CSA was not present during the coring of this hole, but logged the extruded core on Thursday, August 10, 2017. A packer was observed in this 3-inch drain hole when CSA arrived on site Thursday morning and little to no water was flowing from a hose bibbed drain pipe secured by the packer. 3-inch diameter drain holes PH1.1 and PH1.2 were cored and logged on

PACKER INSTALLED  
CORED ON 8/9/17  
PH-1.0 AFTER 3 PM

37.28' TO SE WALL

5.05' BOT TO FLR

2.76' TOP TO CEIL

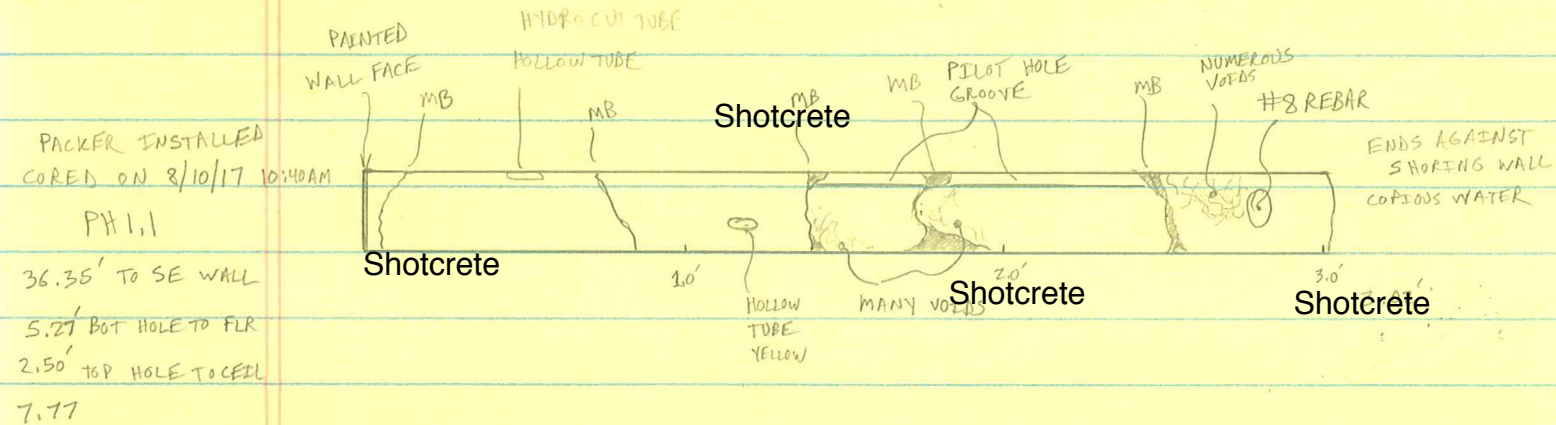
# PH1.1: 3" Diameter Core Log

Thursday, August 10, 2017. PH1.1 produced approximately 20 gpm of water (visual estimation) immediately following coring and PH1.2 was dry following completion of coring.

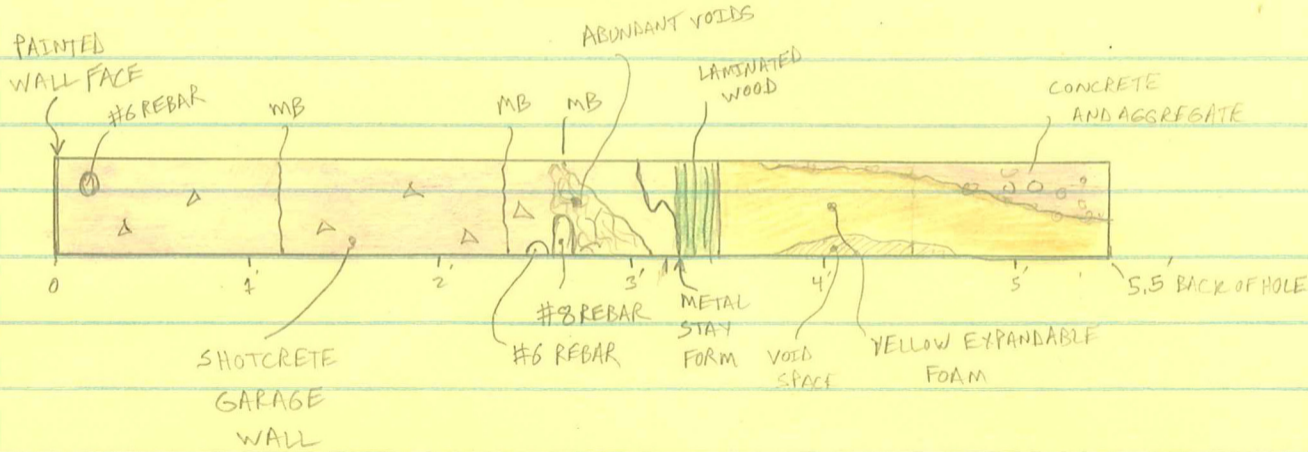
# PH2: 6" Diameter Core Log

PH2 was cored with a 6-inch diameter core barrel on Tuesday, August 15, 2017. No water was observed seeping from this hole following coring.

CORED ON 8/15/17  
LOGGED ON 8/16/17  
PH2 6"  $\phi$  CORE  
ANGLED 3° UP

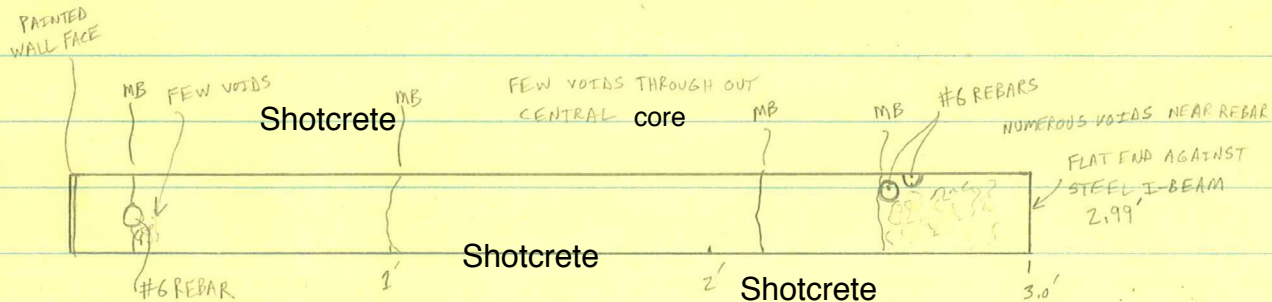
# PH2.1: 3" Diameter Core Log

**PH2 Location:** Penhall cored 3-inch diameter drain holes PH2.0, PH2.1 and PH2.2 on Thursday, August 10, 2017. PH2.2 produced approximately 30 gpm of water (visual estimation) immediately following coring and PH2.0 and PH2.1 were dry following completion of coring.

NO PACKER

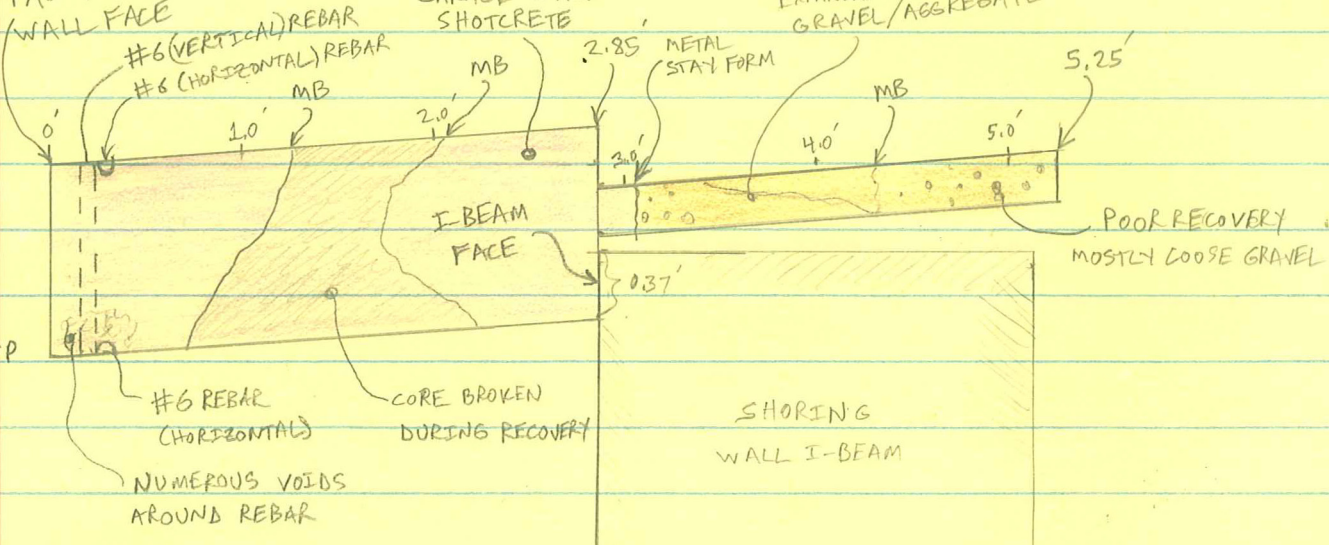
# PH3: 12"/3" Diameter Core Log

PH3 was cored with a 12-inch diameter core barrel back to the shoring wall I-beam on Friday, August 11, 2017, and extended with a 3-inch diameter core barrel above and beyond the face of the shoring wall I-beam. No water was observed seeping from this hole following coring.

PAINTED WALL FACE

GARAGE WALL SHOTCRETE

EXPANDABLE MIXED WITH GRAVEL/AGGREGATE

CORE INCLINED 4° UP

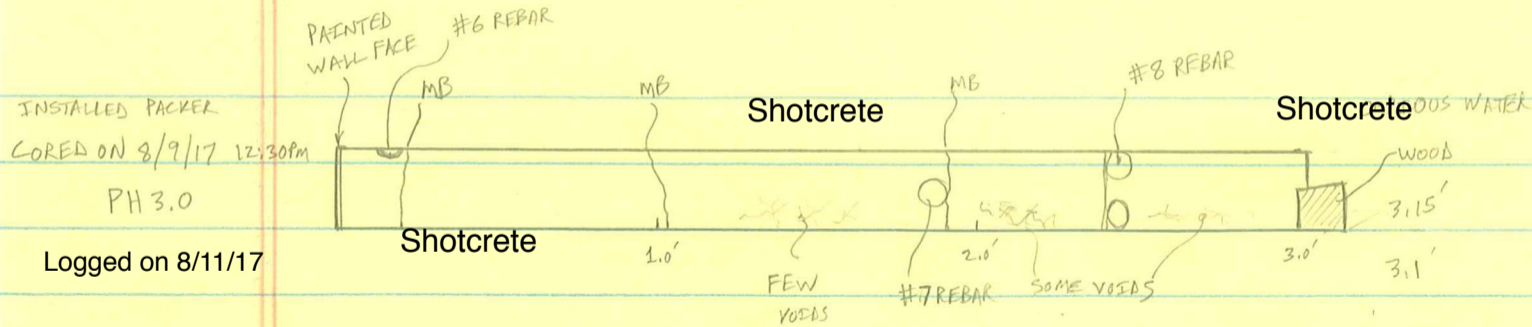
# PH3.0: 3" Diameter Core Log

**PH3 Location:** Penhall cored PH3.0 the morning of Wednesday, August 9, 2017. CSA was not present during the coring of this hole, but logged this core on Friday, August 11, 2017. A packer was observed in this 3-inch drain hole when CSA arrived on site Wednesday afternoon and 7.5 gpm (measured with a 5-gallon bucket) was flowing from its hose bibbed drain pipe secured by a packer. 3-inch diameter drain hole PH3.1 was cored on Wednesday, August 9, 2017. PH3.1 was dry following completion of coring.

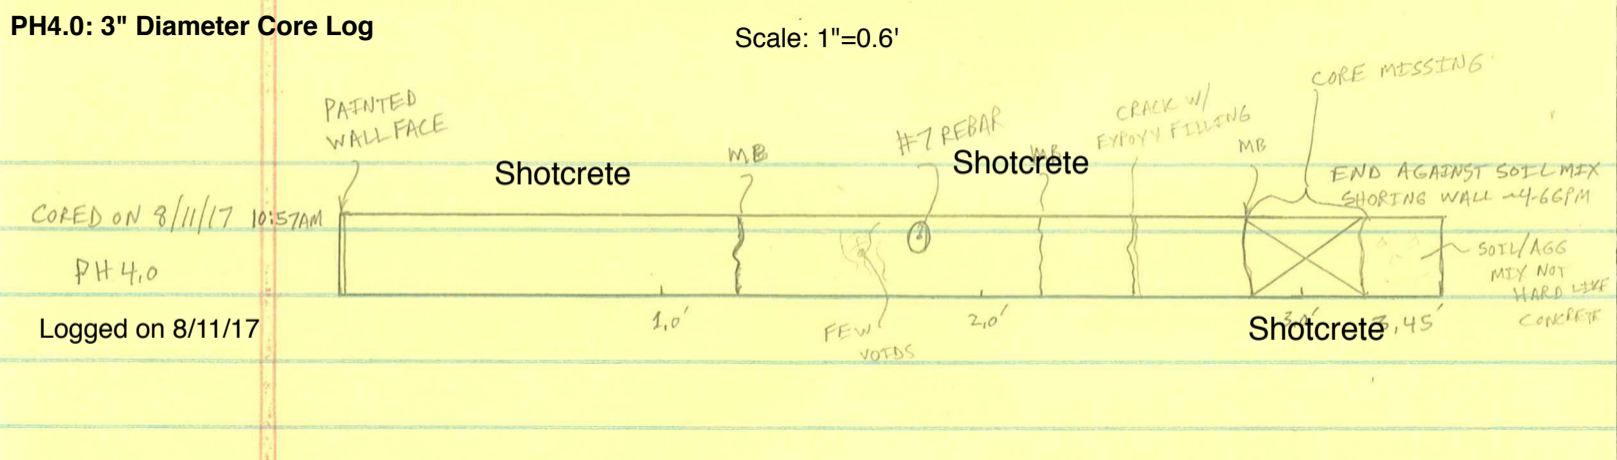
# PH4.0: 3" Diameter Core Log

**PH4 Location:** Penhall cored 3-inch diameter drain holes PH4.0 and PH4.1 on Friday, August 11, 2017. PH4.0 produced approximately 4-6 gpm of water (visual estimation) immediately following coring and PH4. 1 produced less than 1 gpm of water (visual estimation) immediately following coring.

CRACK W/  
EPOXY FILLING

FEW  
VOIDS

END AGAINST SOIL MIX  
SHORING WALL ~4-6GPM

SOIL/AGG  
MIX NOT  
HARD LIKE  
CONCRETE

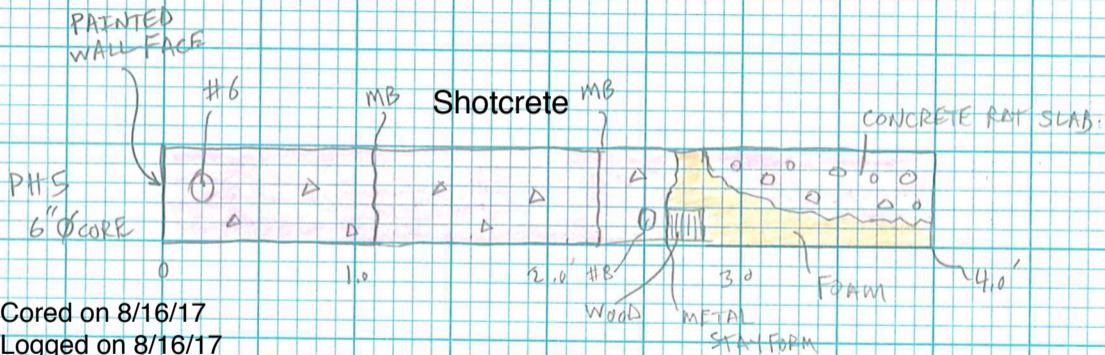
# PH5: 6" Diameter Core Log

PH5 was cored with a 6-inch diameter core barrel on Wednesday, August 16, 2017. A minor amount of water was observed seeping from this hole following coring.

Core Inclined 2.5 Degrees Up

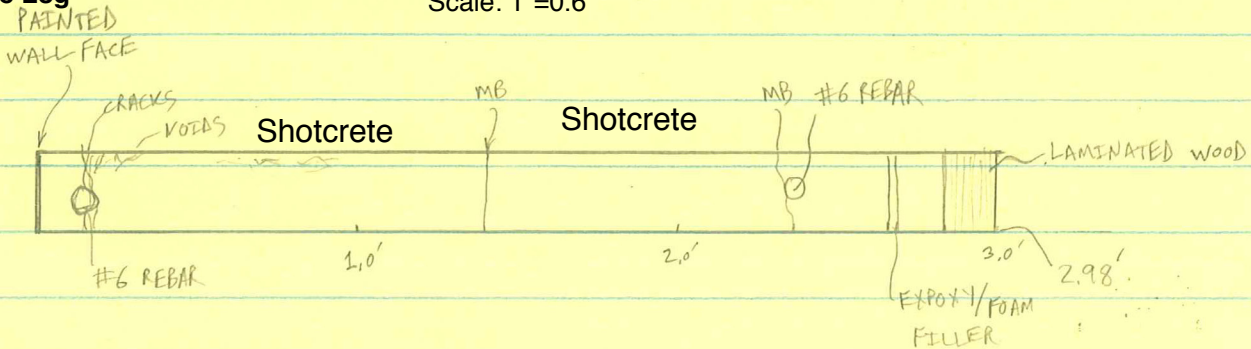
# PH5.0: 3" Diameter Core Log

**PH5 Location:** Penhall cored 3-inch diameter drain holes PH5.0 and PH5.1 on Friday, August 11, 2017. PH5.0 and PH5.1 produced less than 1 gpm of water (visual estimation) immediately following coring.

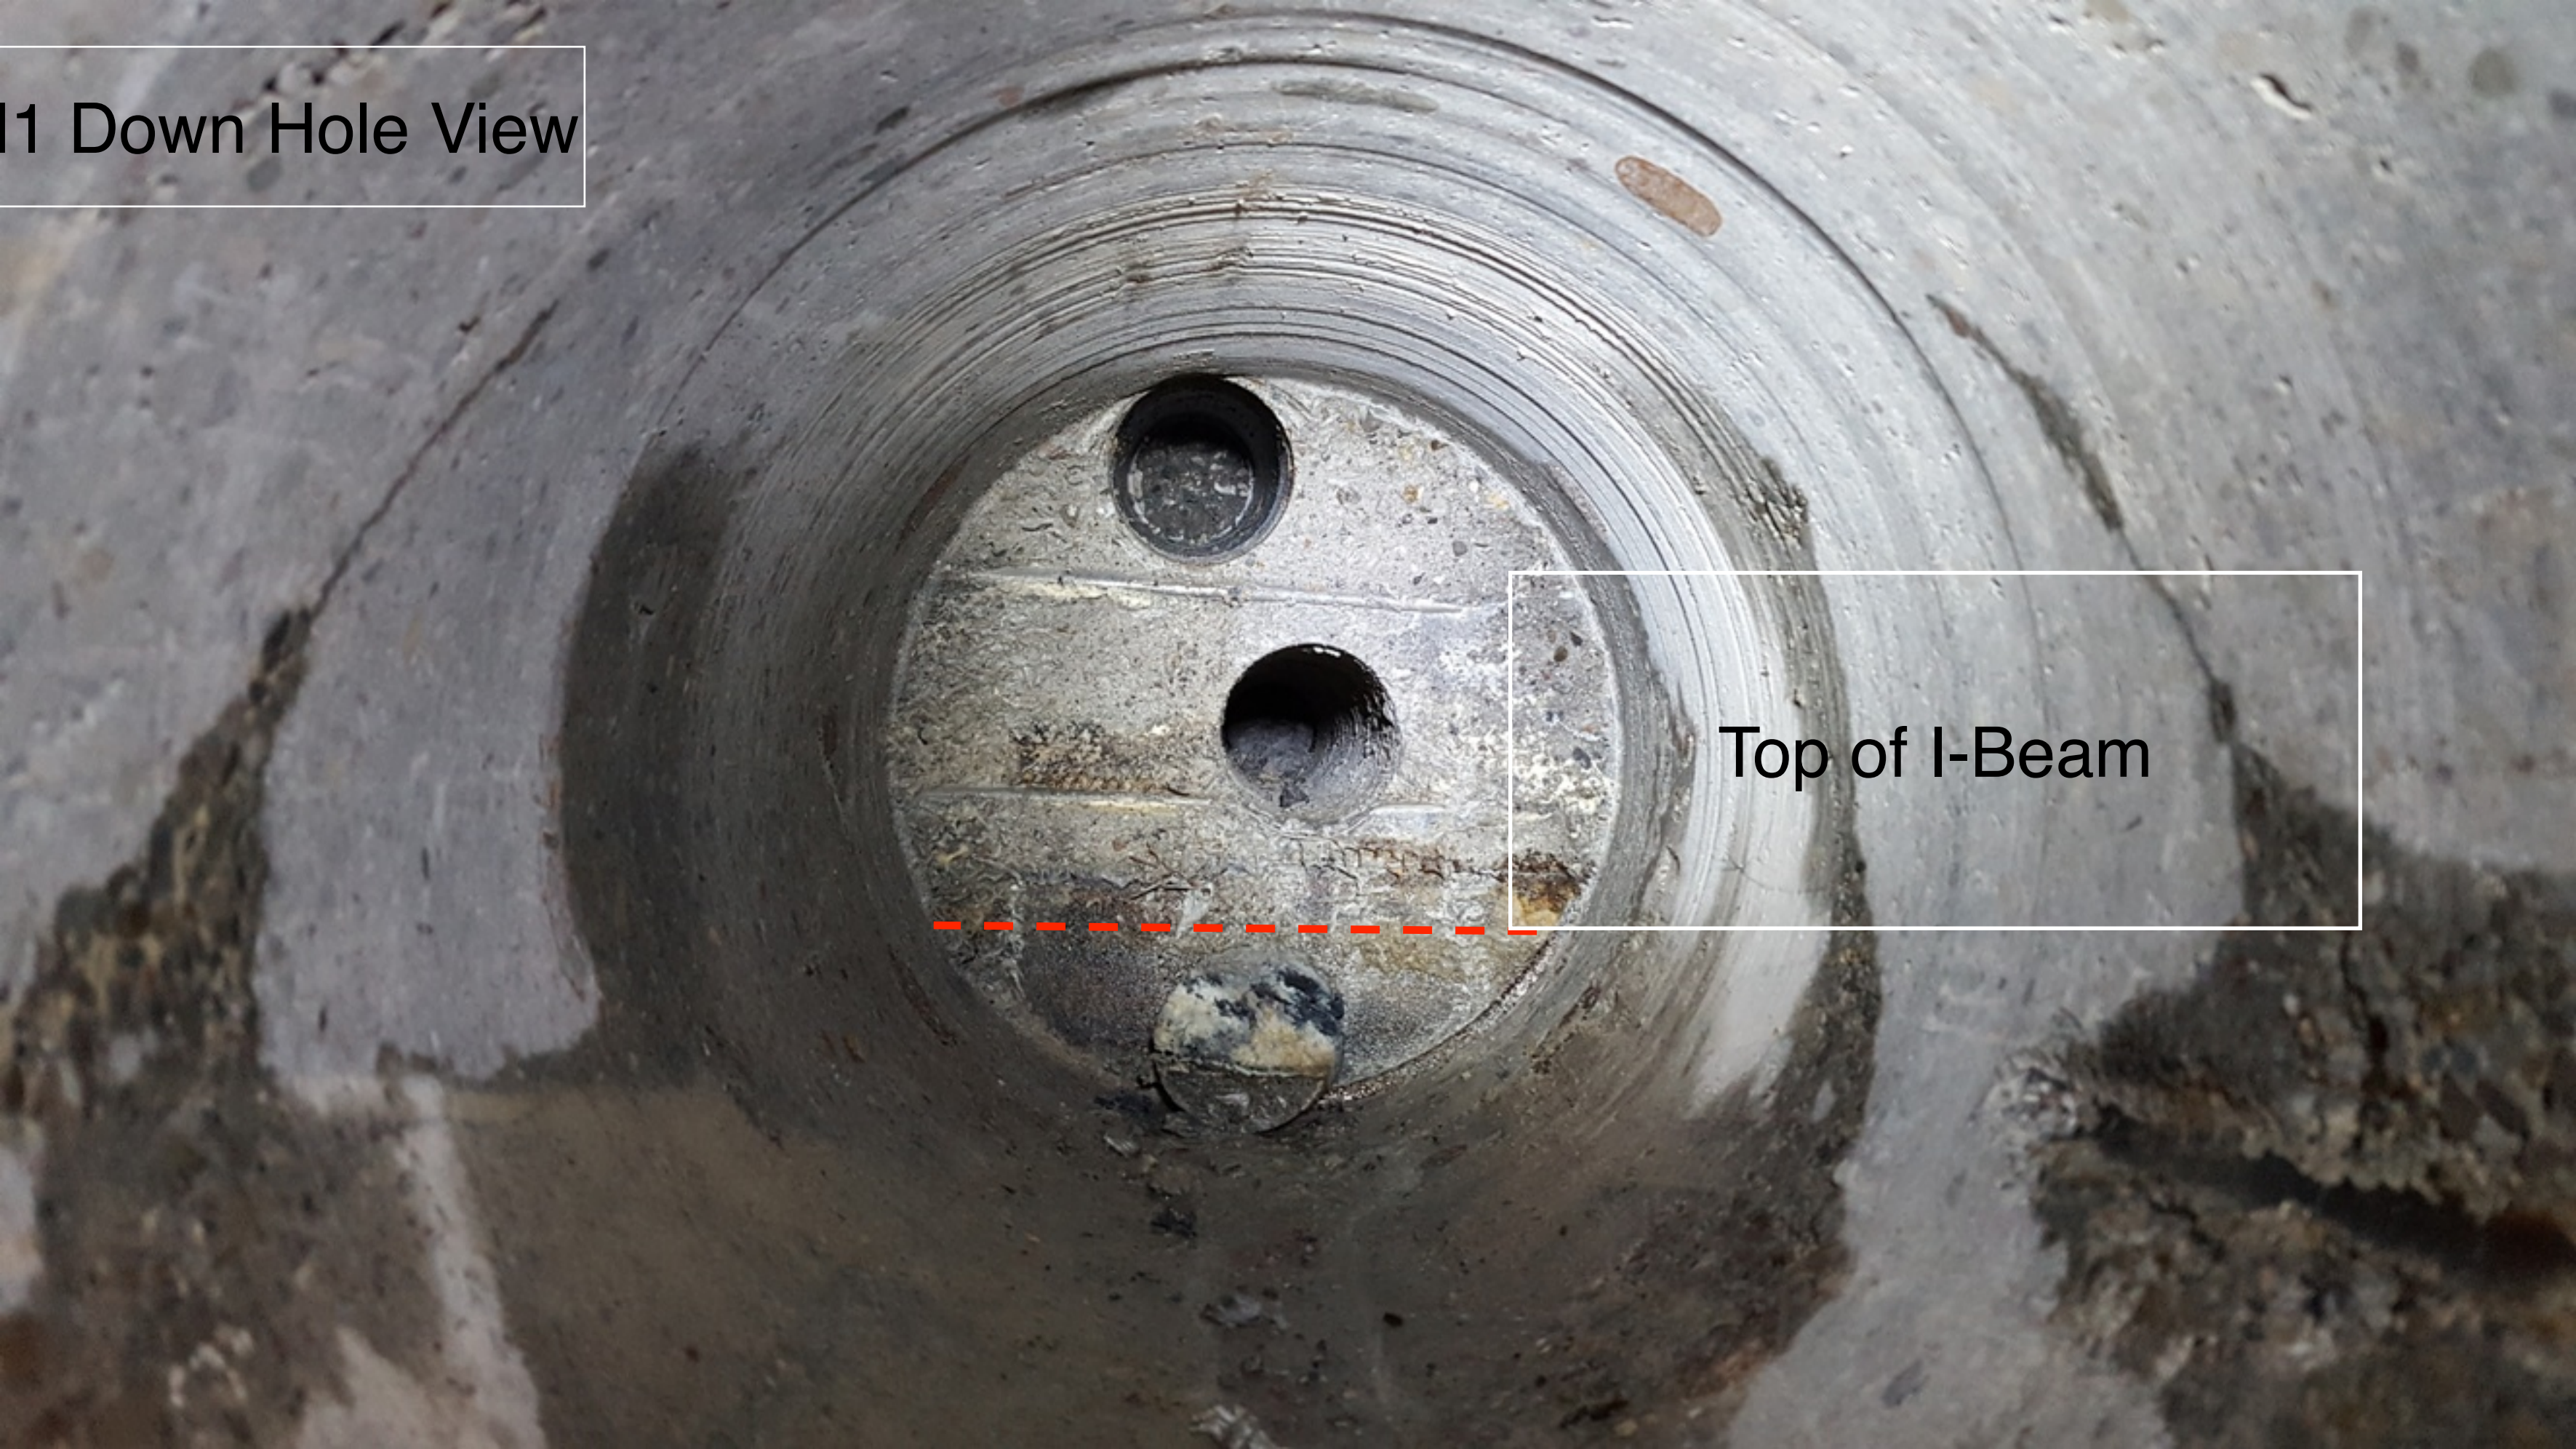
11 Down Hole View

Top of I-Beam

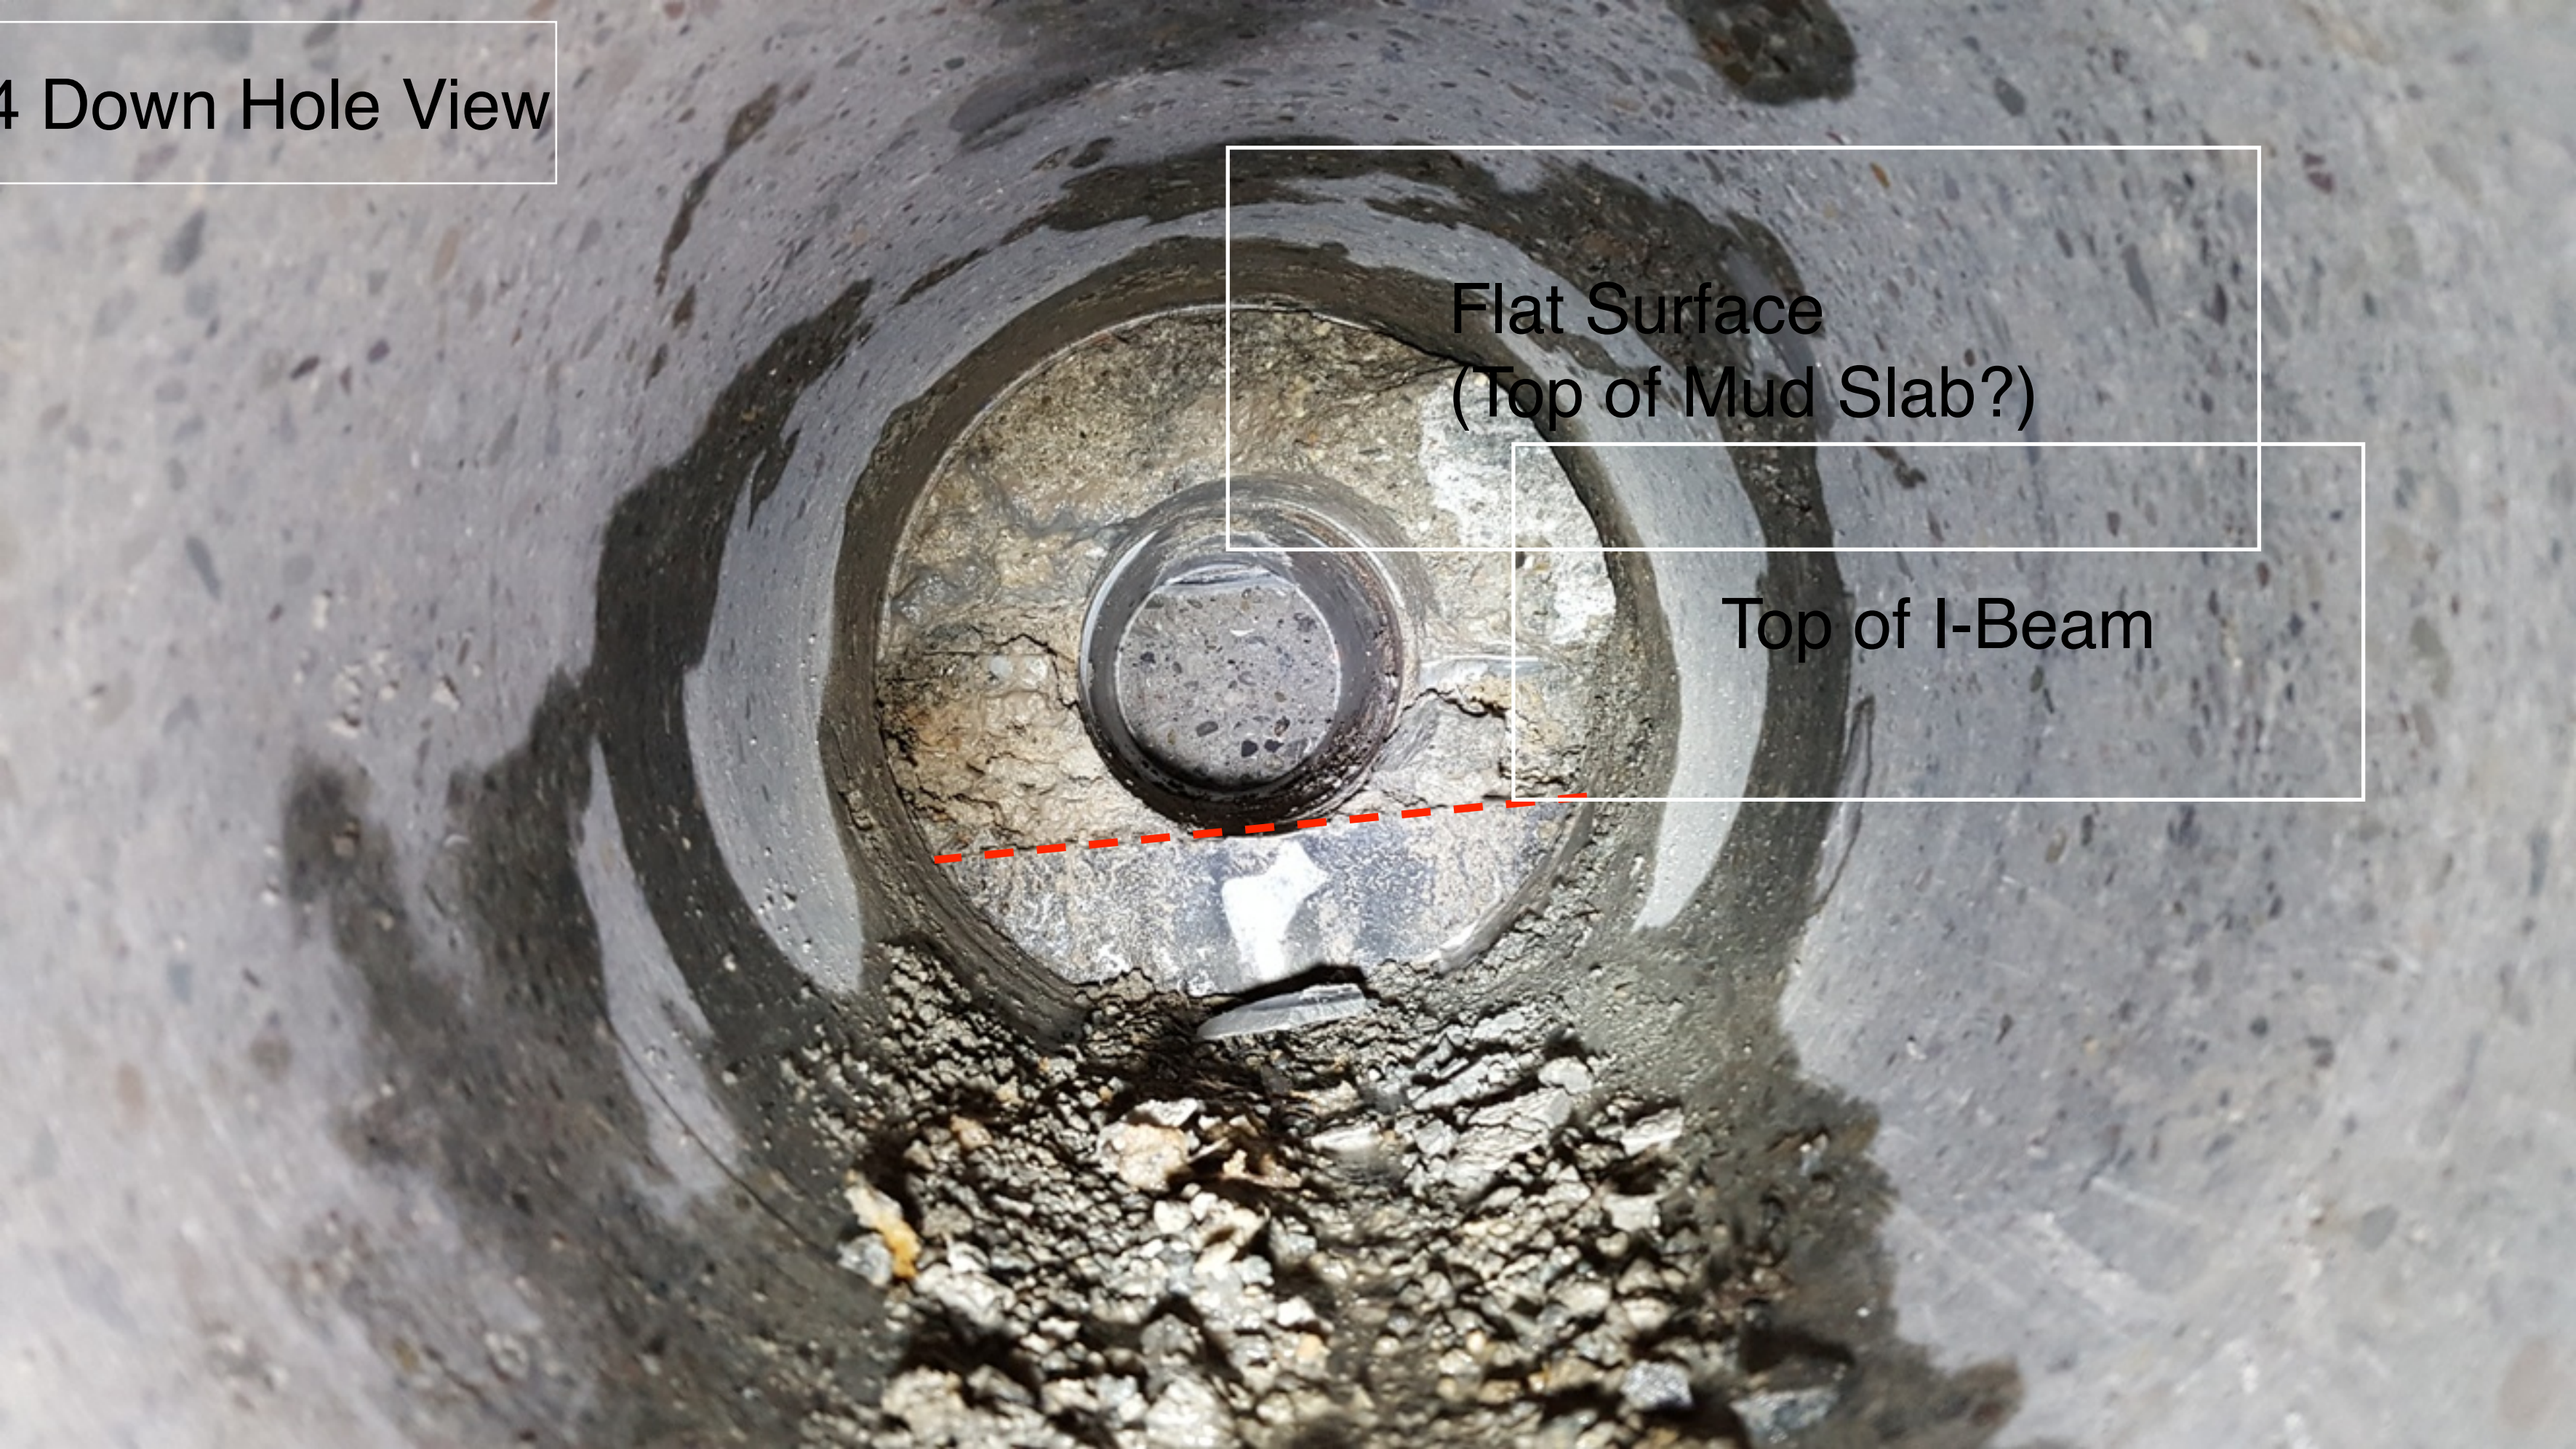
4 Down Hole View

Flat Surface  
(Top of Mud Slab?)

Top of I-Beam

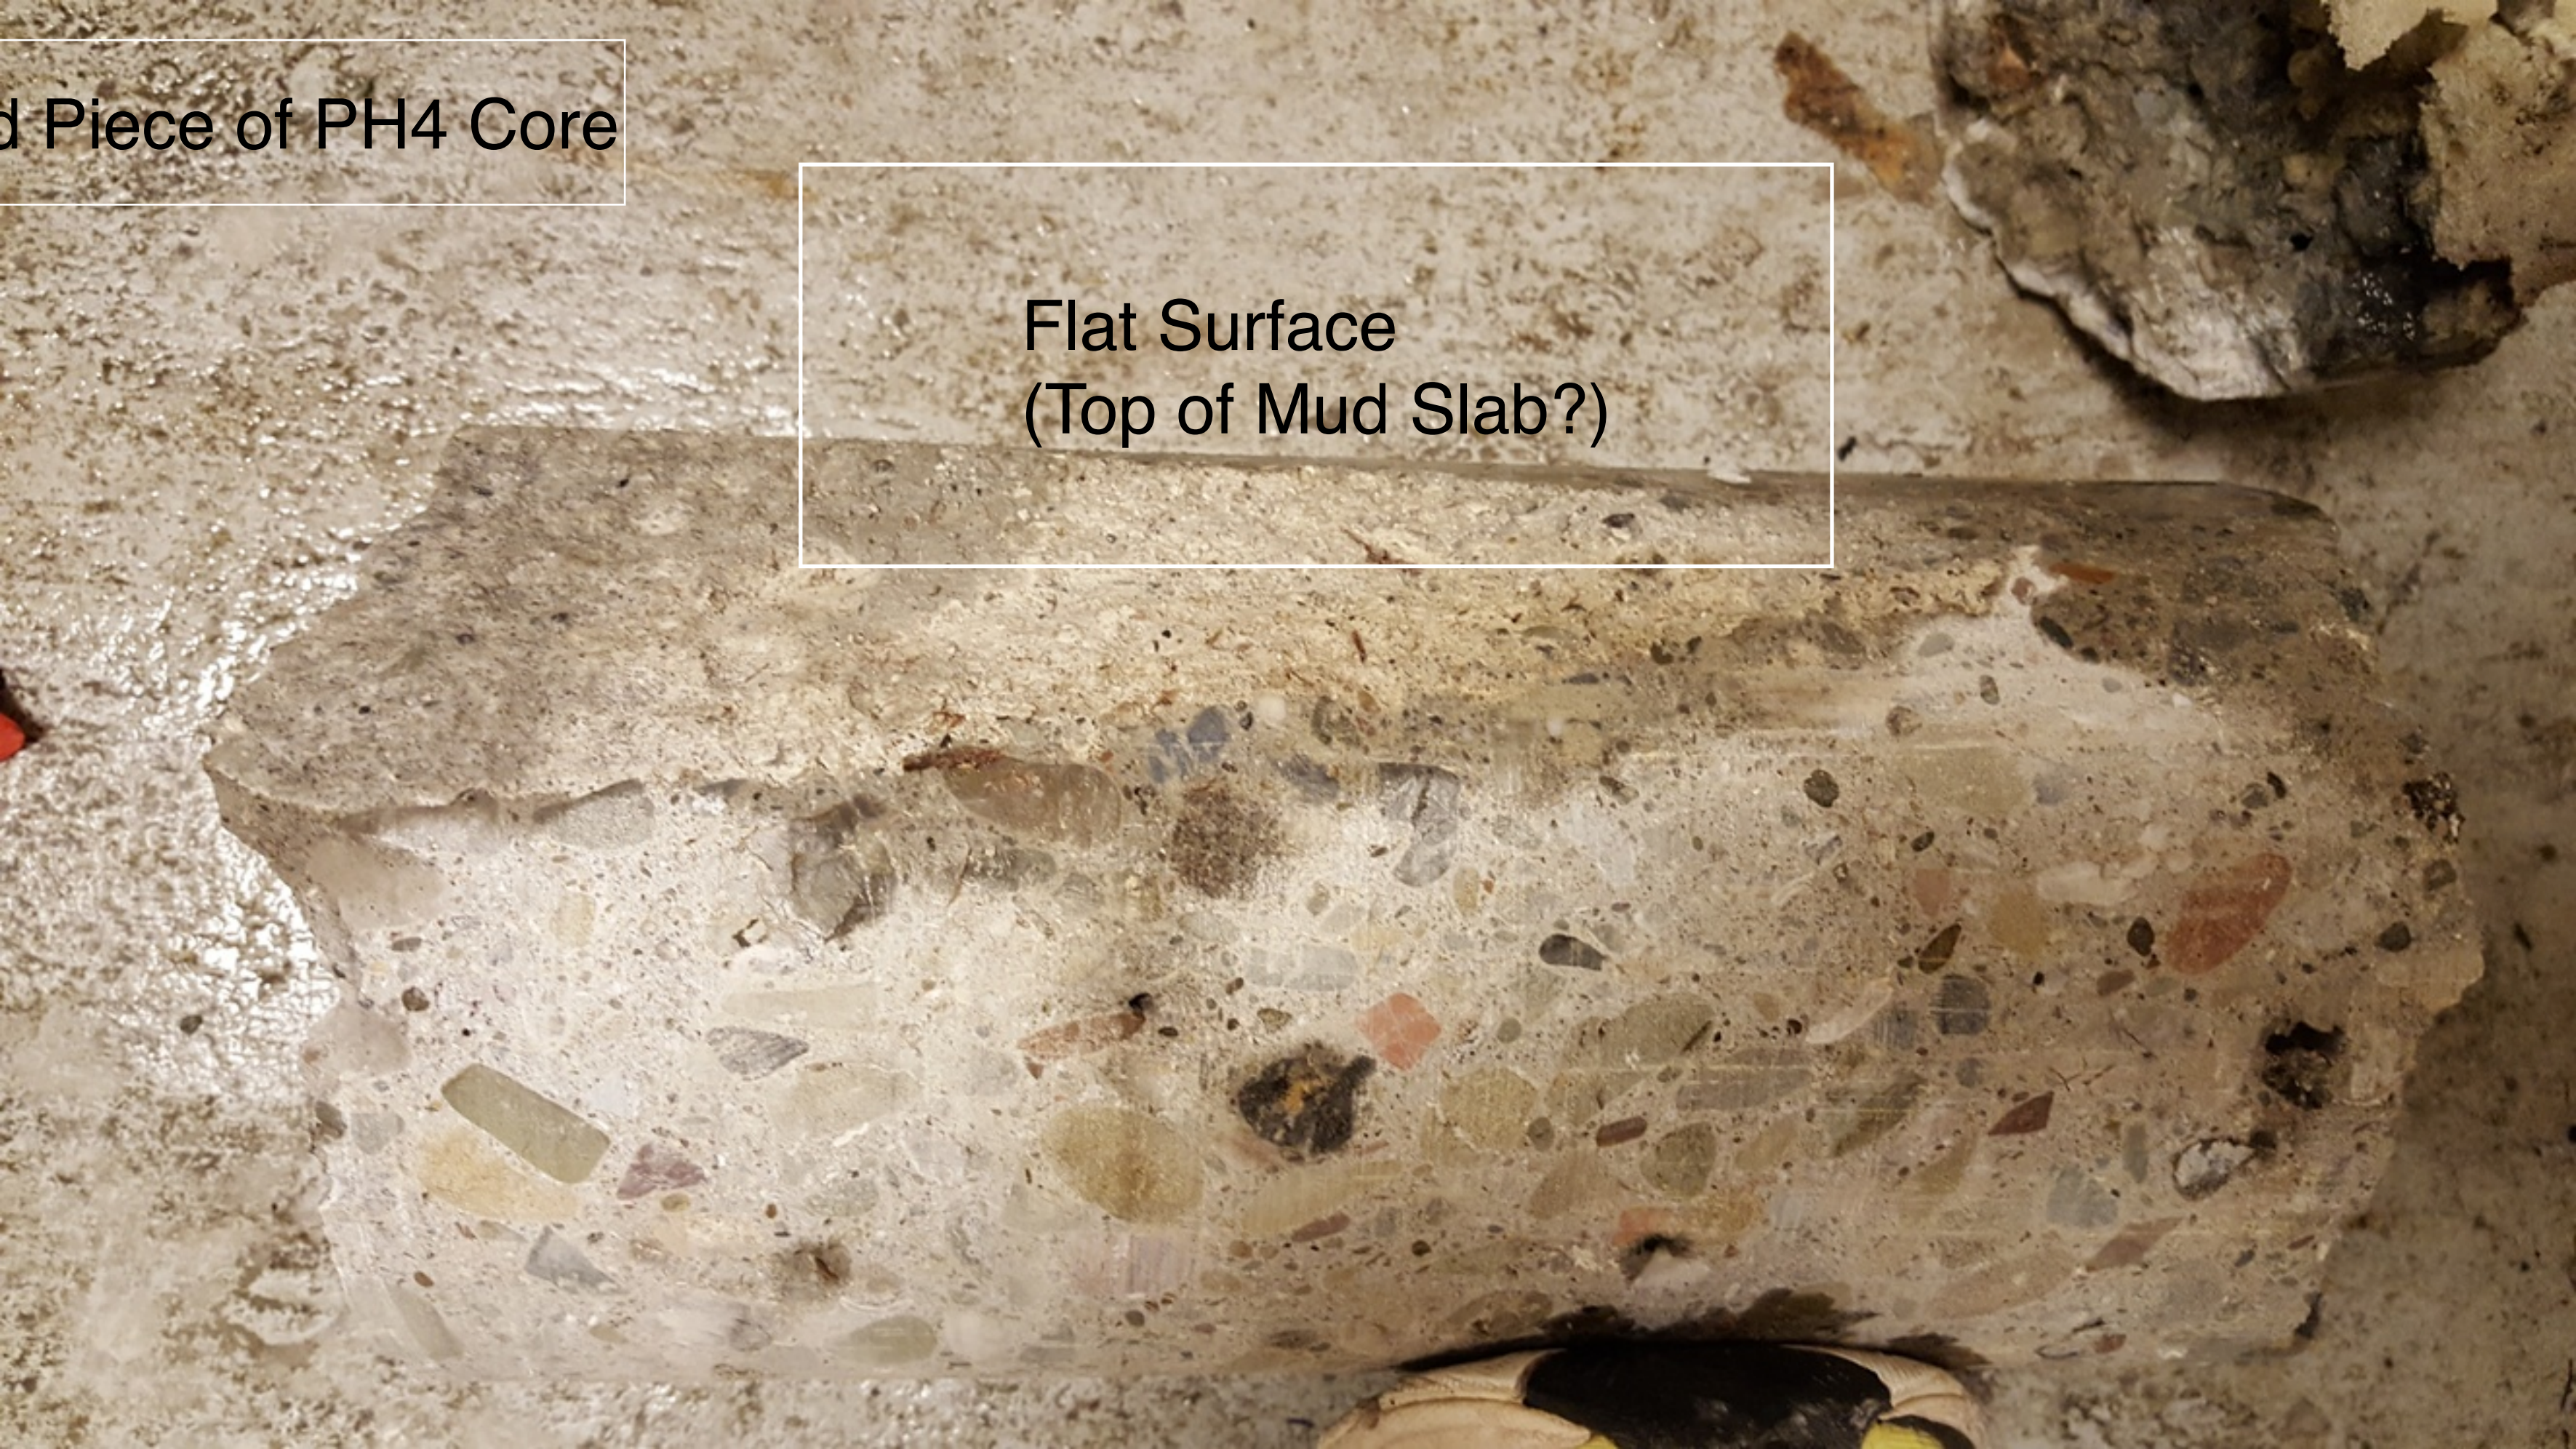
nd Piece of PH4 Core

Flat Surface  
(Top of Mud Slab?)
