**MEMORANDUM**

TO: Vision Winter, Esq., O'Melveny and Myers LLP  
FROM: Patrick O. Shires, Cotton, Shires and Associates, Inc.  
RE: **Millennium Tower Shoring Wall Exploration August 9 through 17, 2017**  
DATE: August 24, 2017

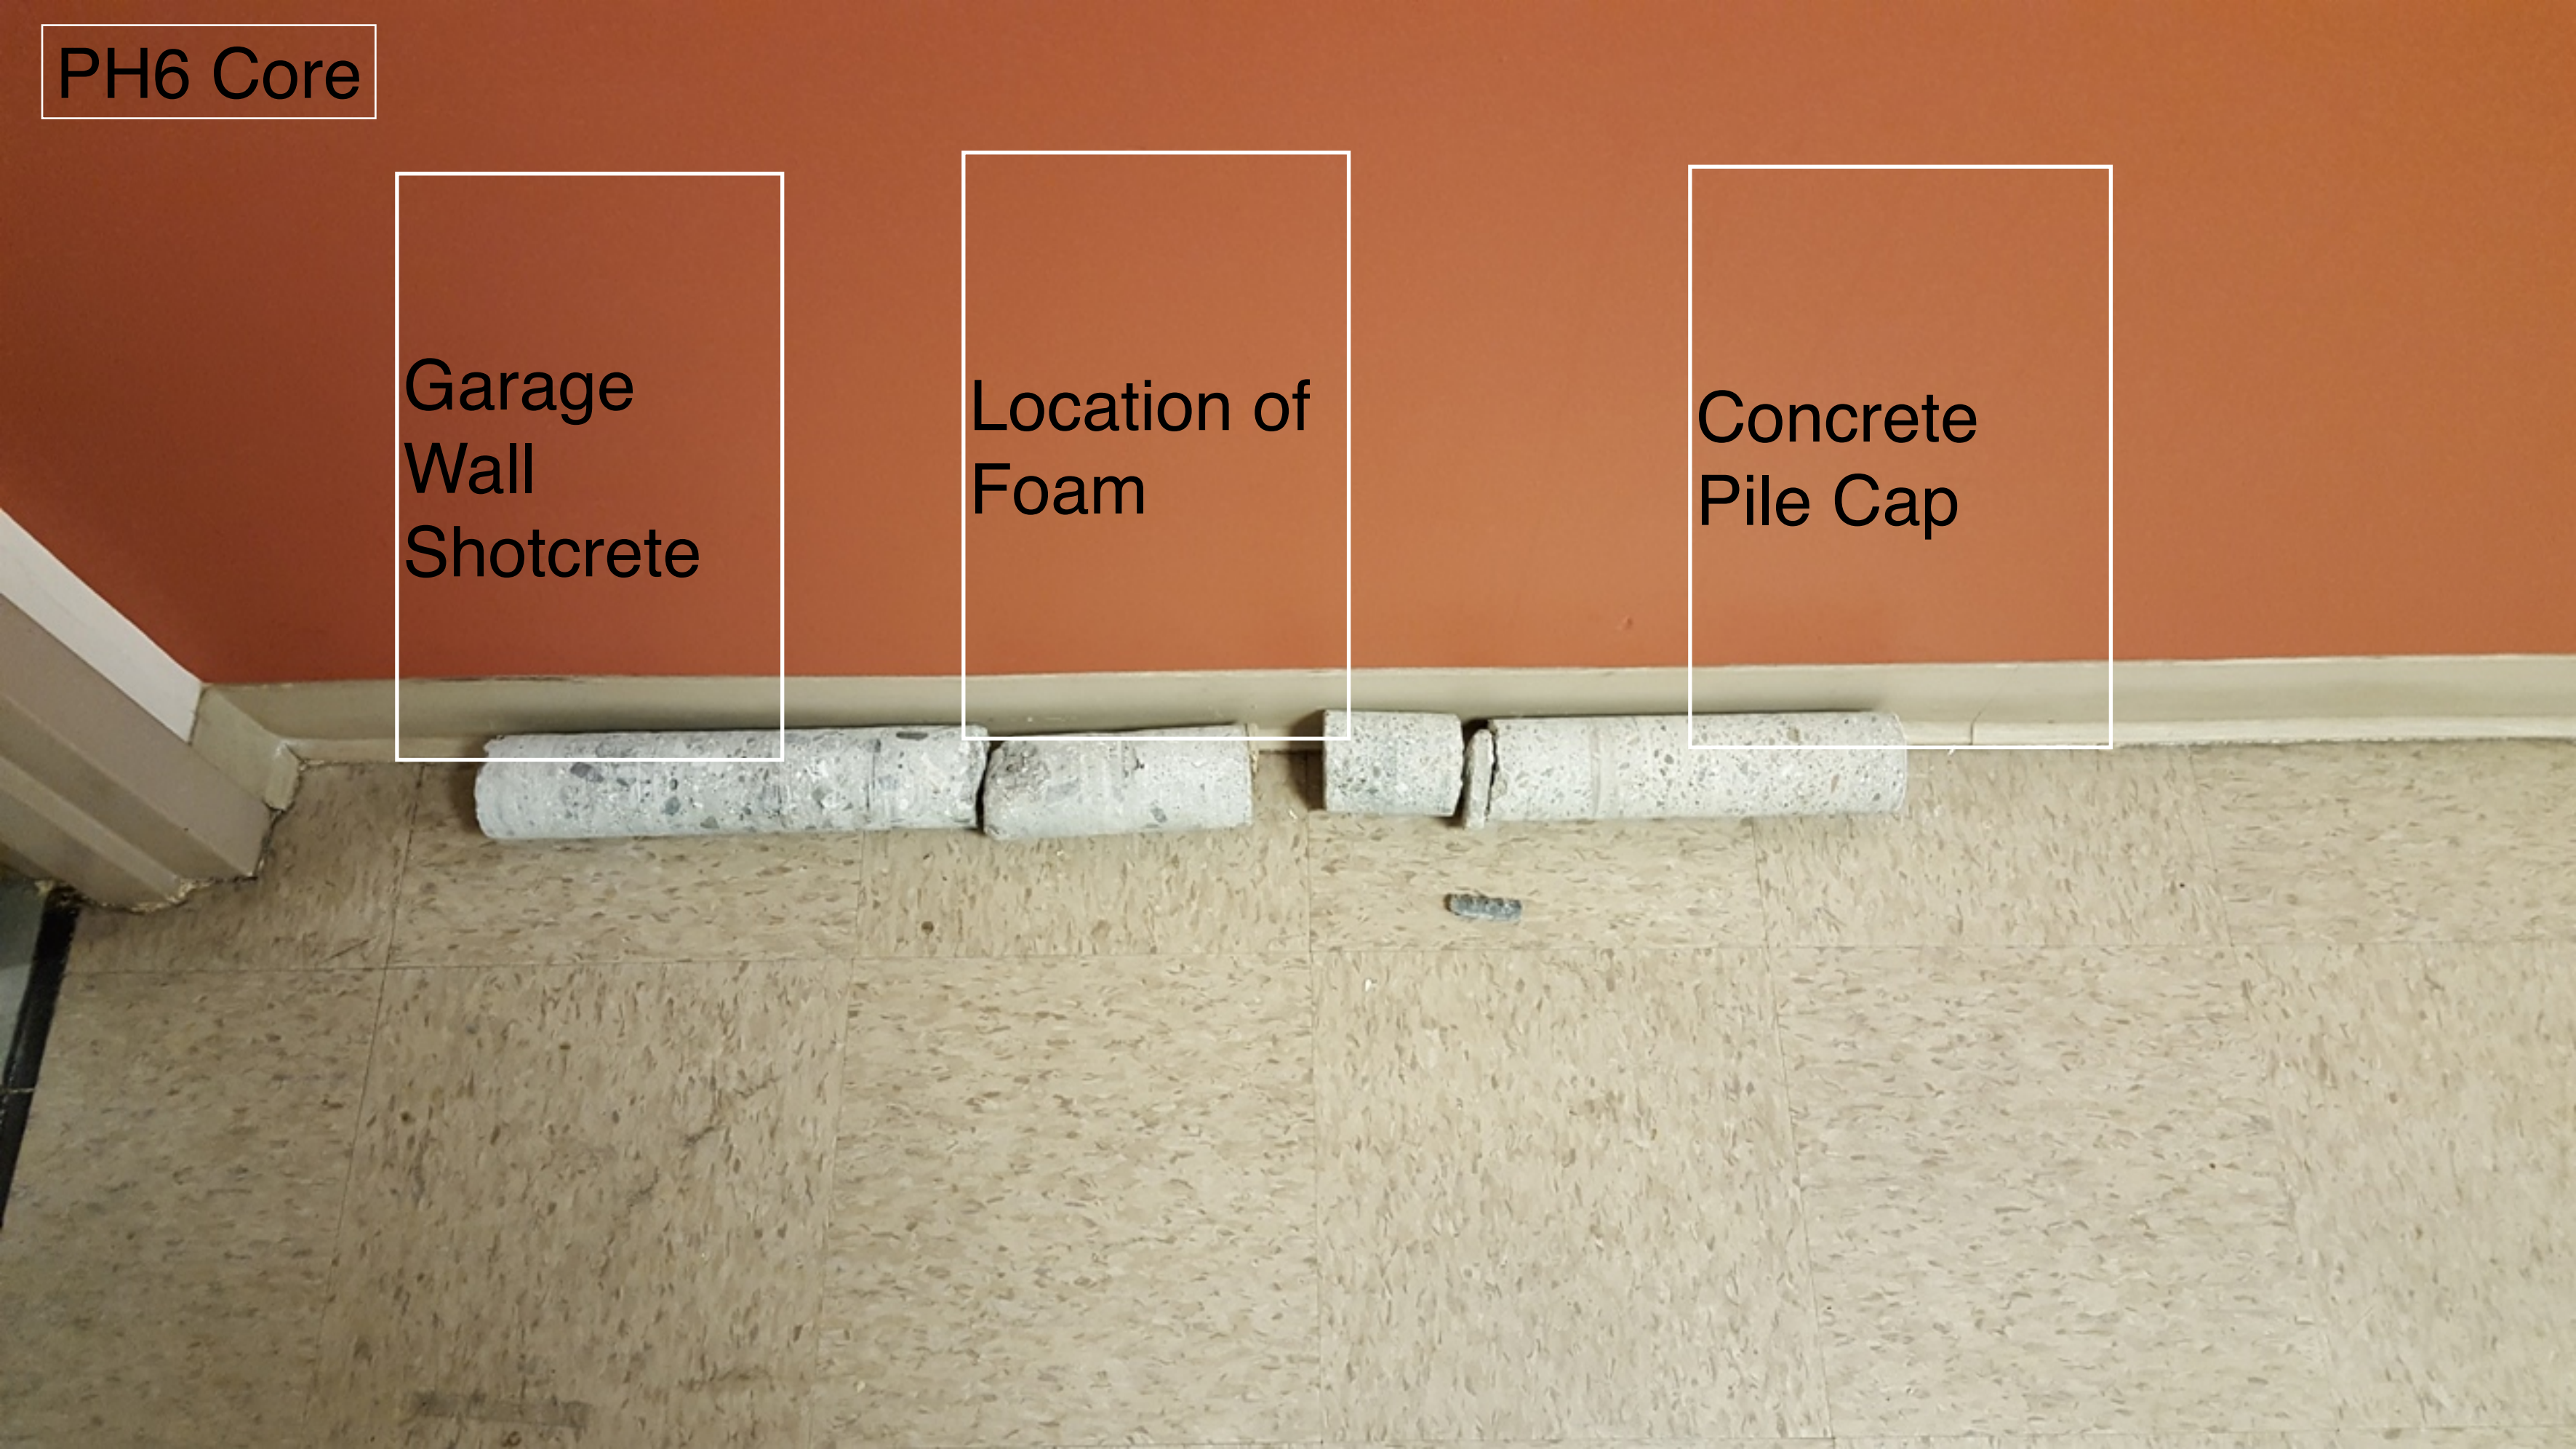
PH6 Core

**PH6 Location:** Penhall cored 3-inch diameter hole PH6.0 on Monday, August 14, 2017, on parking garage Level B2. PH6.0 consisted of a core through the shotcrete garage wall and into the concrete pile cap below the high-rise portion of the building. An approximately 2-inch thick section of polymeric joint filler was observed between the two sections of concrete. Striations were visible on the surface of this filler. No water was observed flowing from this hole following completion of the coring.

Garage  
Wall  
Shotcrete

Location of  
Foam

Concrete  
Pile Cap

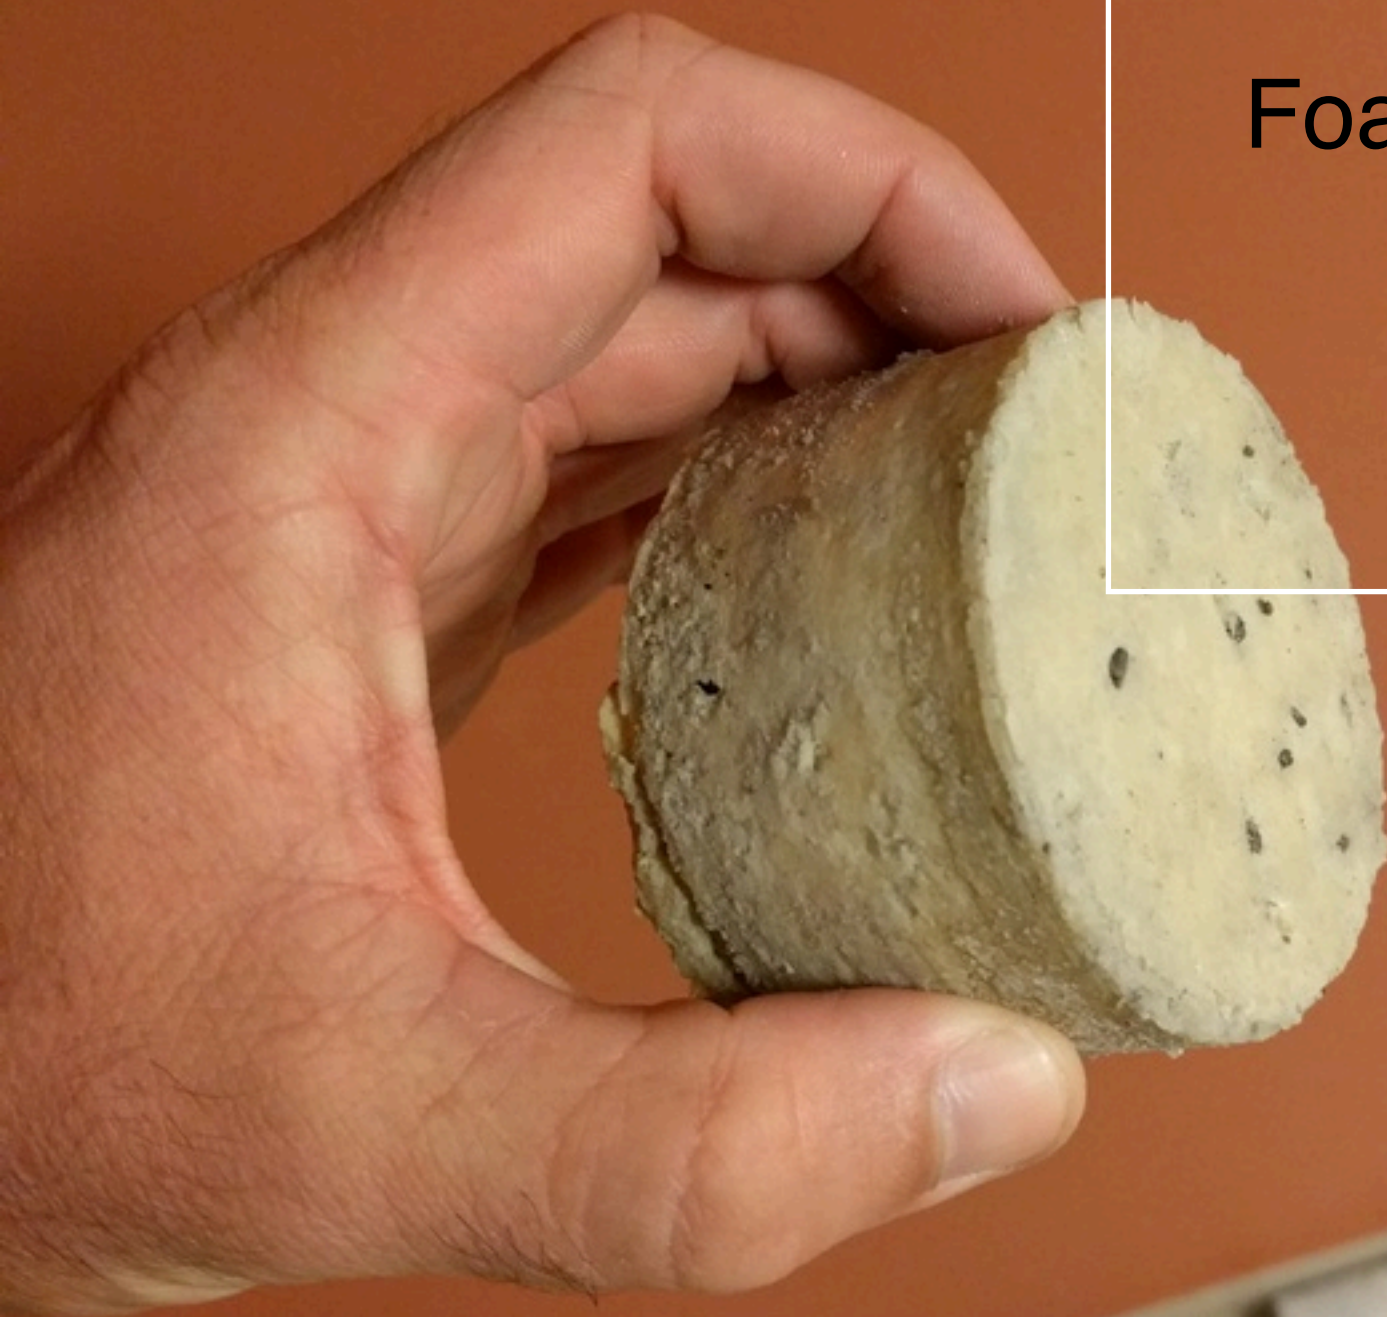
PH6 Core

Foam

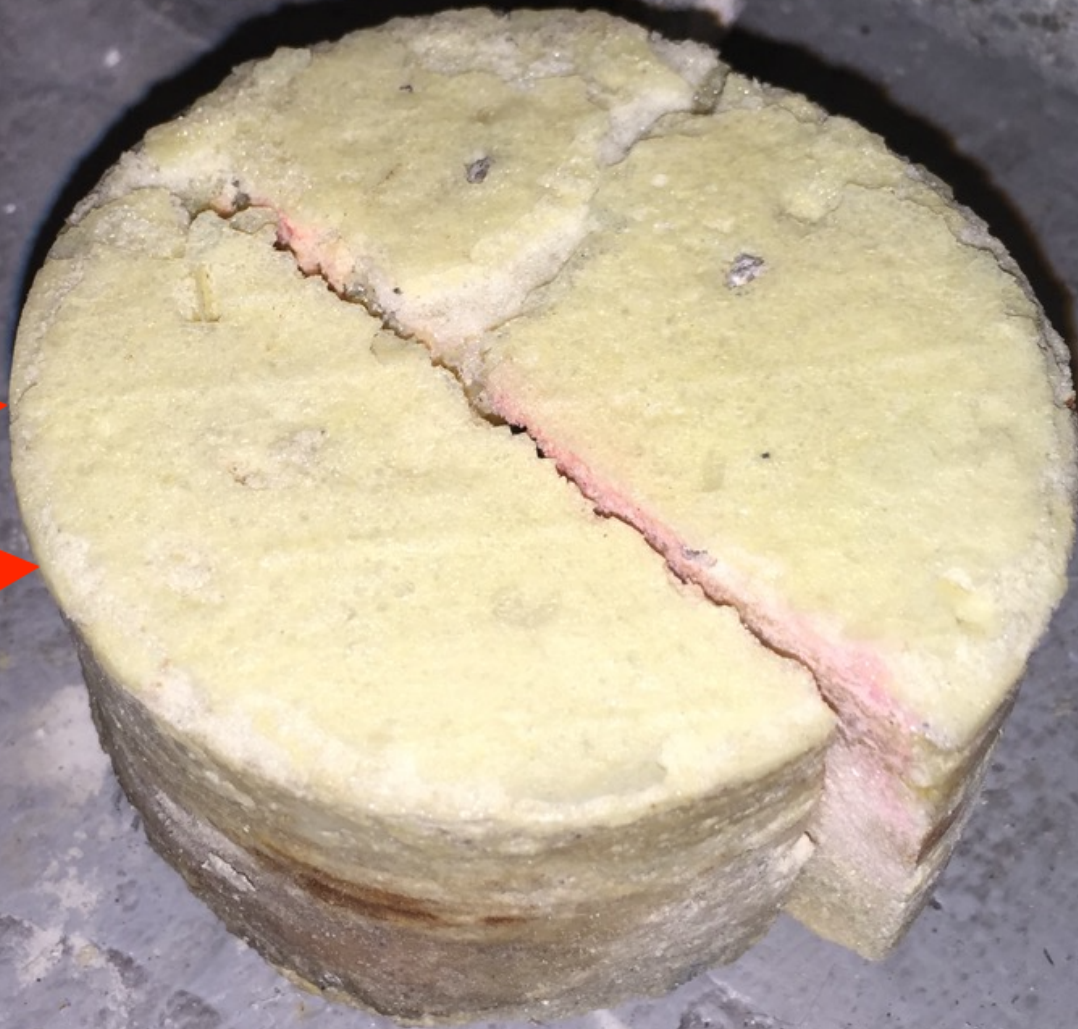
**STRIATIONS ON JOINT FILLER**

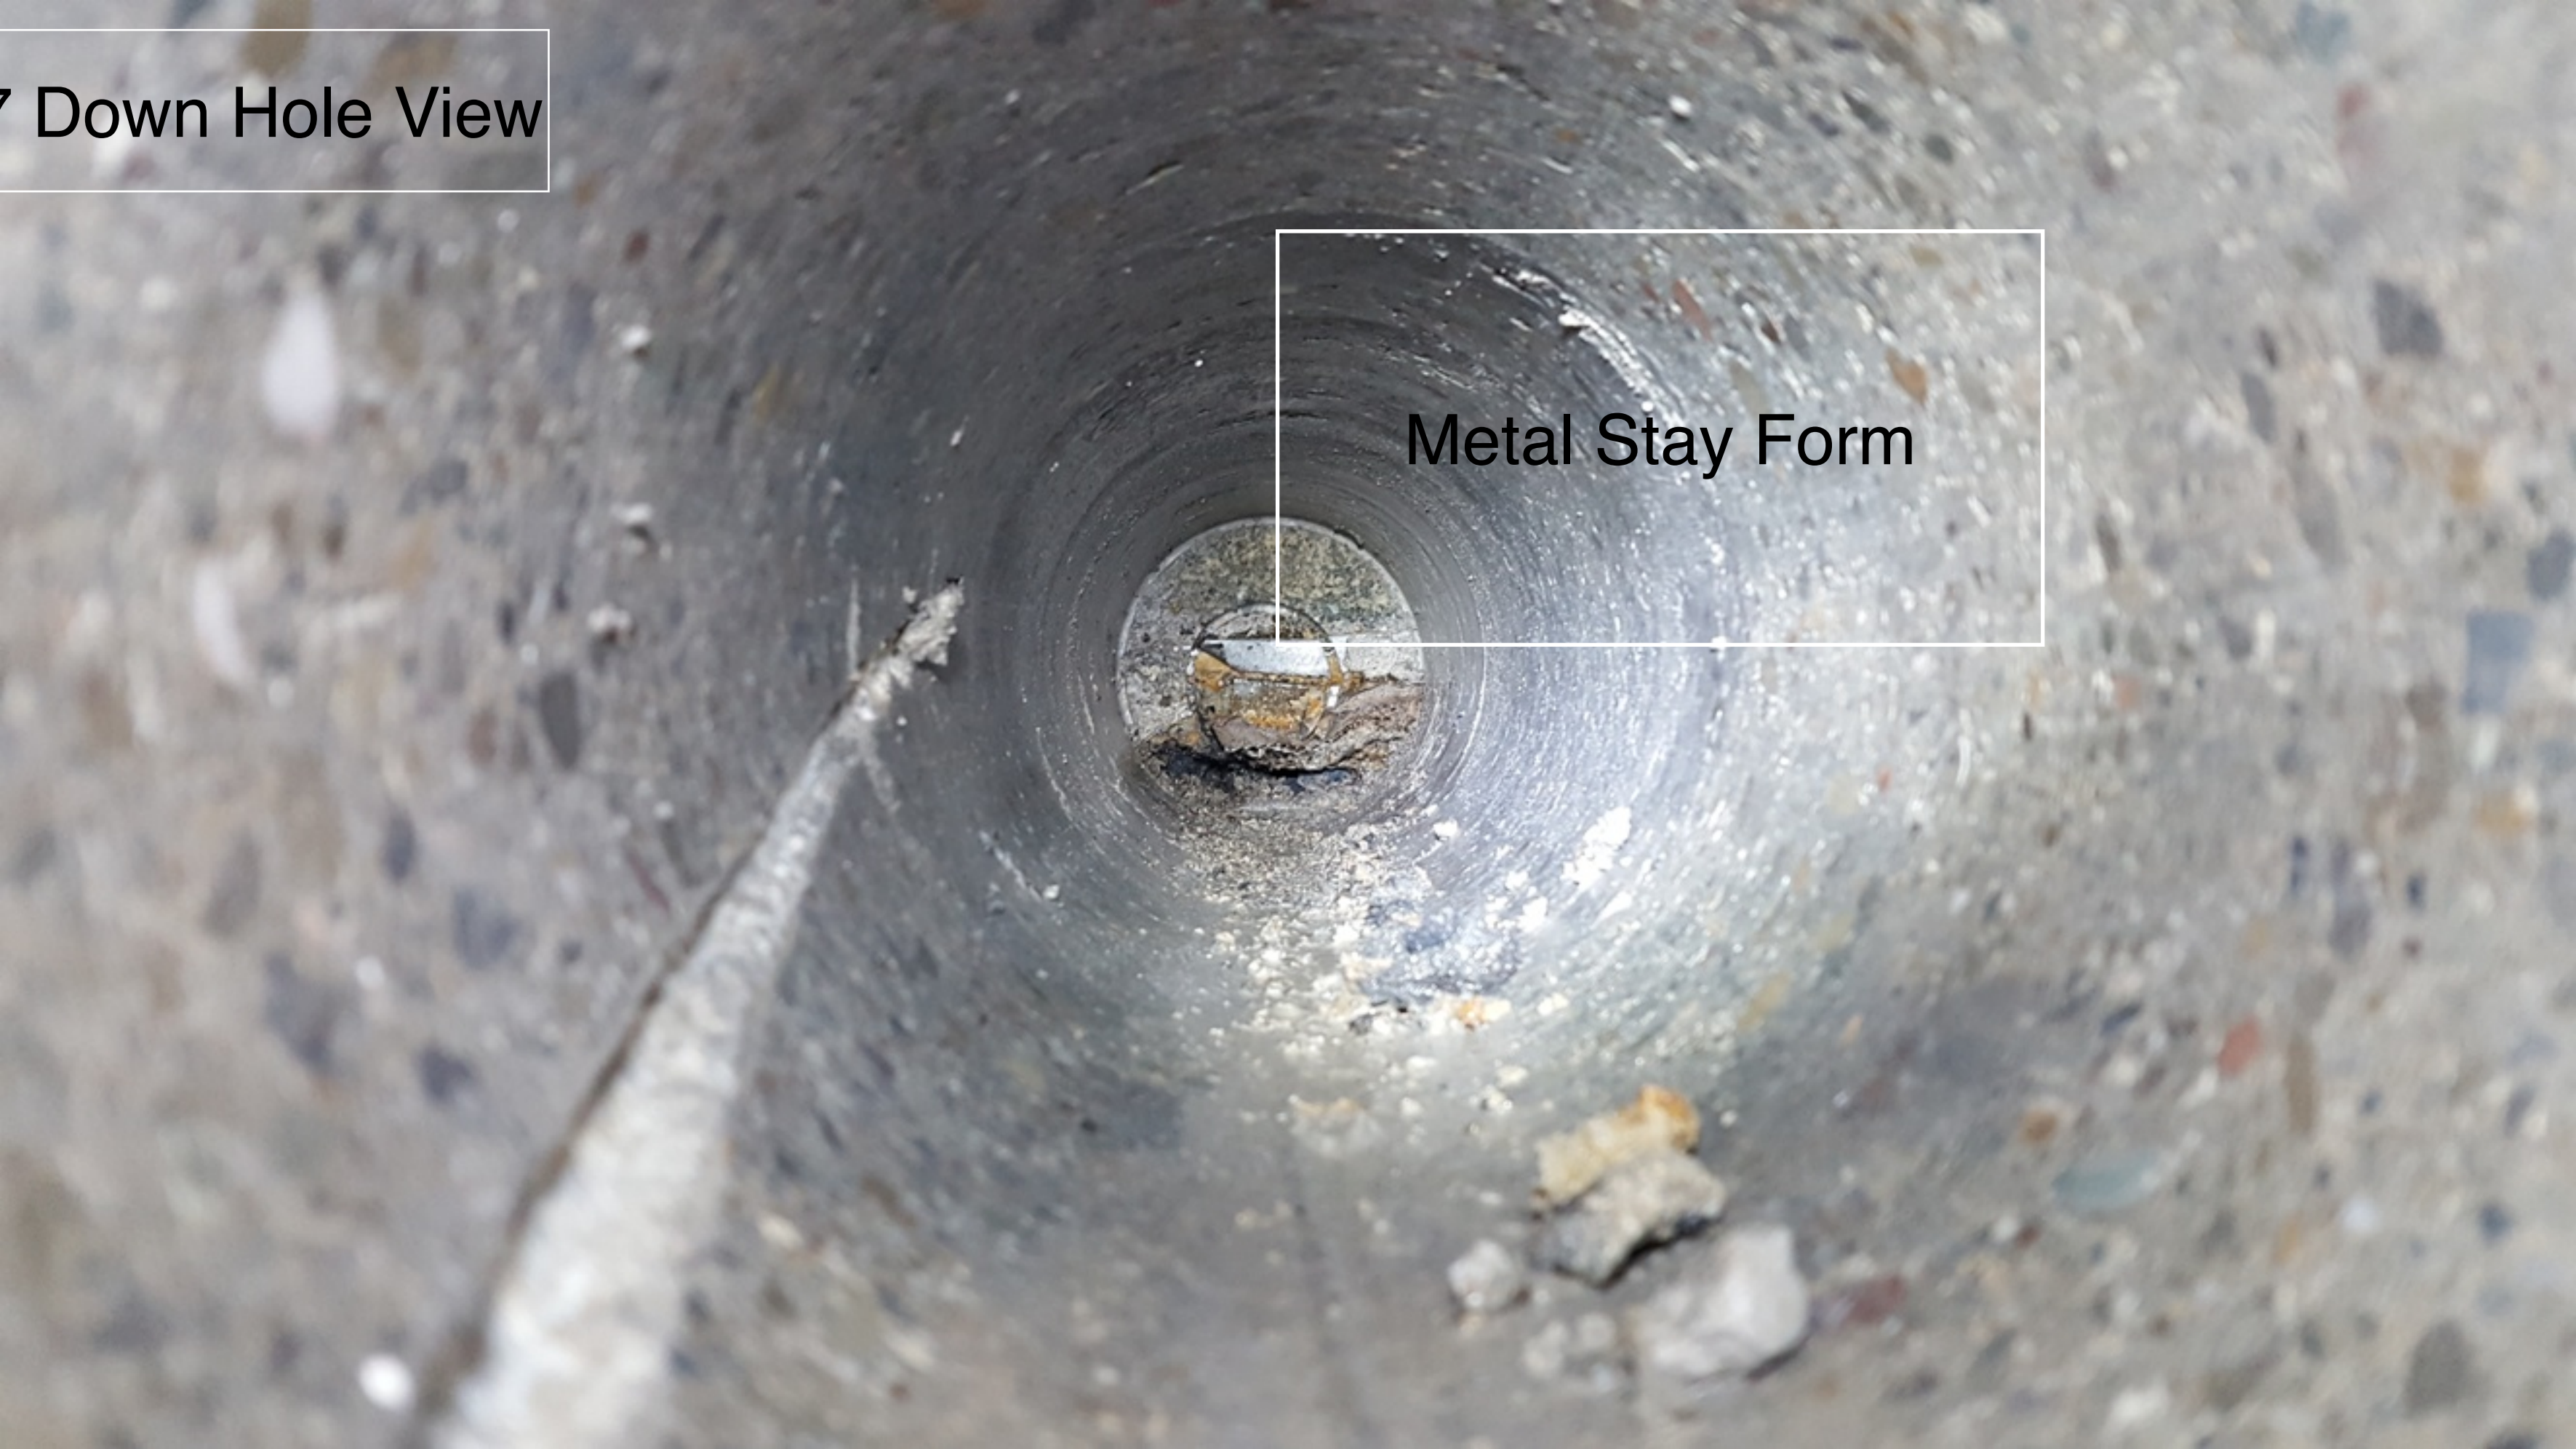
7 Down Hole View

**PH7 Location:** Penhall cored 6-inch diameter hole PH7 on Wednesday, August 16, 2017. The top of the shoring wall I-beam was not observed at the back of this hole. No water was observed flowing from this hole following completion of the coring.

Metal Stay Form

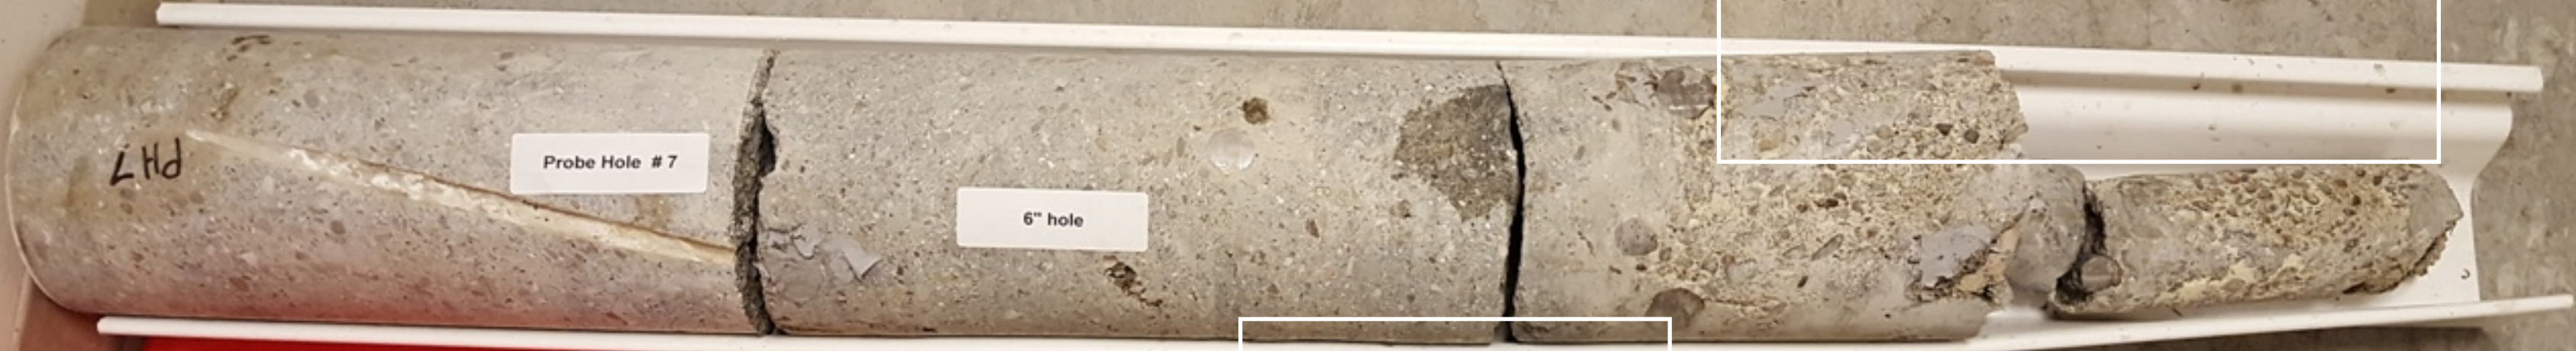
PH7 Core

Garage Wall  
Shotcrete with Foam  
Filled Spaces

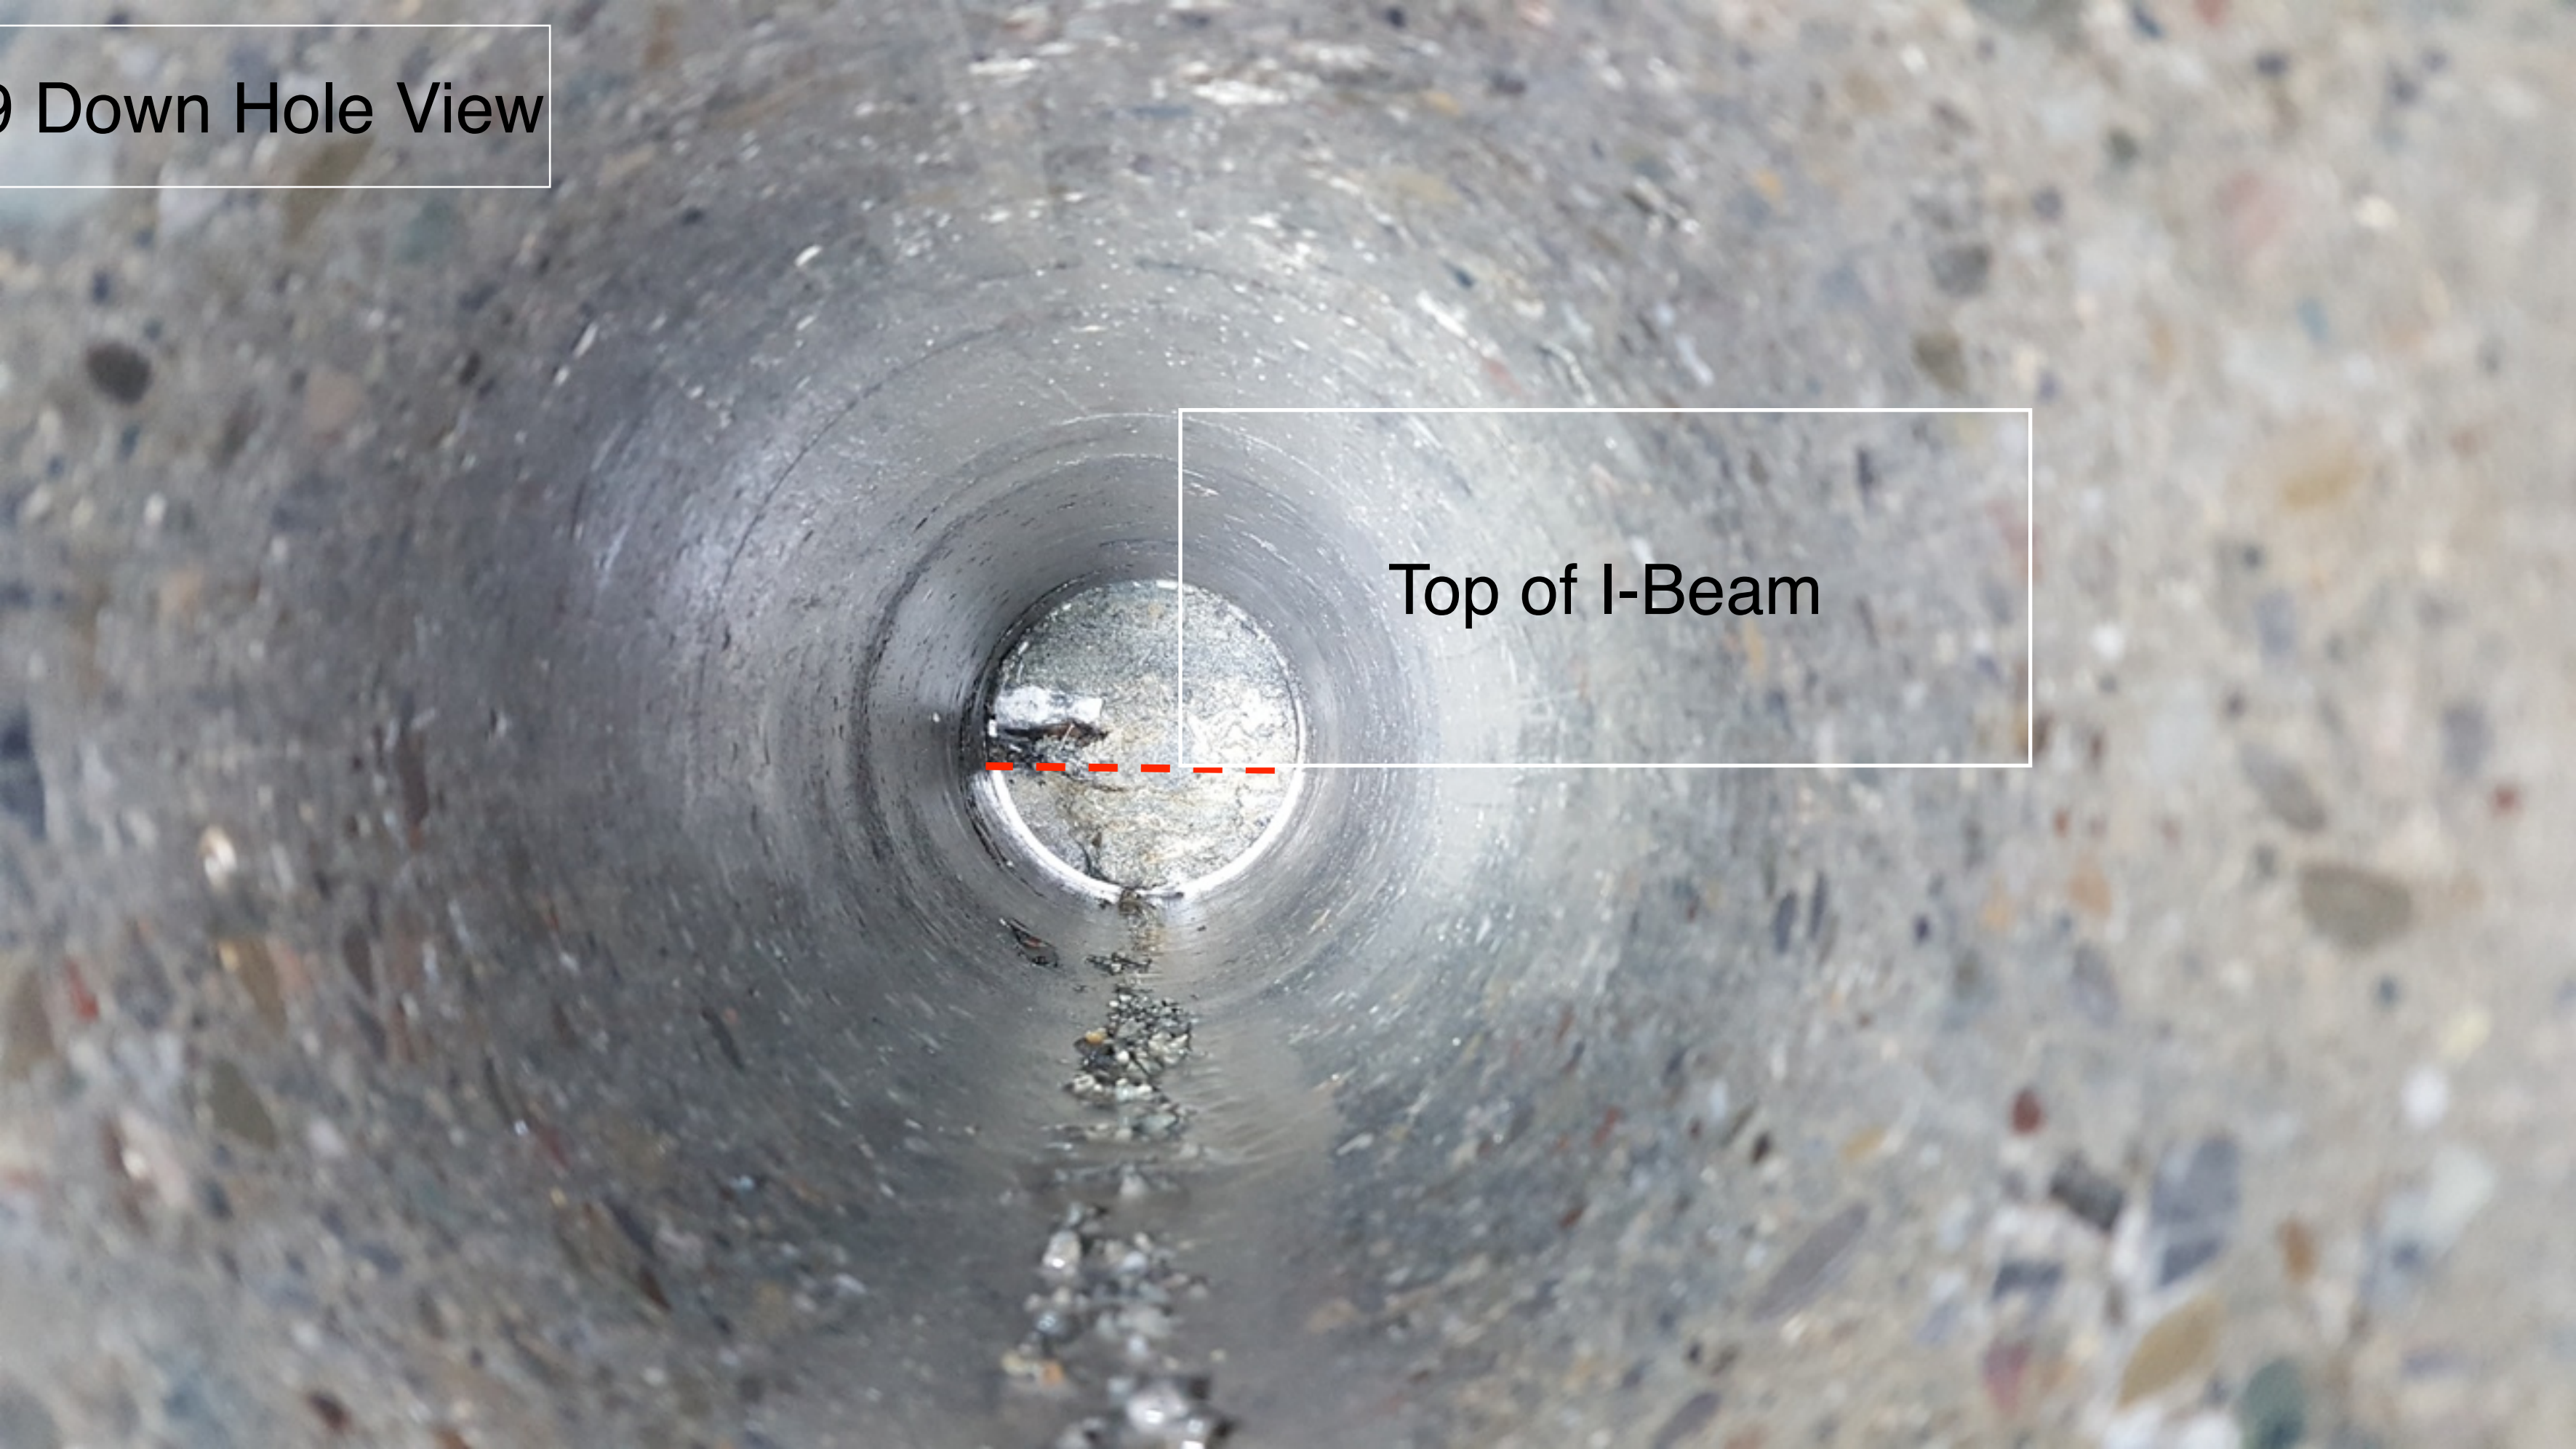
Down Hole View

**PH9 Location:** Penhall cored 6-inch diameter hole PH9 on Wednesday, August 16, 2017. The top of the shoring wall I-beam was observed at the back of this hole. No water was observed flowing from this hole following completion of the coring.

Top of I-Beam

Following the expert committee inspection on Thursday, August 17, 2017, Jason Stone (LERA), Jim Eggers (Nicholson Construction Company), and Joe Durdella (CSA) discussed that larger diameter core holes PH4, PH5, PH8, and PH9 would remain open for potential future purposes and that Nicholson Construction Company (NCC) would install larger diameter packers in these holes to prevent groundwater seepage through the garage wall. It was discussed that larger diameter core holes PH1, PH2, PH3, and PH7 would be closed up using hydraulic cement pumped through a former mounted flush with the garage wall face and pumped through a port until it returns through an escape port on the former. At the request of CSA, Jim Eggers (NCC) agreed to leave the 3-inch diameter drain holes open, but install packers towards the back of the holes for future drainage or pressure monitoring purposes. CSA plans to install vibrating wire piezometers in 3-inch drain holes PH1.1, PH2.2, PH3.0, PH4.0, and PH5.1 either sooner or when it is time to close these holes permanently.
