**LAWRENCE B. KARP**  
CONSULTING GEOTECHNICAL ENGINEER

July 10, 2019

Subject: Millennium Tower  
301 Mission Street, San Francisco  
Two Differing Plans for Foundation Retrofitting

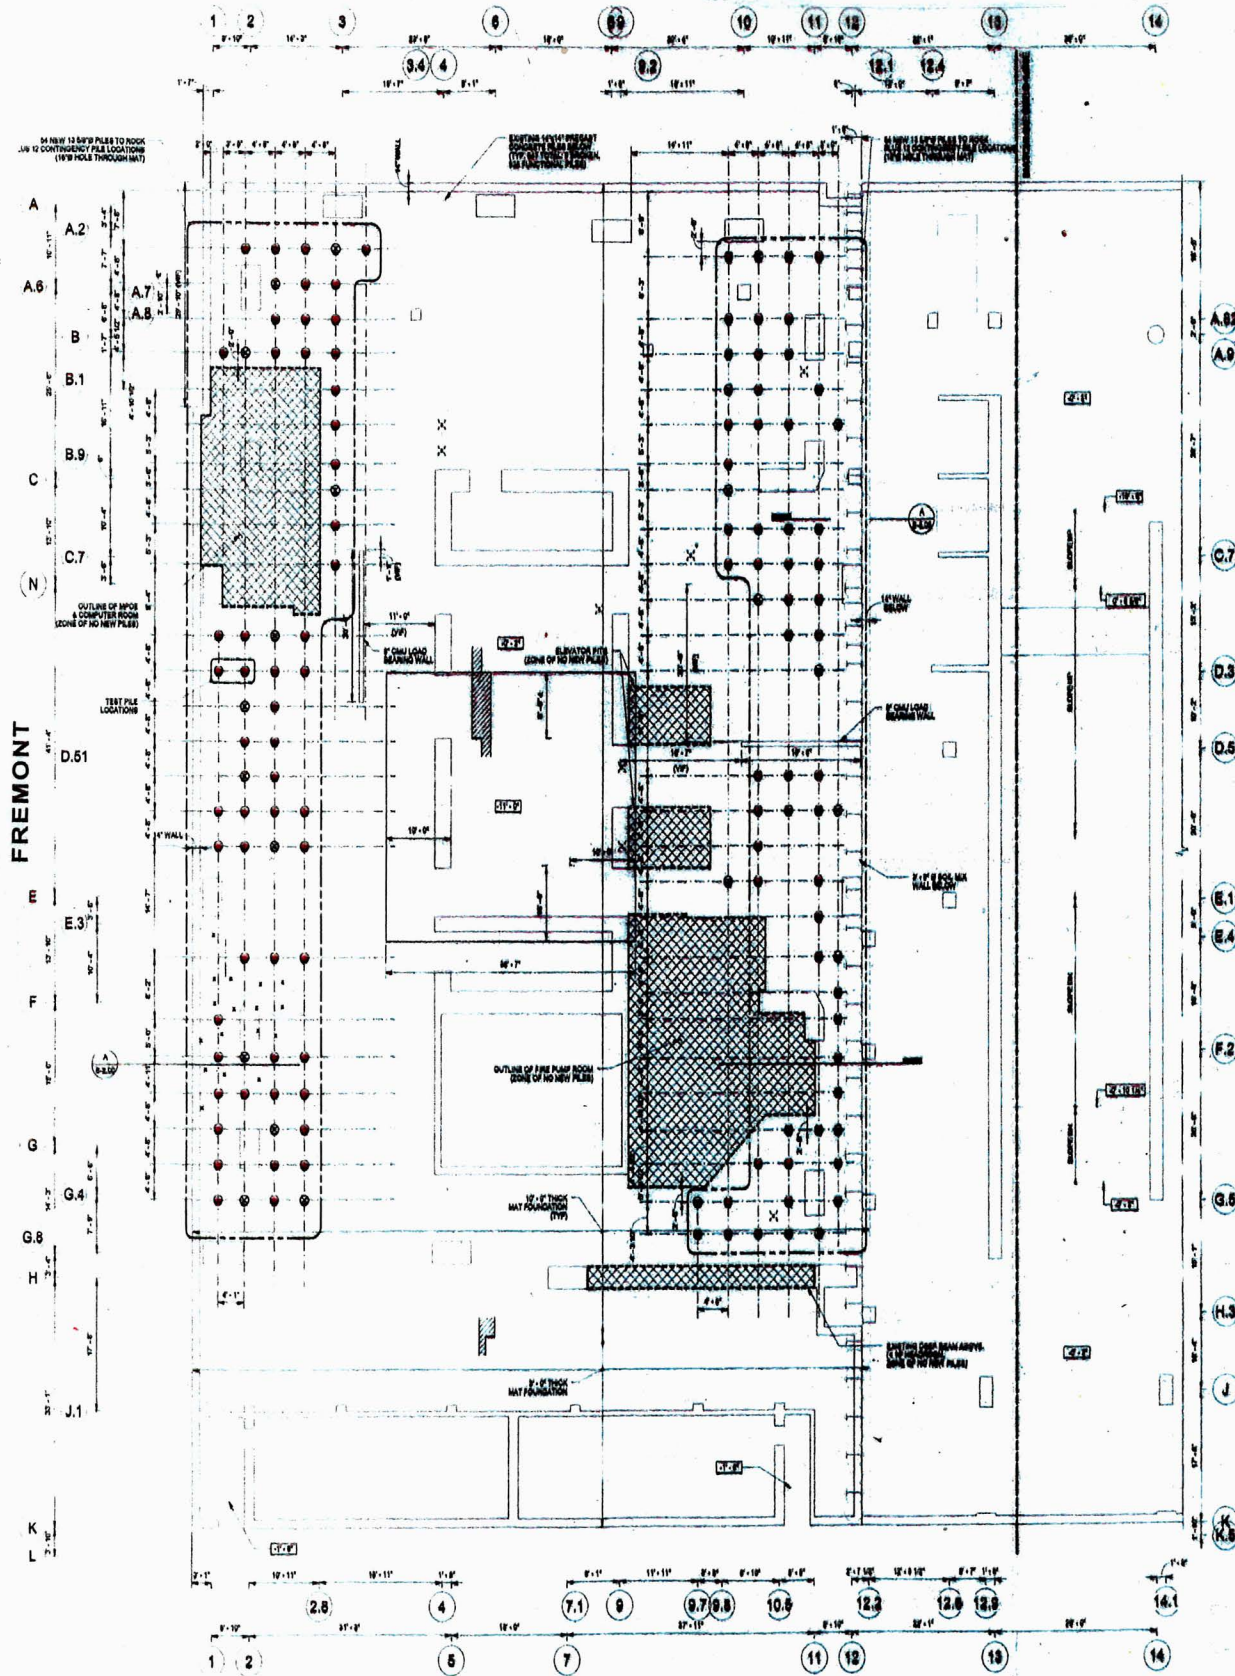
INTERNAL SYMMETRICAL FOUNDATION PLAN

The internal plan (attached schematic), designed by Leslie E. Robertson Associates (LERA), Consulting Structural Engineers, designer of the World Trade Center in New York, has a total of 108 new steel jacketed piles, 54 on the Fremont side and 54 on the opposite side of the building, arranged in a symmetrical longitudinal and transverse pattern that are installed inside the basement and will perform entirely within the building's footprint. The upper portions of the 13-5/8 inch outside diameter 5/8 inch wall thickness steel rock piles are 30 feet long in and below the existing concrete mat, and inside the larger pipes are 9-5/8 inch outside diameter 1-3/8 inch wall thickness steel rock piles. The smaller piles extend through the larger piles into bedrock that is projected to be 220 feet from the bottom of the Millennium Tower mat portion of the substructure.

The entirely new pile system will provide full uniform and symmetrical vertical and lateral support for the Tower. The new lateral resistance to base shear provided by the 108 13-5/8 inch diameter piles below the mat is a much improved lateral force resisting system over the original design that relied on passive resistance against the basement wall and the prestressed concrete piles with the design assumption that the bottom of the mat substructure would remain level.

The new piles will be jacked into bedrock through holes cut through the basement slab. The jacking system uses the weight of the concrete building as a reaction. Pile locations as finally set were arranged to avoid MPE utilities, computer facilities, and fire pump house. Pile sections have threaded connections, there is no welding and annular space in the piles are grouted. The internal plan does not involve any dewatering and there is no drilling through soils. There is potential with the internal plan to at least partially return the substructure to a more level condition during the jacking process.
