Date: May 31, 2021 Project Number: 19-009

Subject: 301 Mission Retrofit Monitoring Report 004: Results as of May 28, 2021

CONTEXT

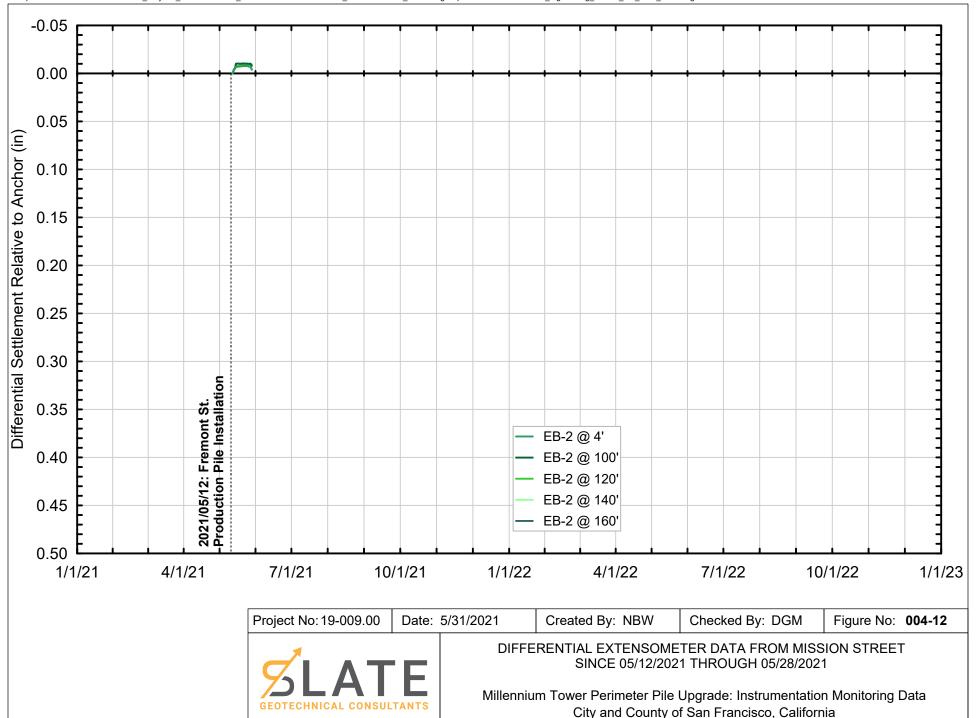
Figure 10 presents extensometer data from within the Tower basement since the start of production pile installation (May 12, 2021) through May 28, 2021. Figure 11 presents extensometer data from Fremont Street since the start of production pile installation (May 12, 2021) through May 28, 2021. Figure 12 presents extensometer data from Mission Street since the start of production pile installation (May 12, 2021) through May 28, 2021.

- Figure 12 Extensometer Data from Mission Street since 5/12/2021 through 5/28/2021
