Date: October 27, 2021
Project Number: 19-009
Subject: 301 Mission Retrofit Monitoring Report 026: Results as of October 25, 2021

This memorandum summarizes results from the monitoring plan implemented at the 301 Mission property. Instrumentation to monitor the structure prior to, during and after the retrofit was installed in January 2021, including piezometers and extensometers. Settlement markers installed in April 2009 and January 2017, survey prisms mounted on the exterior of the structure in December 2016, and crack gauges installed in April 2009 have also been monitored. This memorandum is for review only. It only contains ongoing monitoring information. This memorandum does not contain recommendations based upon the ongoing monitoring information.

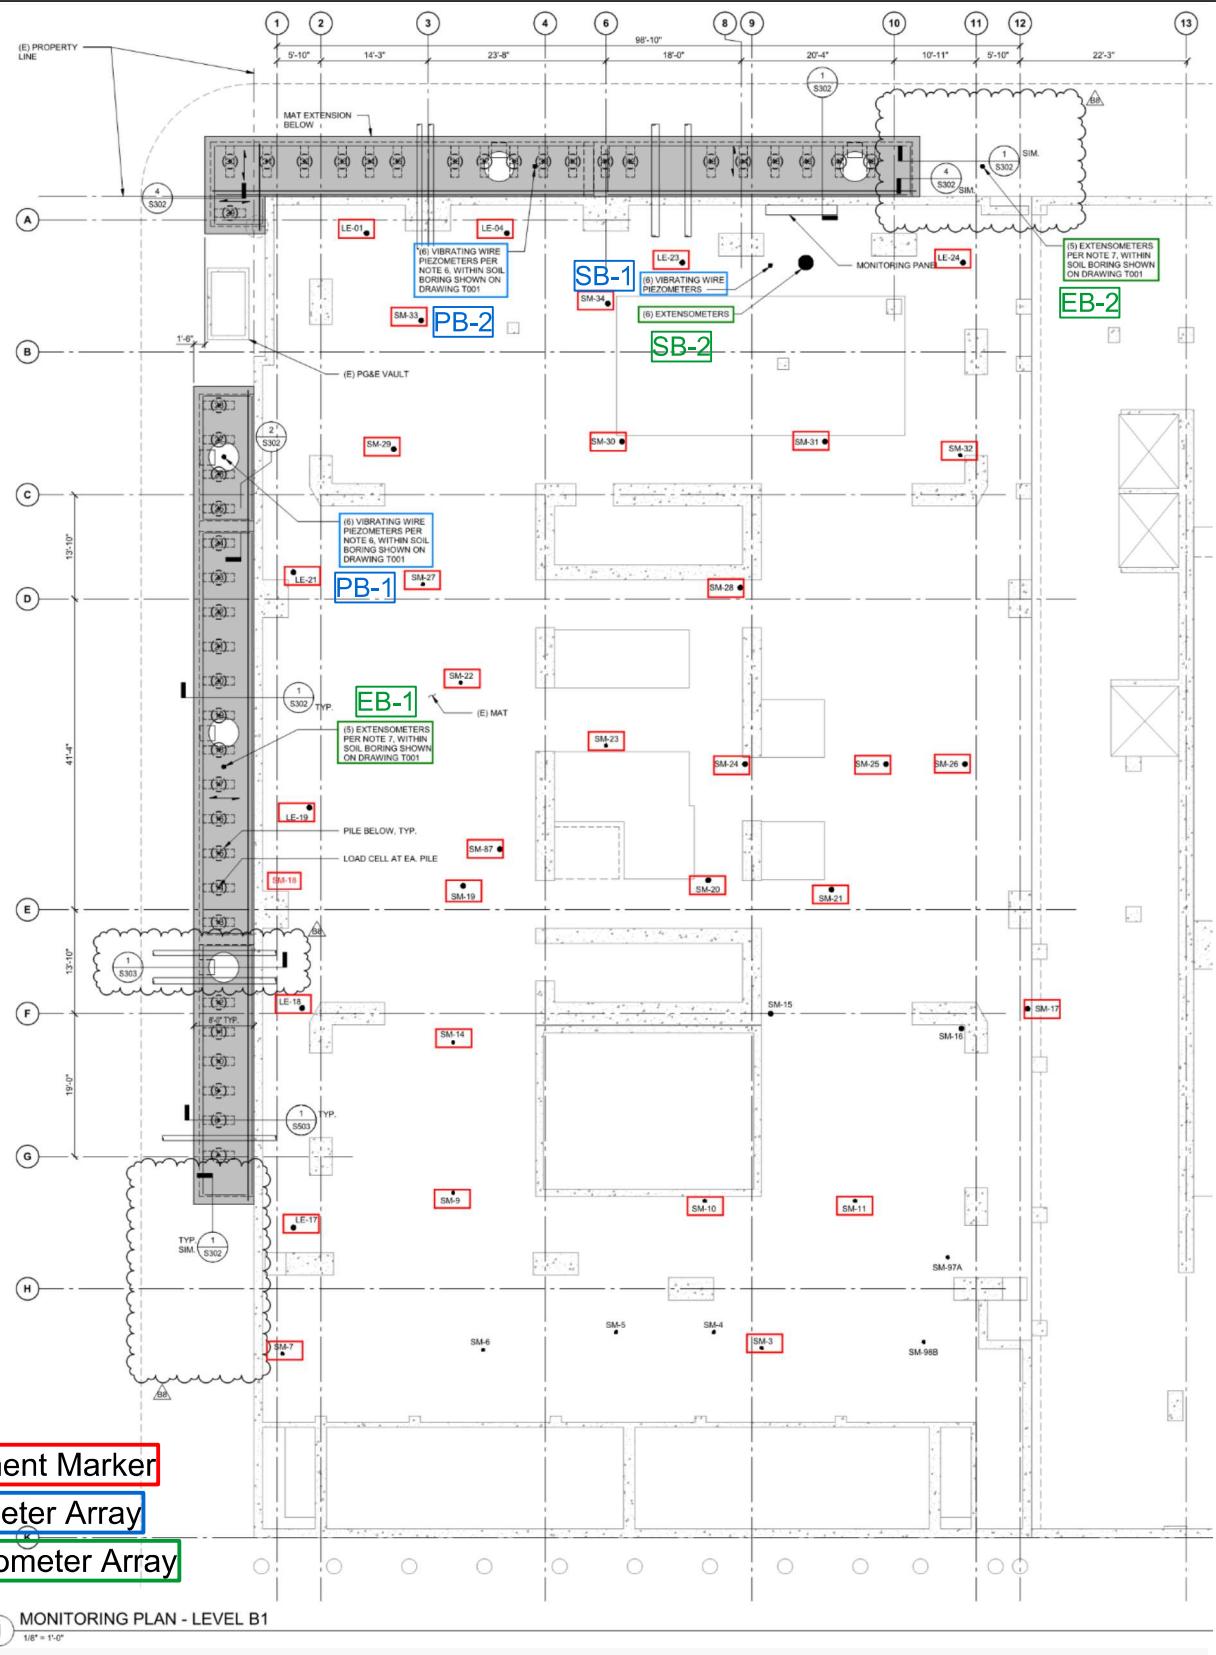
Project No: 19-009.00	Date: 7/26/2021	Created By: NBW	Checked By: DGM	Figure No: 026-01A
-----------------------	-----------------	-----------------	-----------------	--------------------

Figure 01 presents the instrument locations as referenced in later figures.

Settlement Marker

Piezometer Array

Extensometer Array

MONITORING PLAN - LEVEL B1
1/8" = 1'-0"

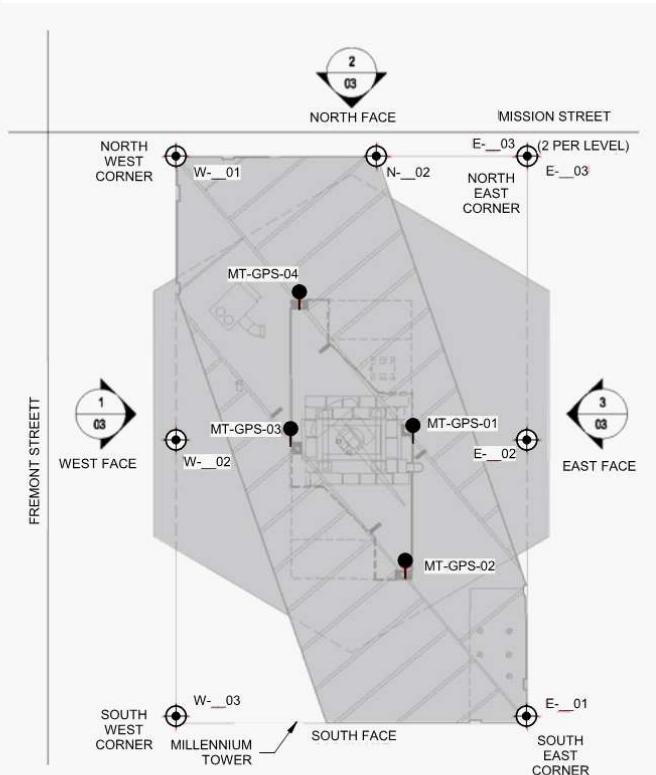
Project No: 19-009.00	Date: 7/26/2021	Created By: NBW	Checked By: DGM	Figure No: 026-01B
-----------------------	-----------------	-----------------	-----------------	--------------------

**3 ROOF PLAN OF SURVEY PRISM
INSTRUMENTATION**

**2 WEST ELEVATION OF SURVEY PRISM
INSTRUMENTATION**

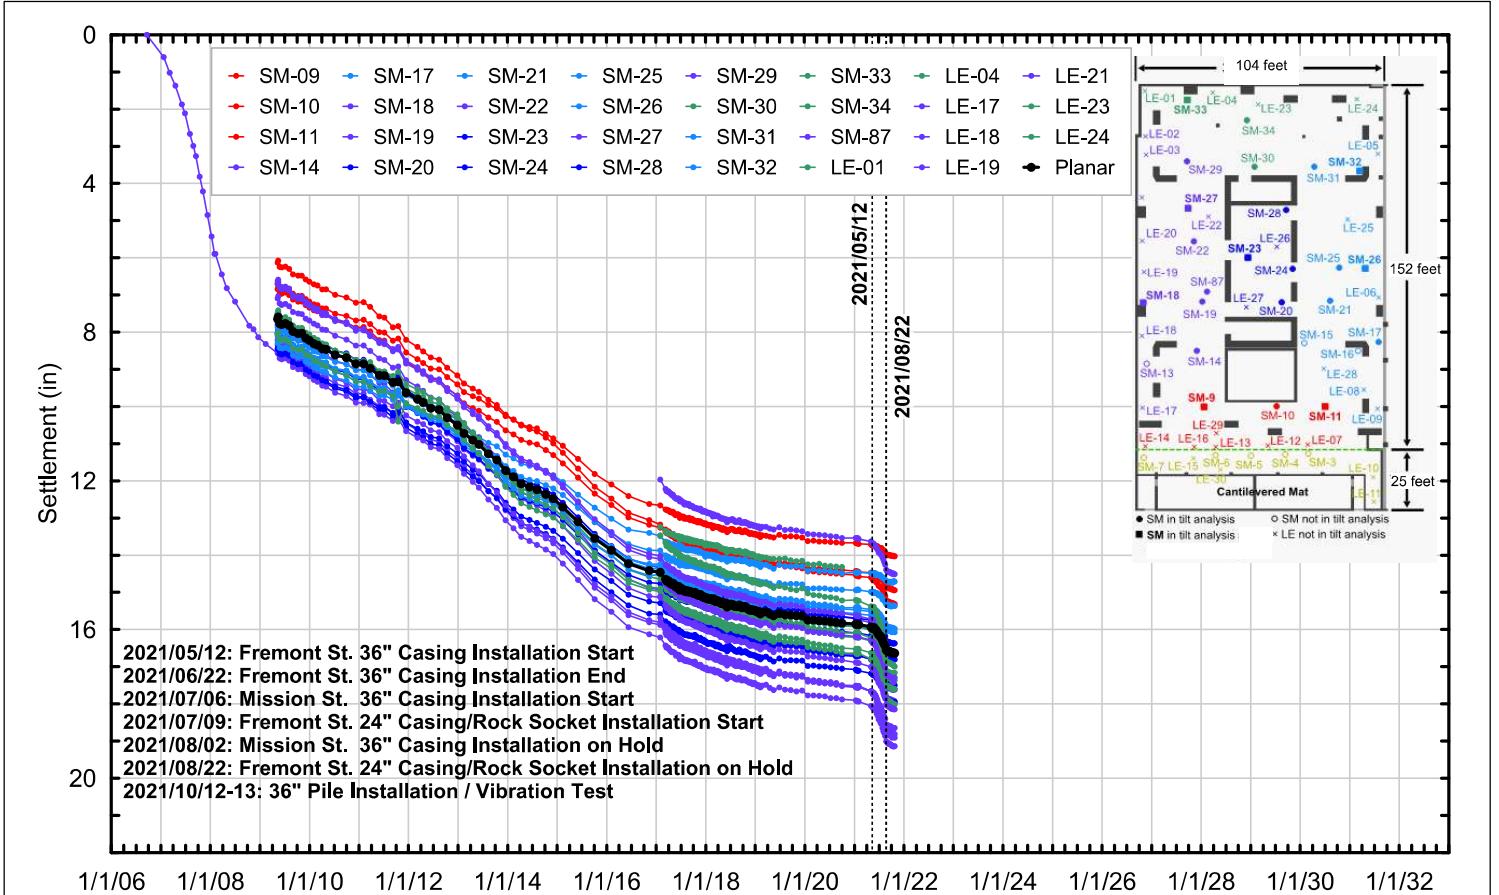
Project No: 19-009.00	Date: 10/27/2021	Created By: NBW	Checked By: DGM	Figure No: 026-02
	HISTORICAL SETTLEMENT MARKER DATA			Millennium Tower Perimeter Pile Upgrade: Instrumentation Monitoring Data City and County of San Francisco, California

Figure 02 presents the historical settlement data interpreted from settlement markers installed on the B-1 Level of 301 Mission Tower. In addition, data from surveys performed during the retrofit are included. Figure 03A presents settlement data since the start of production pile installation (May 12, 2021; baseline readings on May 10, 2021) through October 25, 2021. Figure 03B presents settlement data since January 11, 2021, through October 25, 2021. Figure 04 presents current settlement contours (in inches) on October 25, 2021.

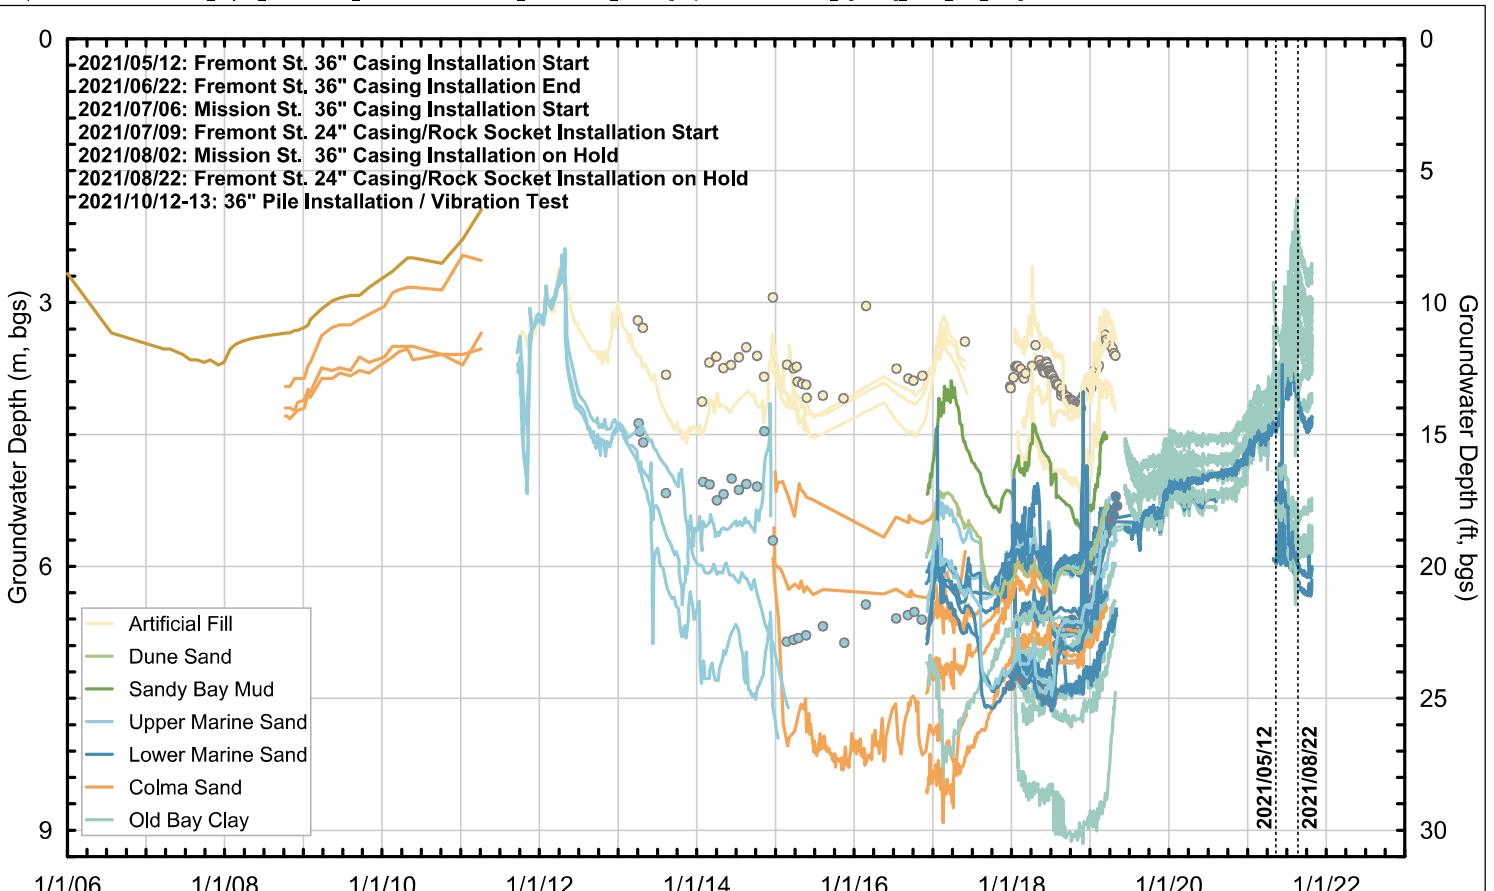
Project No: 19-009.00	Date: 10/27/2021	Created By: NBW	Checked By: DGM	Figure No: 026-07

Figure 07 presents the historical groundwater elevation interpreted from piezometer readings at locations near 301 Mission. In addition, data from piezometers installed to monitor groundwater elevation during the retrofit are included. Figures 08 and 09 present groundwater elevation interpreted from piezometer readings in the Marine/Colma Sand and the Old Bay Clay, respectively, for the time period prior to the start of production pile installation (January 1, 2021) through October 25, 2021.

HISTORICAL GROUNDWATER ELEVATION MEASUREMENTS AT LOCATIONS NEAR 301 MISSION			Millennium Tower Perimeter Pile Upgrade: Instrumentation Monitoring Data City and County of San Francisco, California

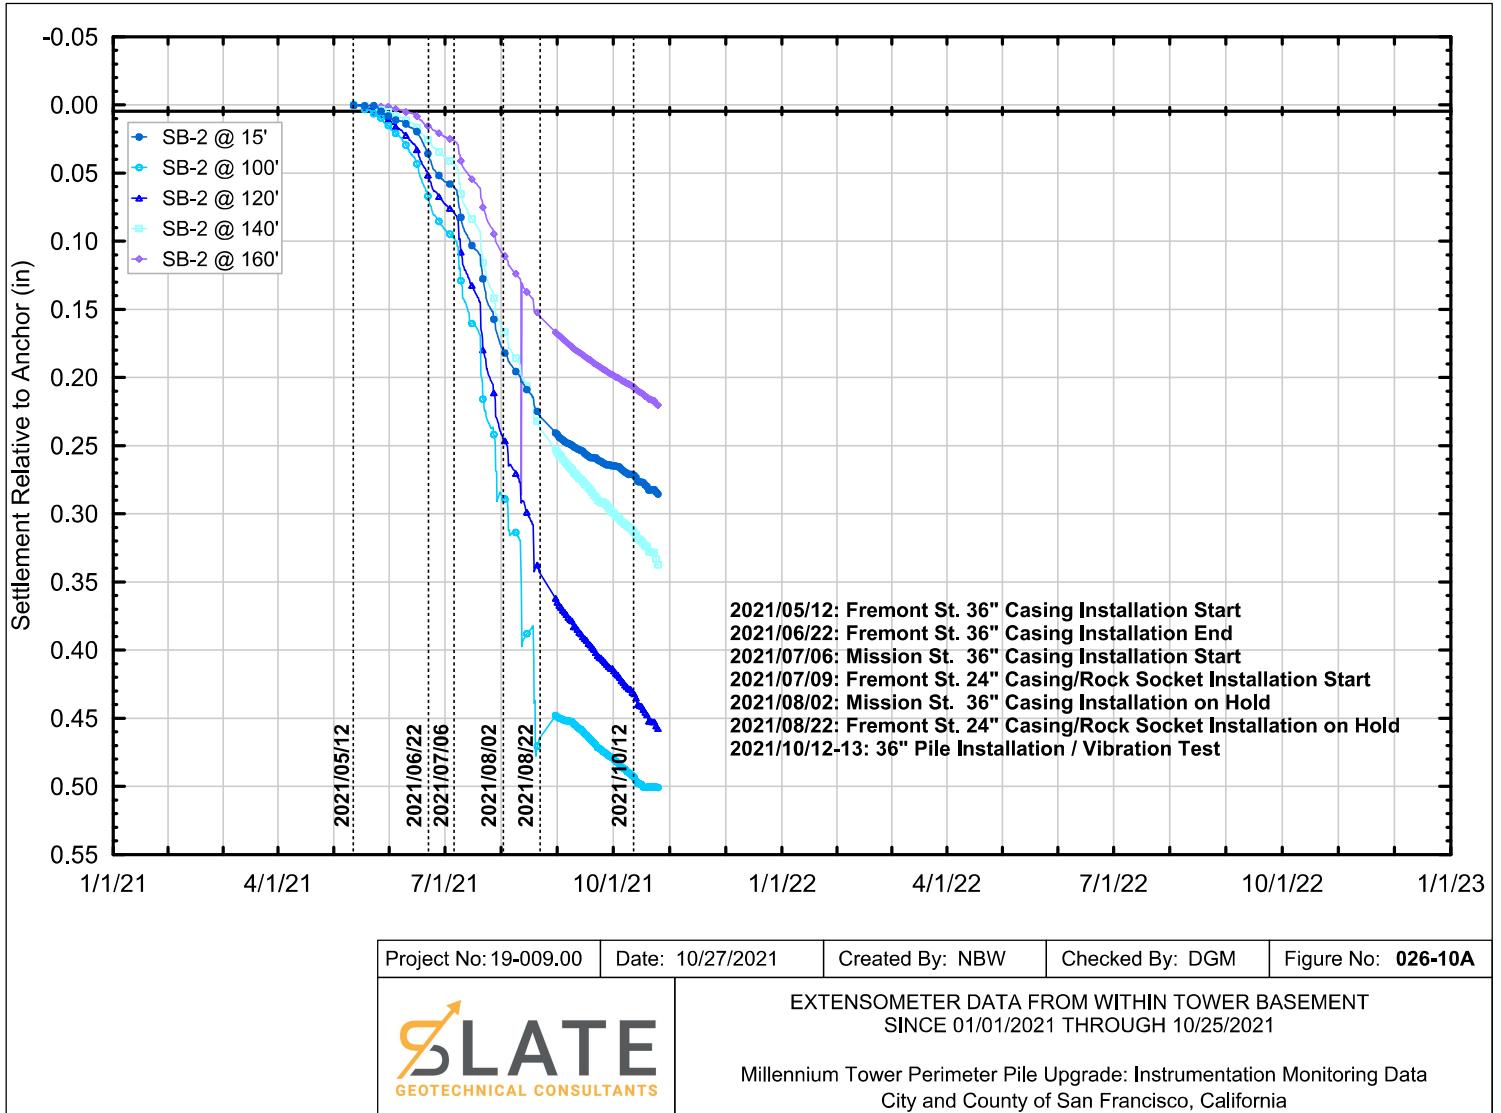
Filepath: S:\SlateDrive - Documents\Projects_2019\19-009.00_Millennium Tower Retrofit\10_Construction\01_Monitoring Reports\TowerSoilWater\00_Figures\Fig_026-10A_Ext_Data_Basement.grf

Figure 10 presents extensometer data from within the Tower basement since the start of production pile installation (May 12, 2021) through October 25, 2021. Figure 11 presents extensometer data from Fremont

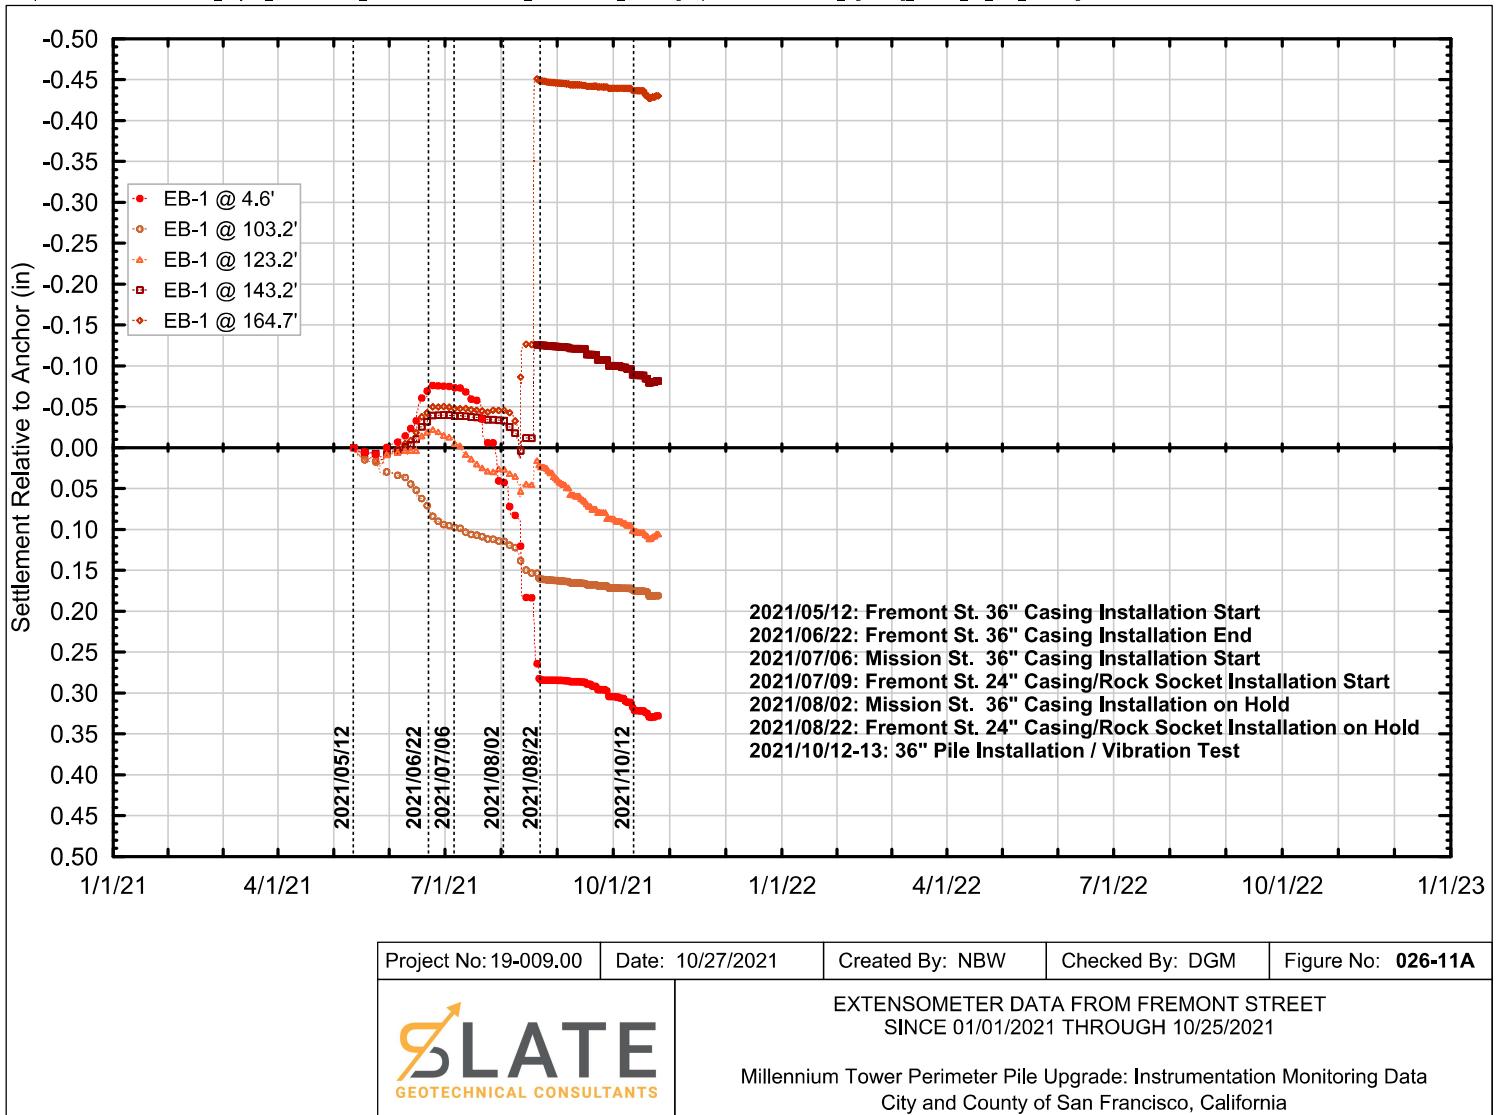
Filepath: S:\SlateDrive - Documents\Projects_2019\19-009.00_Millennium Tower Retrofit\10_Construction\01_Monitoring Reports\TowerSoilWater\00_Figures\Fig_026-11A_Ext_Data_Fremont.grf

Street since the start of production pile installation (May 12, 2021) through October 25, 2021. Figure 12 presents extensometer data from Mission Street since the start of production pile installation (May 12, 2021) through October 25, 2021.
