RAPID RECOVERY

To reopen State Route 1 as quickly and as safely as possible, Caltrans opted to construct a newly relocated highway across the body of the landslide.

After a major landslide closed a section of the iconic State Route 1 through central California's scenic coastal region of Big Sur, the California Department of Transportation swung into action. Relying on teamwork, innovative processes, and cutting-edge technology, Caltrans developed balanced solutions to restore access to this vital arterial as rapidly as possible while taking steps to protect the highway and its travelers from the effects of similar events in the future.

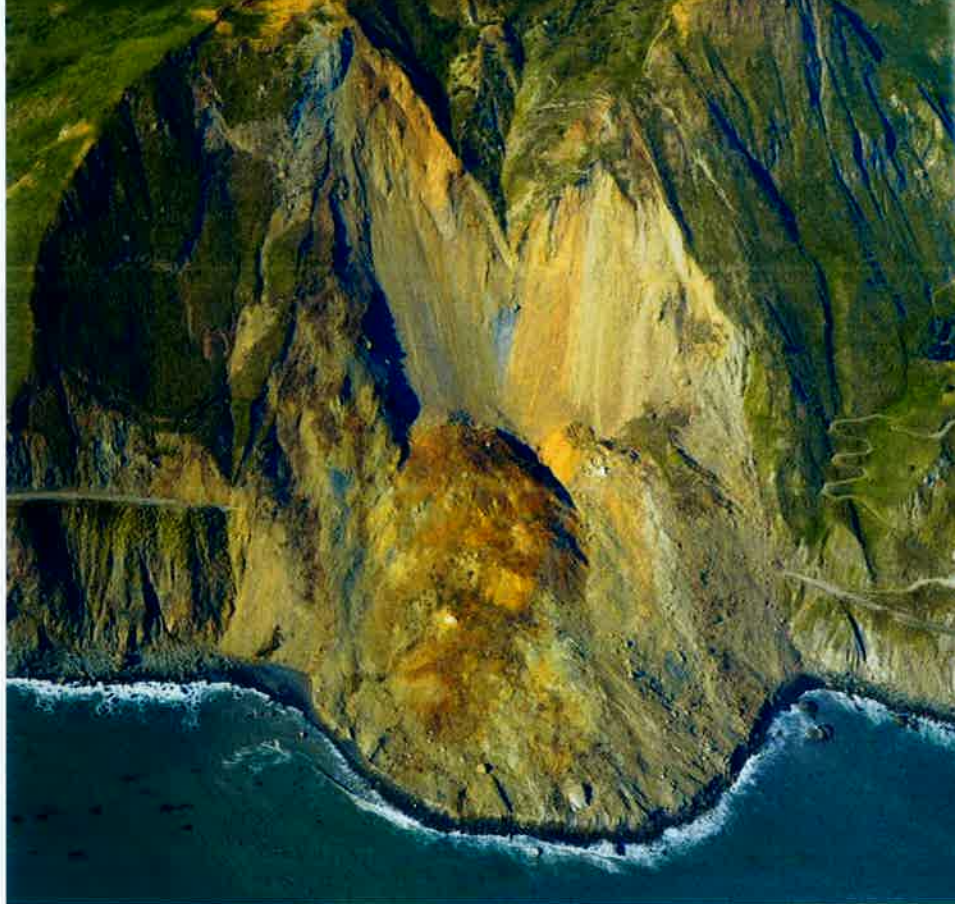
In May 2017, a massive landslide buried about 1,000 ft of State Route 1 beneath 160 ft of earthen materials.

At one point in May 2017, a subcontractor foreman determined it was unsafe to continue working on the highway and demobilized all the construction equipment from the site. The final pieces of equipment were removed on May 19. The next evening, 50 acres of land and more than 5 million cu yd of earth broke free from the mountainside. With a thunderous roar—likened to an earthquake by a nearby resident—a new 15-acre peninsula was created. About 1,000 ft of State Route 1 was now buried beneath 160 ft of earthen material. The new 2,400 ft long coastline jutted out 550 ft into the Pacific Ocean (see “Major Landslides on Iconic Coastal Roadway Occupy Caltrans in Big Sur Region,” *Civil Engineering*, July/August 2017, pages 16–17). Thanks to the expert judgment

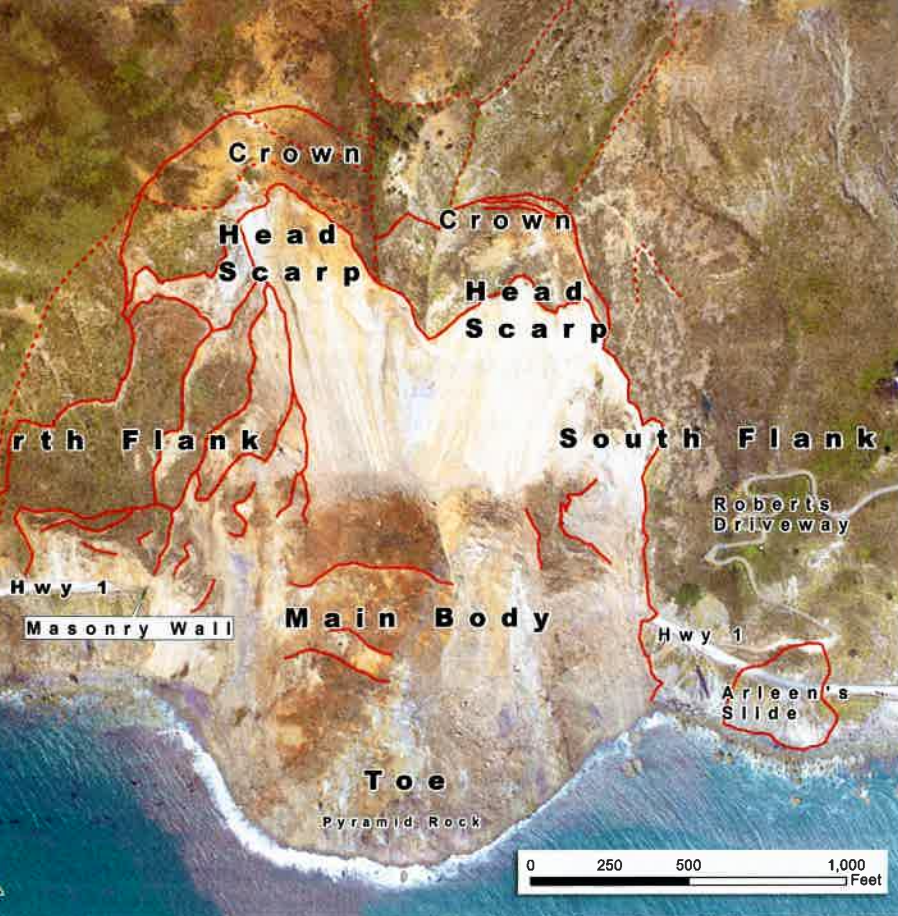
LANDSLIDES, no matter how large or small, generally consist of the same features. The main body of the slide is the material that moved downslope. The scarp is the freshly exposed mountain-side. Between these two features is the head of the slide. The crown of a slide is the material above the scarp, and the flanks are the soil on either side of the main body and scarp. The toe of a slide represents the outer limits of the main body, and in the case of a landslide into the ocean, it is the new shoreline. Although the Mud Creek slide was much larger than typical, it still behaved in a way that has been witnessed before. The perimeter slide areas, near the scarp and flanks, settled over time into a more natural equilibrium, while the main body remained relatively static.

Although the Mud Creek slide was much larger than typical, it still behaved in a way that has been witnessed before. The perimeter slide areas, near the scarp and flanks, settled over time into a more natural equilibrium, while the main body remained relatively static.

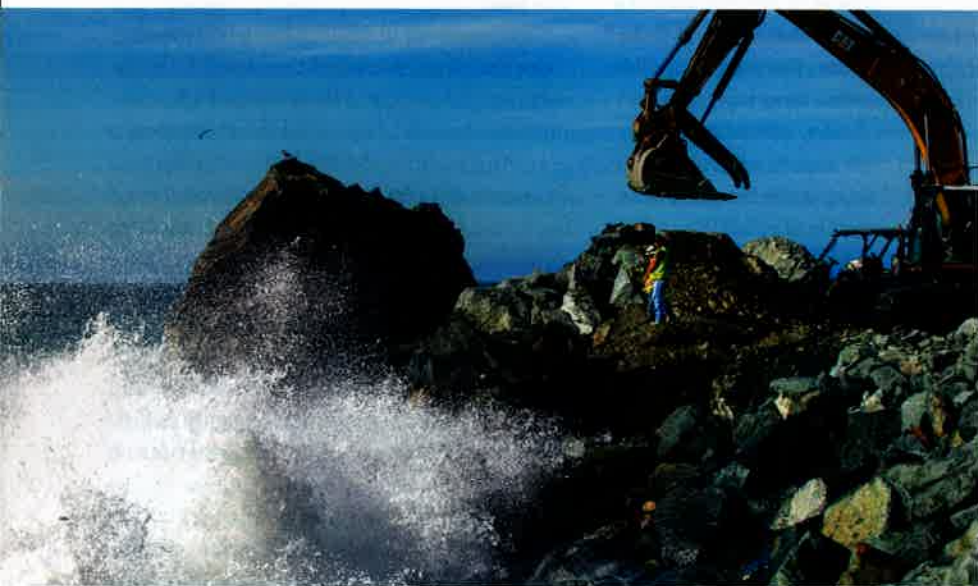
From fall 2017 to winter 2018, several large storms in the northern Pacific Ocean caused large swells and breaking waves at the project site, hampering construction of the rock revetment at the toe of the slide.

From fall 2017 through the winter, several large storms in the northern Pacific Ocean caused large swells and breaking waves at the project site, hampering construction of the rock revetment at the toe of the slide. During high tide and on days with larger swells, excavators and equipment were struck by the remains of breaking ocean waves, and in some instances work had to stop until the waves reduced in height and the tide lowered. One of the larger swell events occurred in October 2017, when some of the completed sections of the revetment were overtopped by the waves. Before this incident, the initial revetment design was proposed to be 26 ft tall. However, the swell and resulting waves prompted a design modification in structural height to 40 ft in the sections of revetment most exposed to the energy of the Pacific Ocean.

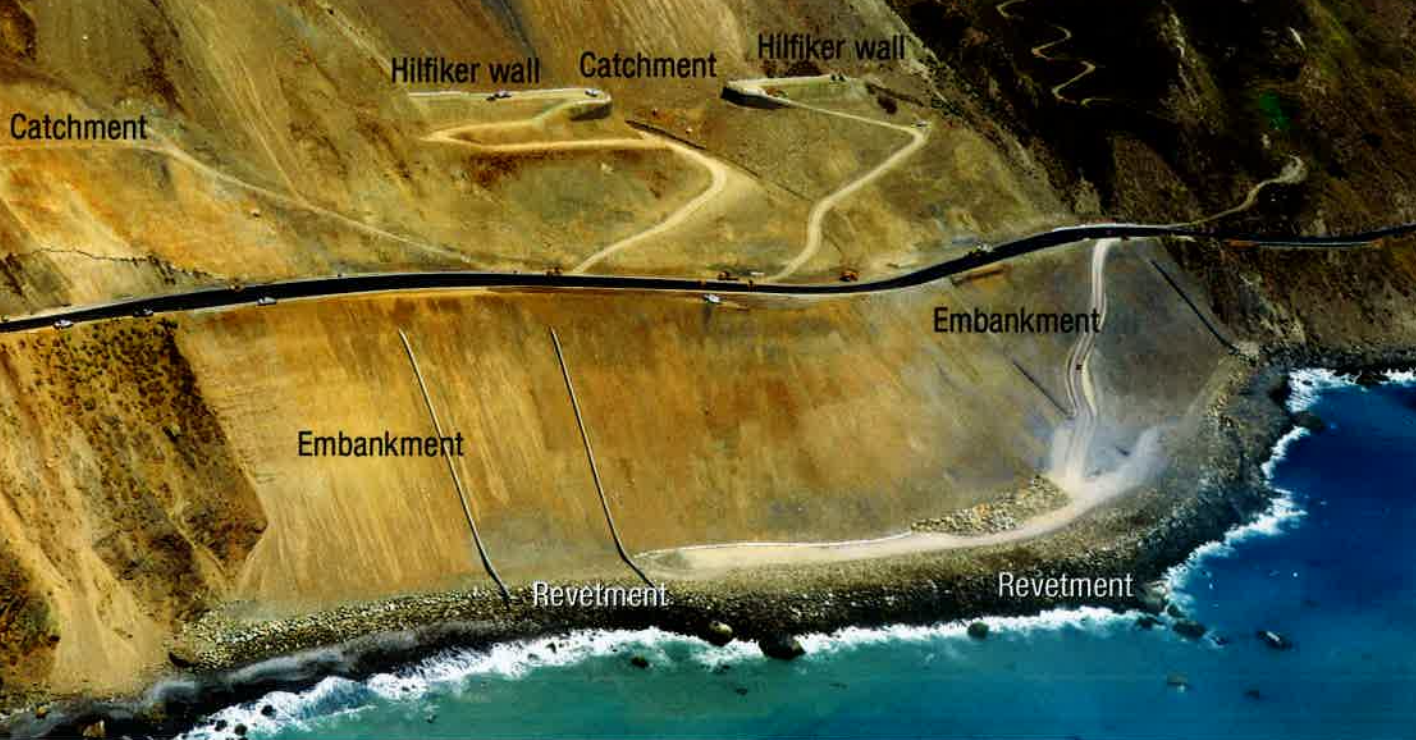
The main features of the completed project included a rock revetment at the toe of the landslide to control erosion, a new embankment built up from the revetment, and large earthen berms outfitted with a type of rock basket wall known as a Hilfiker wall to capture materials that travel downslope from the catchment above.

Erosion caused by ocean wave action resulted in a steady retreat of the toe of the slide. To stanch this erosion, the contractor installed a rock revetment at the toe of the landslide. Extending for more than 2,000 ft along the new coastline, the revetment consisted of a trapezoidal structure made of rock that was keyed into the newly formed beach 6 ft below sea level and built to heights of 40 ft at the most exposed limits. Because of the large sizes of the required rocks, some of which weighed as much as 8 tons, the semi-trailer trucks used to haul the rocks could transport only two at a time. Overall, about 200,000 tons of rock would eventually be placed to build the revetment, which was designed by Caltrans staff. Coastal environment expert Gary Griggs, Ph.D., a distinguished professor of earth sciences at the University of California, Santa Cruz, provided input on this effort.

Once the revetment was built, the project team decided that the massive cut planned to be made at the north end of the site would not be needed. Instead, the highway could be founded on a new embankment built up from the revetment. To provide more outside width on the southbound side of the highway,

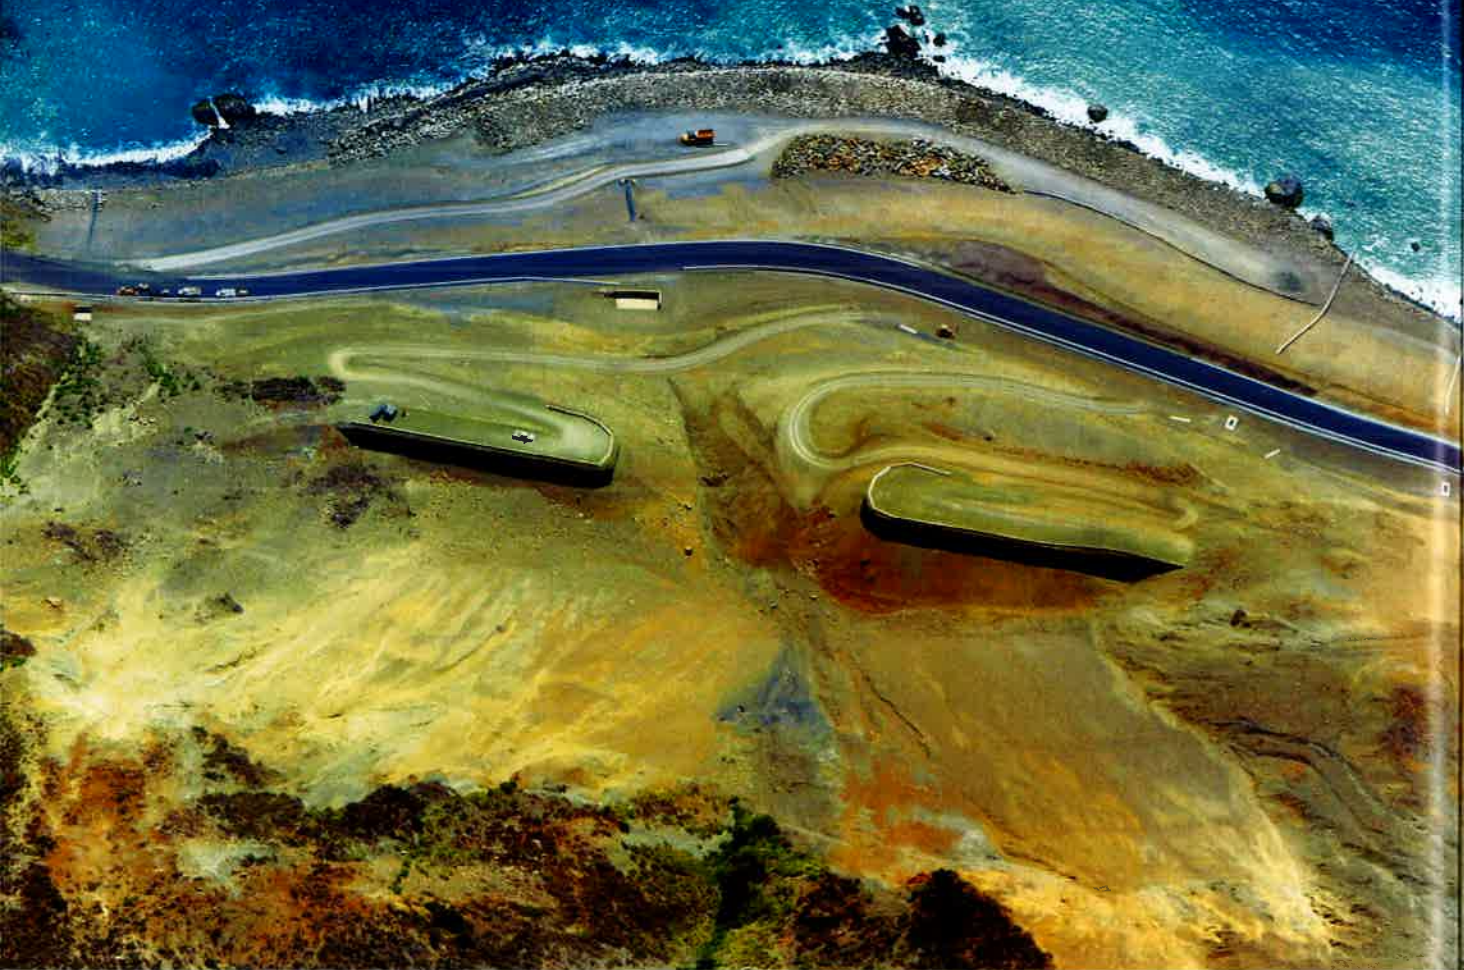
At the Mud Creek site, the rock basket walls were built up to about 25 ft in face height, dramatically improving the ability of the above-roadway catchments to protect the new highway below.

scarp. The project team improved this catchment by constructing large earthen berms on top of the head of the main body. A berm in its simplest form is a long, raised mound of soil. At Mud Creek, where everything is on a massive scale, these berms were more than 100 ft wide and 200 ft long measured at the top, towering 180 ft above the proposed realigned highway. Two rock-basket walls were added on top of the berms to further increase the capacity of the large bowls created by the landslide. Commonly known as a Hilfiker wall, these retaining walls were built with steel wire that is welded together to form mats. Rock is backfilled on top of each mat in lifts or horizontal sections. Another mat is placed and backfilled, and the process repeats until the wall is at the desired height.

At the Mud Creek site, these walls were built up to about 25 ft in face height, dramatically improving the ability of the above-roadway catchments to protect the new highway below. The walls stretch the entire length of the berms but with a gap between them to accommodate runoff and debris anticipated to flow down Mud Creek. To facilitate periodic maintenance of the catchments in the future, two
