Foundation Repairs

San Francisco Advises Continued Pause of Fix for Settling Millennium Tower

Engineer-of-record stopped pile-foundation upgrade Aug. 20, after accelerated settlement measured

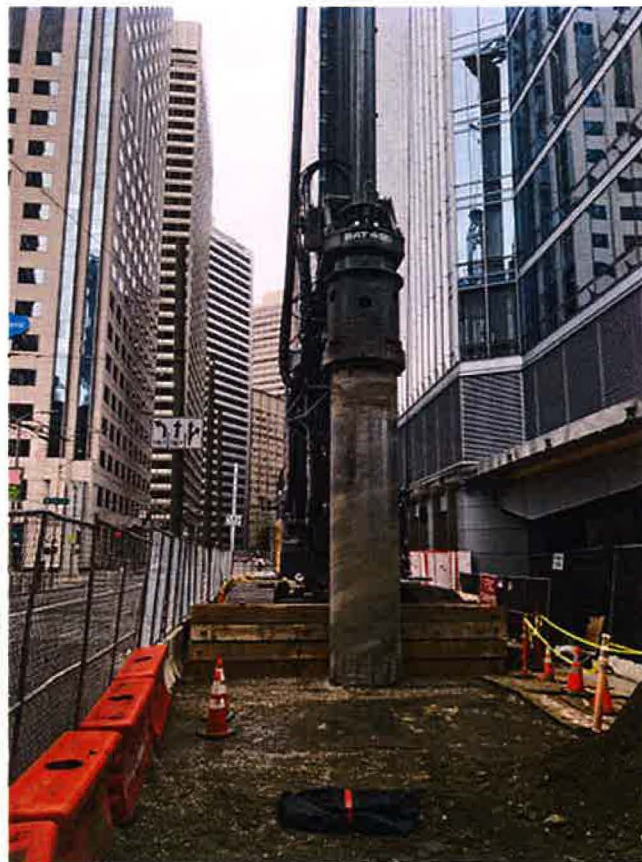
The foundation upgrade has been likened to putting a bumper jack next to a flat tire. It relies on drilling and jacking 52 concrete piles—socketed more than 30 ft into the bedrock that starts 220 ft below grade—under the tower's north and west sidewalks.

The pile scheme calls for transferring a portion of the building's weight to bedrock from its existing foundation system. The fix, likened to putting a bumper jack next to a flat tire, relies on drilling and jacking 52 concrete piles—socketed more than 30 ft into the bedrock—under sidewalks along Mission and Fremont streets. Piles would support a new mat section, known as a collar, tied into the existing mat.

When completed, the casing will isolate the 24-in. pile from the upper soil deposits so that when the load is transferred off the original foundation and onto the new piles, the new piles do not reload the consolidating Old Bay clays, and instead, deliver most of the load directly to the rock, says Hamburger. The consolidation of the clay deposits is the cause of the building settlement in the first place, he adds.
