**Soberanes Fire
Watershed Emergency Response
Team Report**

CA-BEU-003422

September 29, 2016

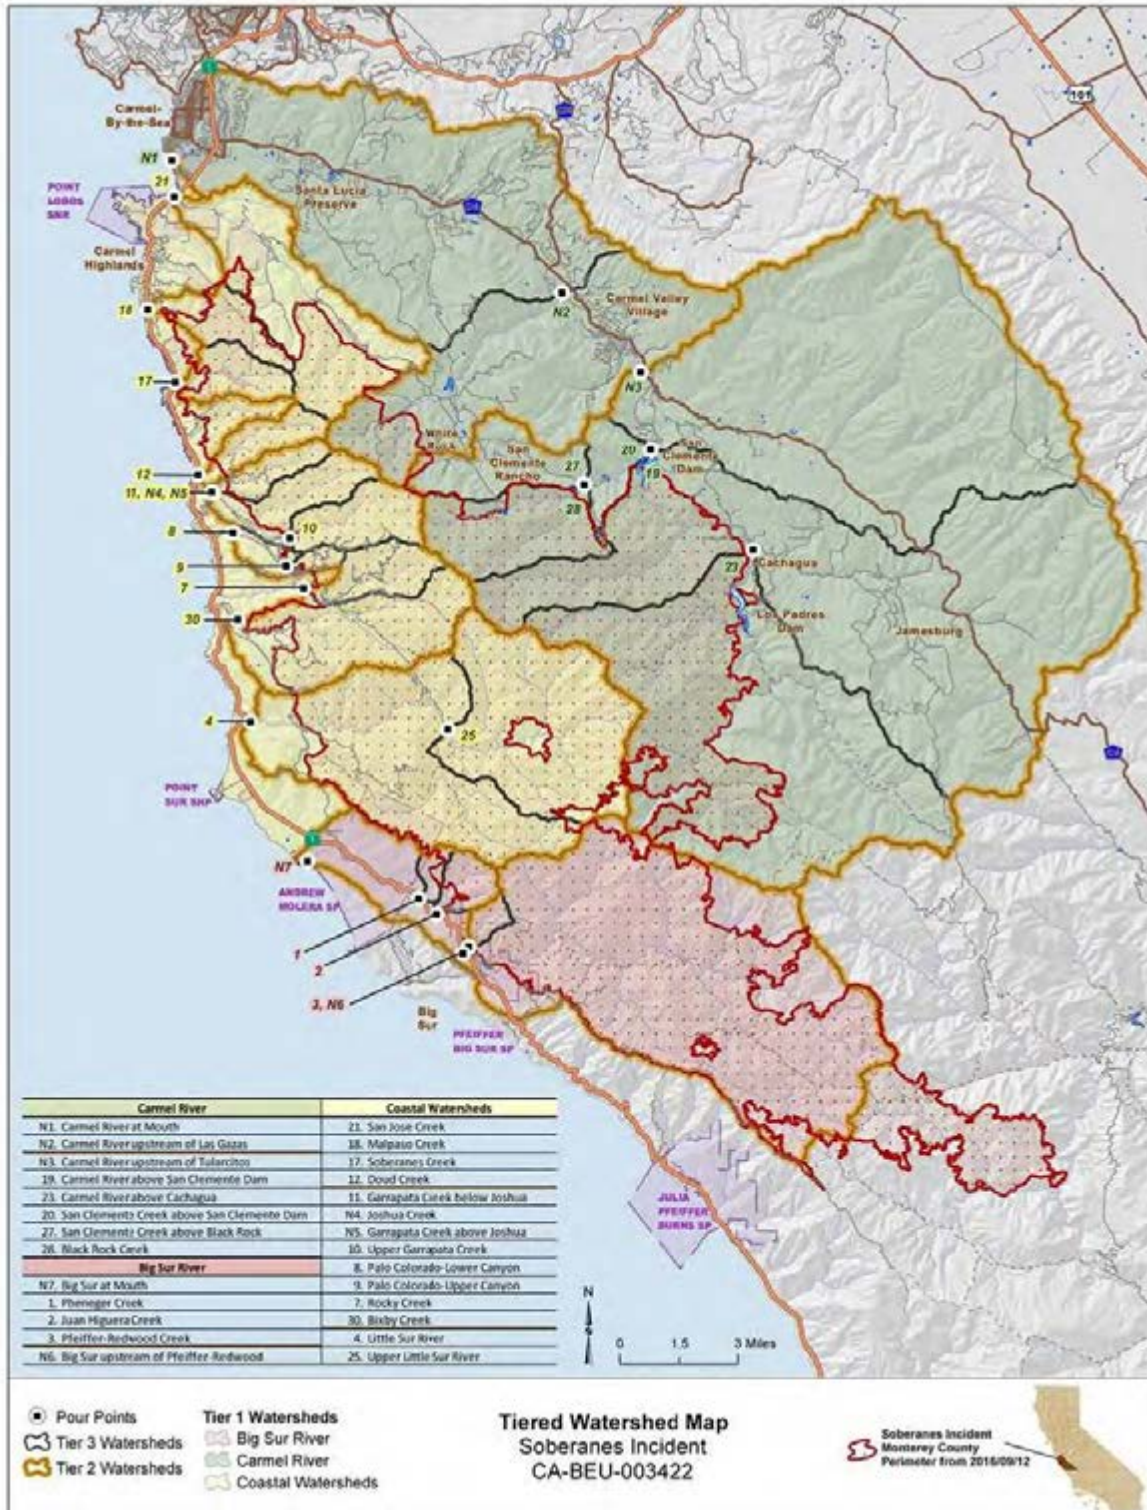
Figure 5. Tiered watershed map for the Soberanes Fire showing how the assessment area is broken into 1) large watersheds, 2) sub-watersheds, and 3) “pour point” watersheds.

Communities and specific Values at Risk were assessed hierarchically using a nested watershed approach. The following figures (Figure 4 and Figure 5) describe how the various watersheds were nested.

Refer to Appendix C for specific “pour point” discussion and Figure 5 (or Appendix B) for location of “pour point” watersheds.

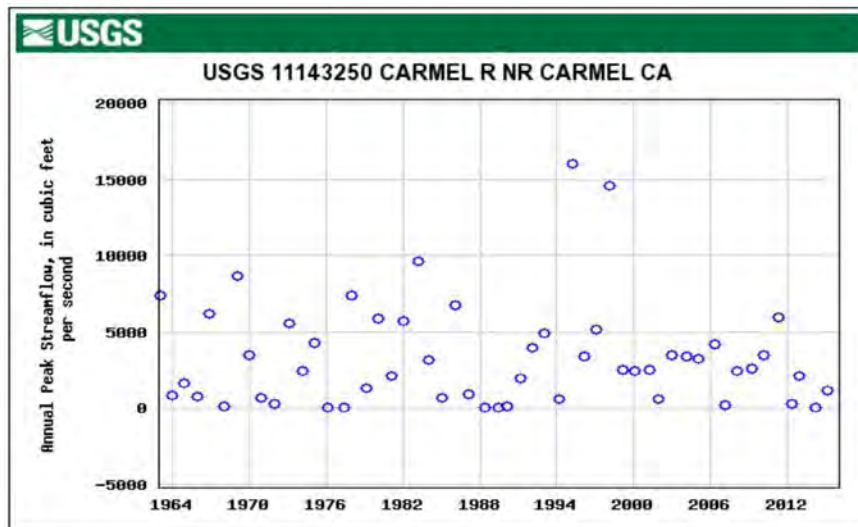
Figure 9. Annual peak flows on Carmel River near Carmel (USGS Gage No. 11143250). Peak flows for the gage were affected by upstream dams.

Two USGS stream gages are located downstream of the burned area on the Carmel River. The first is approximately 3 miles upstream of the mouth of the Carmel River at Carmel (Gage No. 11143250) and has records from 1963 to present (Figure 9-Carmel Gage Plot).

The second gage is located further upstream at Robles Del Rio in the Carmel Valley (Gage No. 11143200) and has records from 1957 to present (Figure 10). The highest peak flows recorded at both gages occurred in 1995 and 1998. The largest was in 1995 when a peak flow of 16,000 cfs was recorded at the Carmel gage (No. 11143250) and is roughly equivalent to a 30-year flood event.

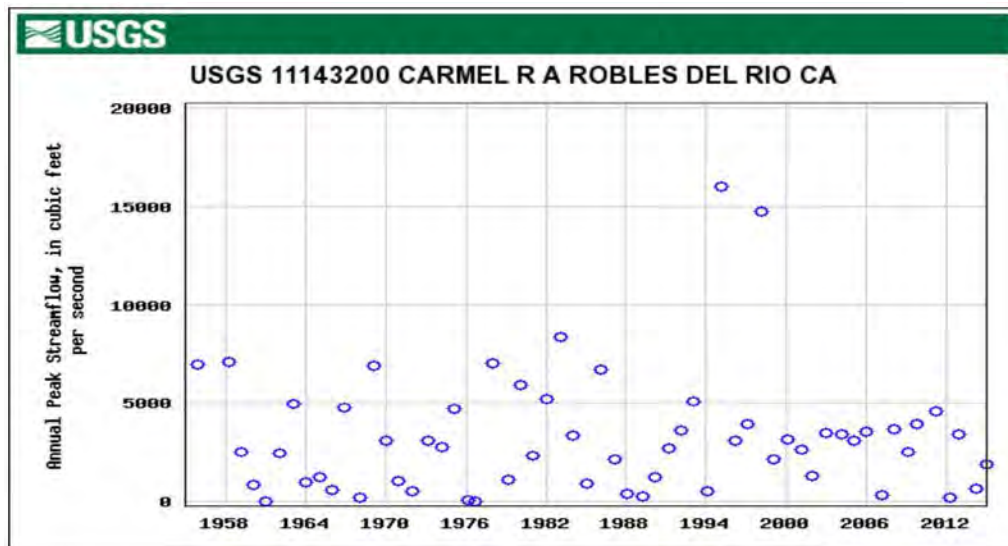
Figure 10. Annual peak flows on Carmel River at Robles Del Rio (USGS Gage No. 11143200). Peak flows for the gage were affected by upstream dams.

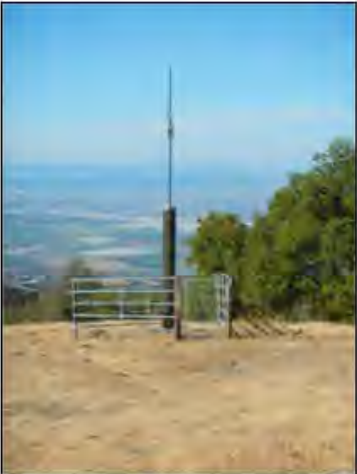
ALERT Flood Warning System

Following the Marble Cone fire of 1977, Monterey County began the installation of one of the first ALERT flood warning networks anywhere. ALERT (Automated Local Evaluation in Real Time) is a communications protocol that was developed by the National Weather Service in the 1970's. ALERT is a reliable, low cost method of transmitting environmental data from remote sites to a central database in real time. ALERT compatible hardware and software has continued to improve and is currently being used for environmental monitoring and flood warning systems throughout the world.

The current Monterey County ALERT flood warning system is operated and maintained by the Monterey County Water Resources Agency. The system consists of approximately 50 remote sites located throughout the major watersheds of Monterey County. These remote sites measure a variety of environmental factors including rainfall, water level, and air temperature that are used to forecast flooding and monitor storm events..

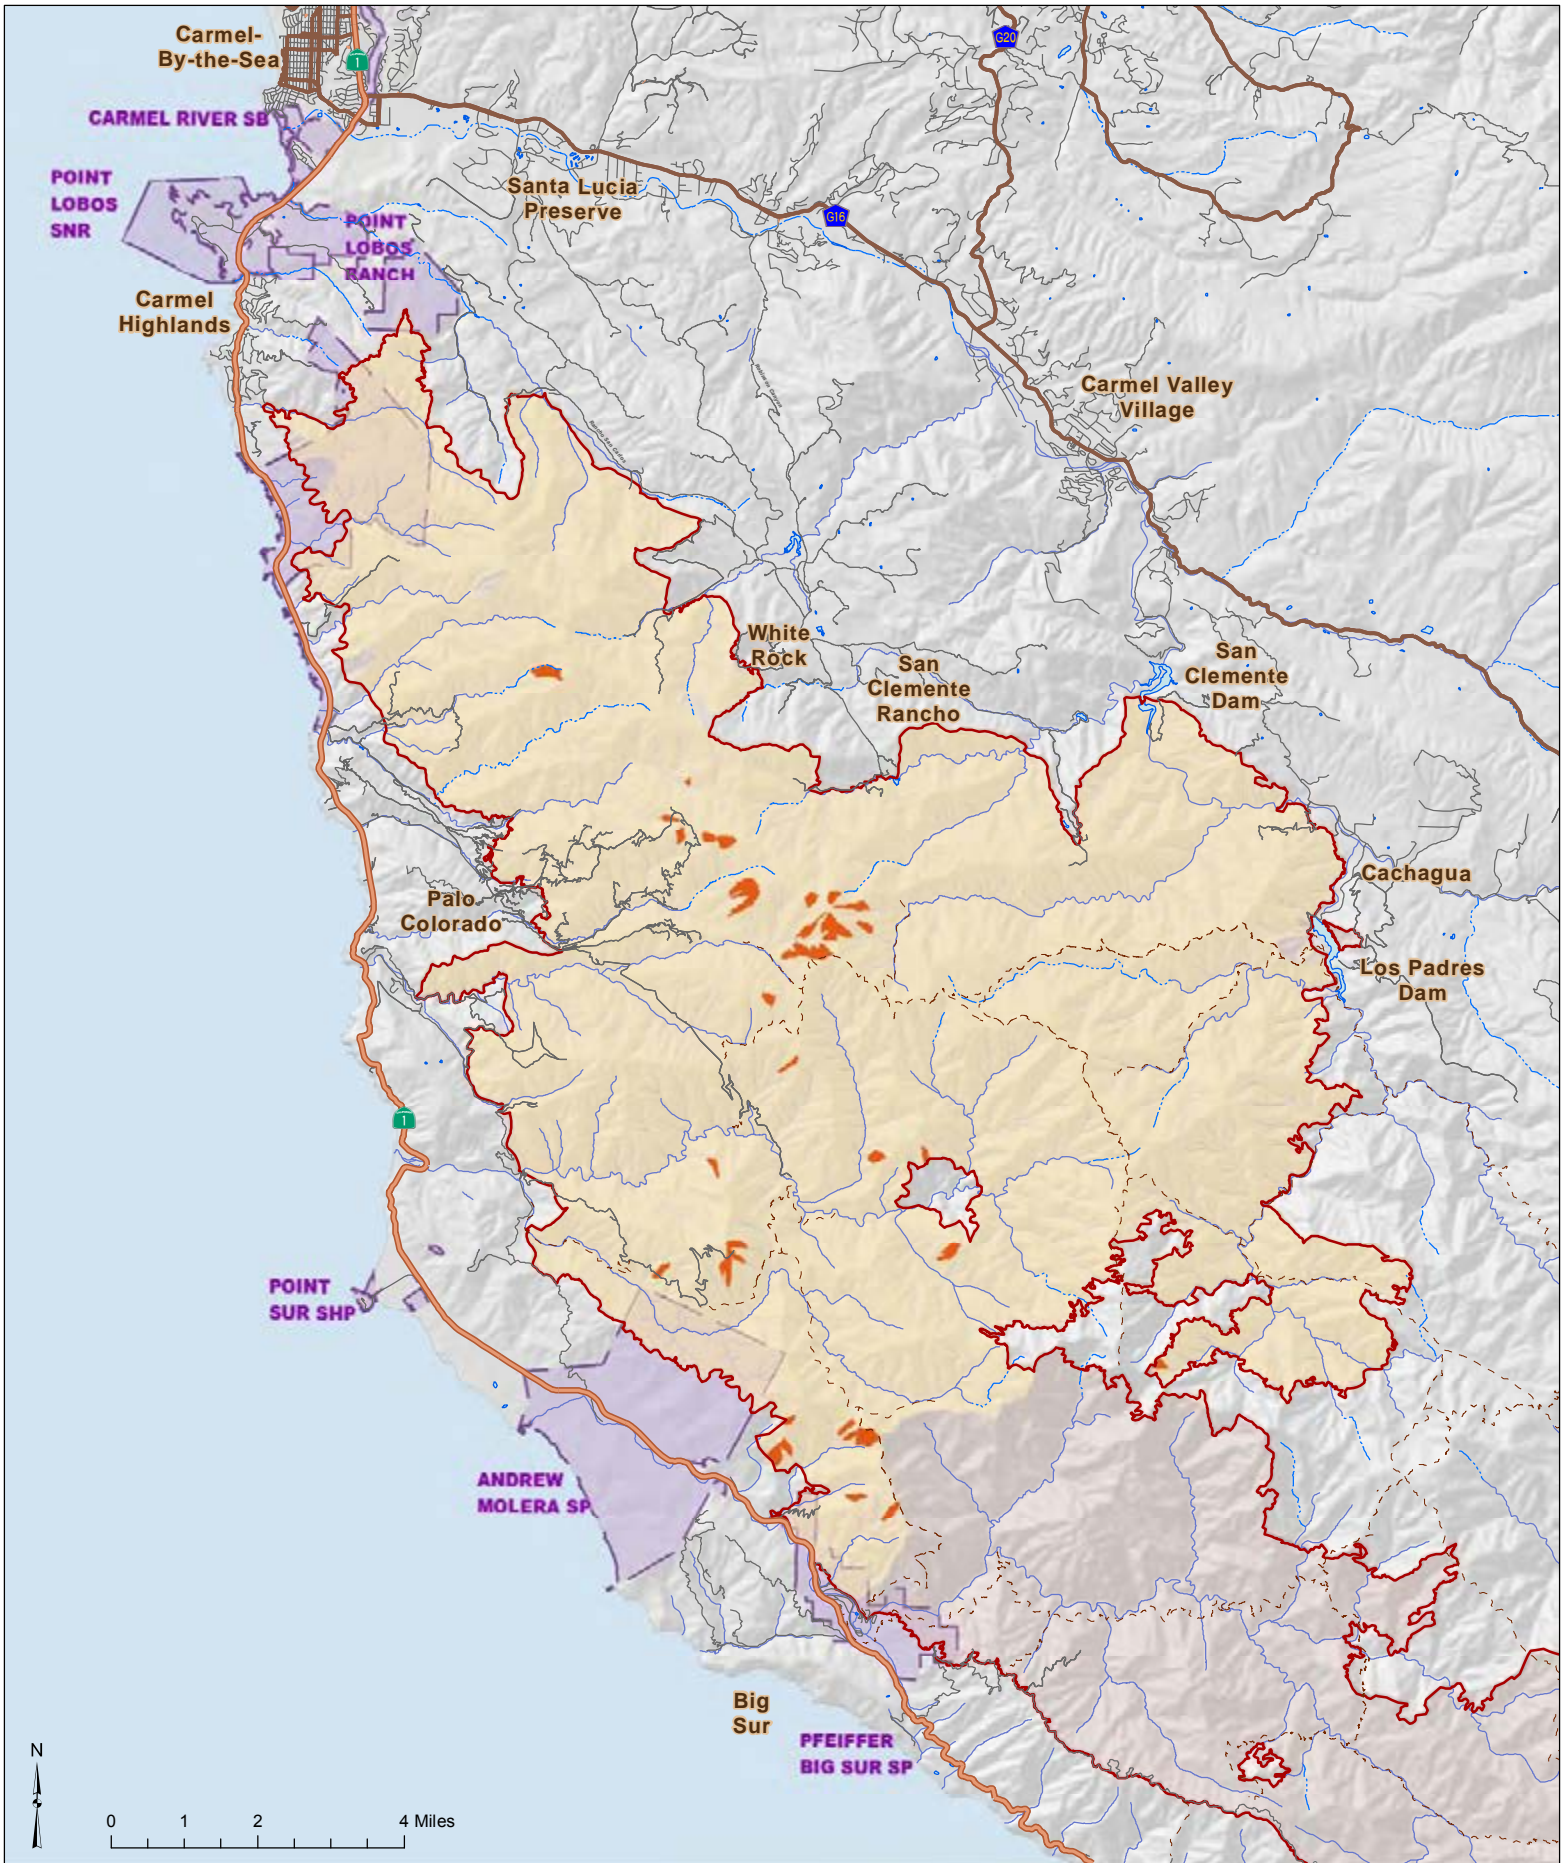
Sediment Production (tons/acre)
 10-year storm event
 0-5
 >5

Appendix E
GeoWEPP Derived Surface Erosion
 Soberanes Incident
 CA-BEU-003422
