Project Number: 19-009

Subject: 301 Mission Retrofit Monitoring Report 038: Results as of January 24, 2022

Millennium Tower Perimeter Pile Upgrade: Instrumentation Monitoring Data
City and County of San Francisco, California

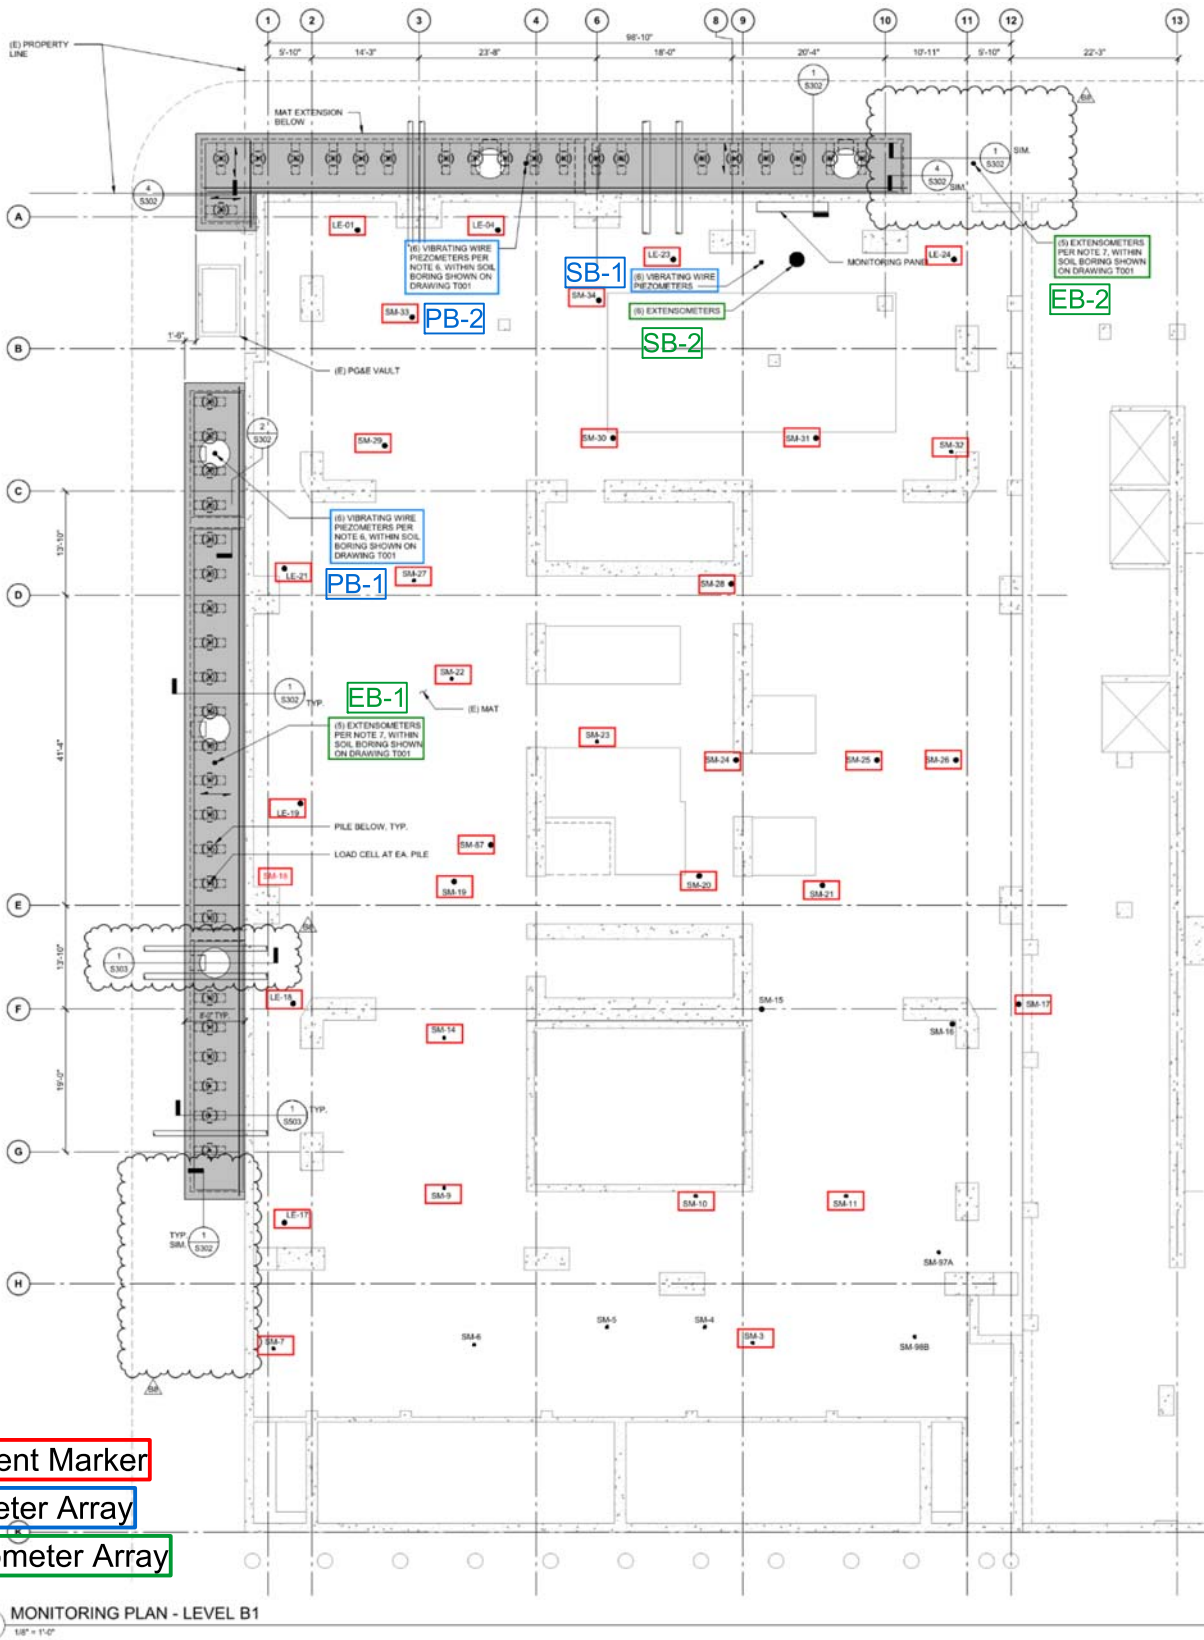
Figure No: 038-01A

Figure 01 presents the instrument locations as referenced in later figures.

INSTRUMENT LOCATION MAP
SETTLEMENT MARKERS, PIEZOMETERS, EXTENSOMETERS

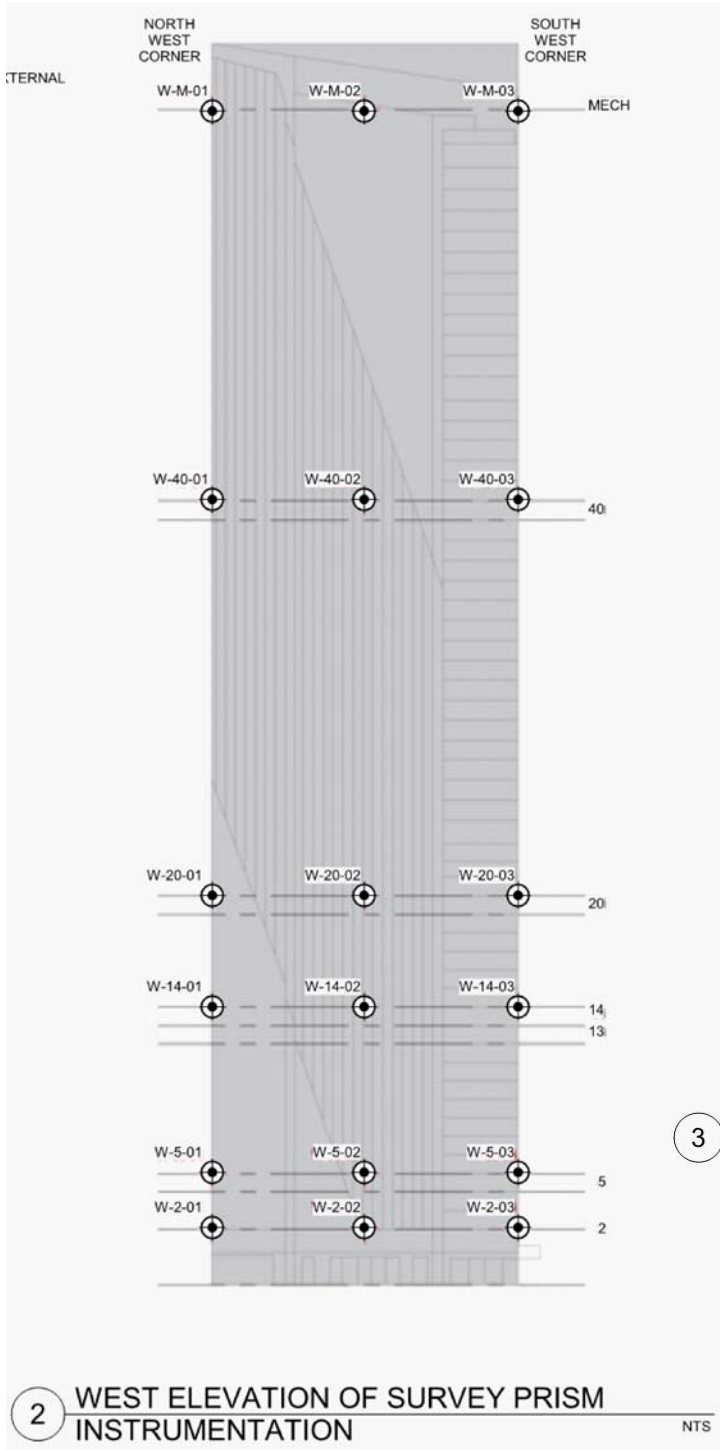
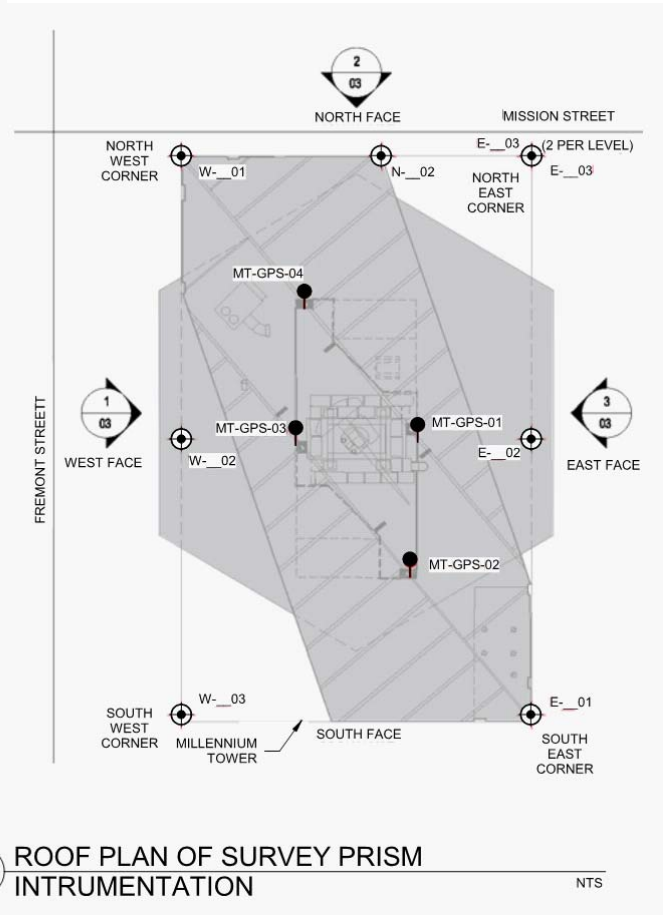
Project No: 19-009.00	Date: 7/26/2021	Created By: NBW	Checked By: DGM	Figure No: 038-01B
-----------------------	-----------------	-----------------	-----------------	---------------------------

TOWER SURVEY PRISM LOCATION SCHEMATIC

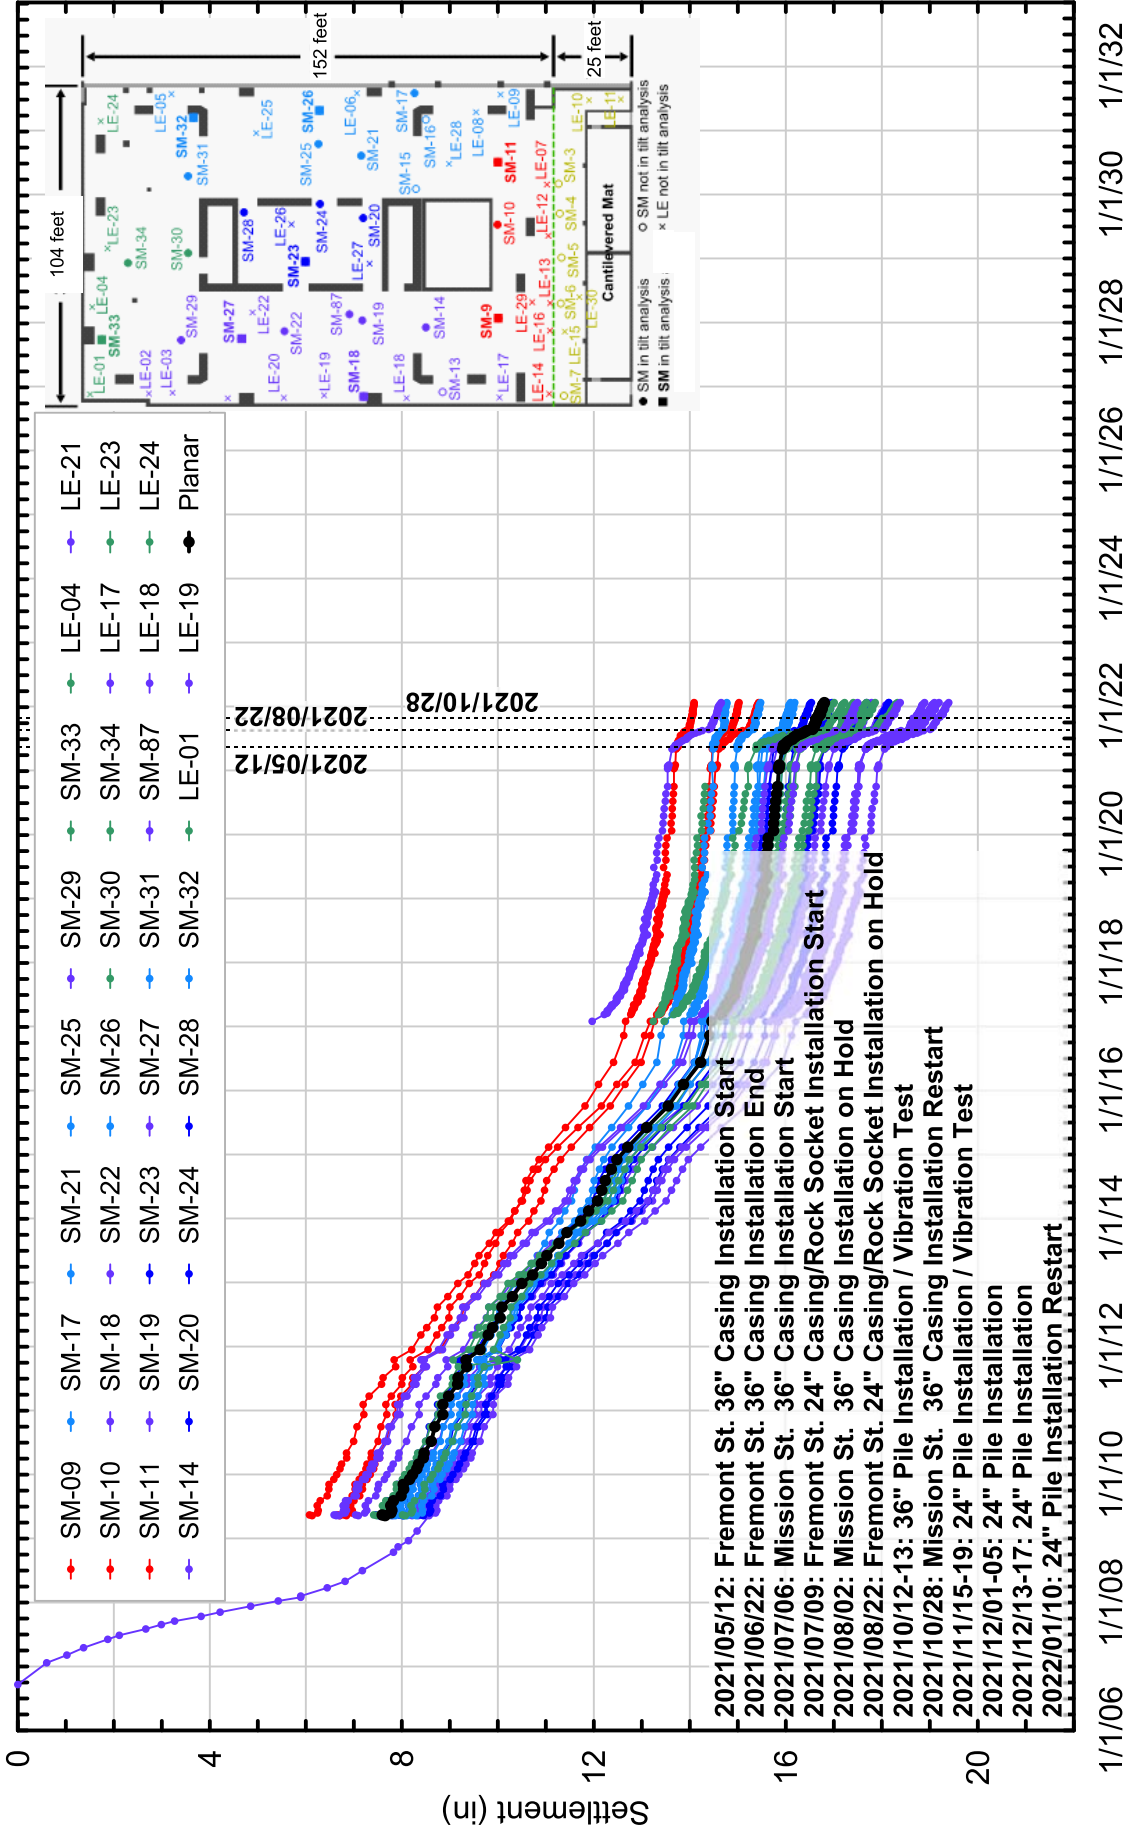
Project No: 19-009.00	Date: 1/24/2022	Created By: NBW	Checked By: DGM	Figure No: 038-02

Figure 02 presents the historical settlement data interpreted from settlement markers installed on the B-1 Level of 301 Mission Tower. In addition, data from surveys performed during the retrofit are included. Figure 03A presents settlement data since the start of production pile installation (May 12, 2021; baseline readings on May 10, 2021) through January 16, 2022. Figure 03B presents settlement data since January 11, 2021, through January 23, 2022. Figure 04 presents current settlement contours (in inches) on January 23, 2022.

HISTORICAL SETTLEMENT MARKER DATA				
Millennium Tower Perimeter Pile Upgrade: Instrumentation Monitoring Data City and County of San Francisco, California

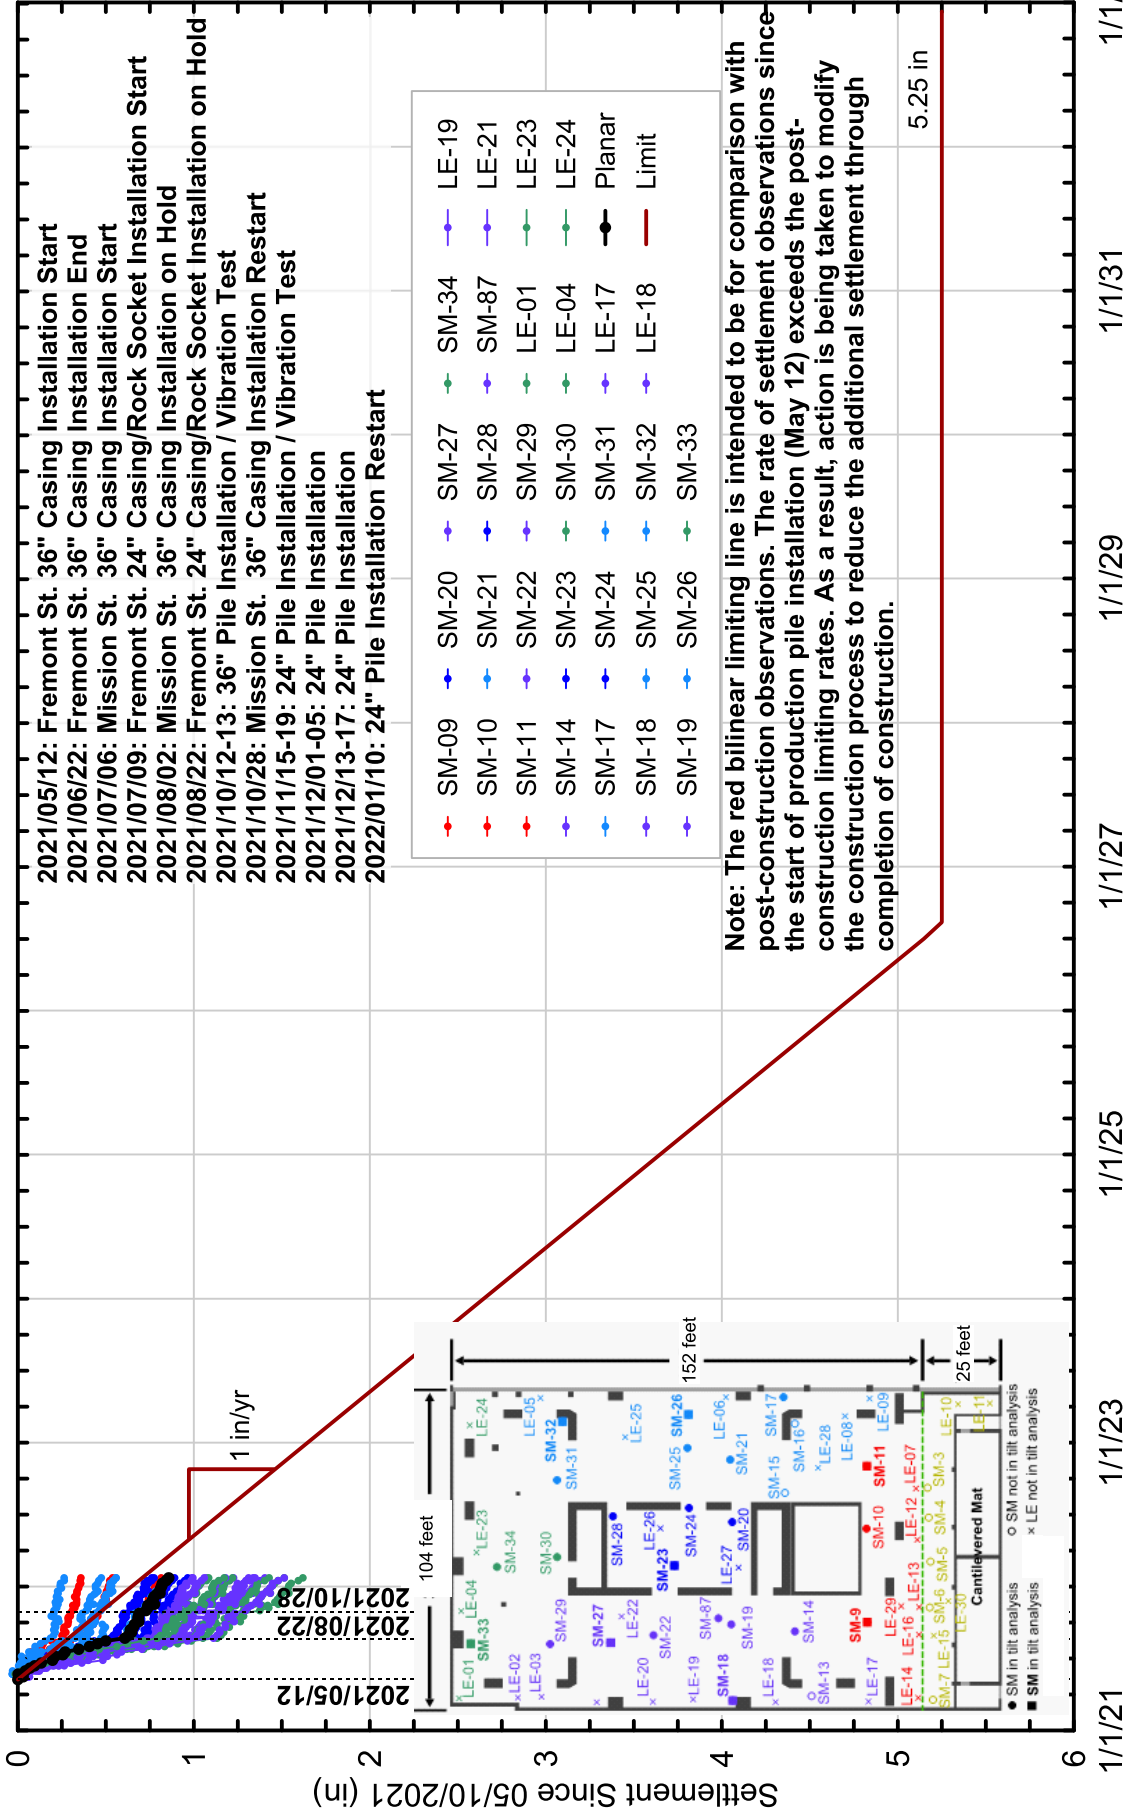
Project No: 19-009.00 Date: 1/24/2022 Created By: NBW Checked By: DGM Figure No: 038-03A

SETTLEMENT MARKER DATA
 SINCE 05/10/2021 THROUGH 01/23/2022

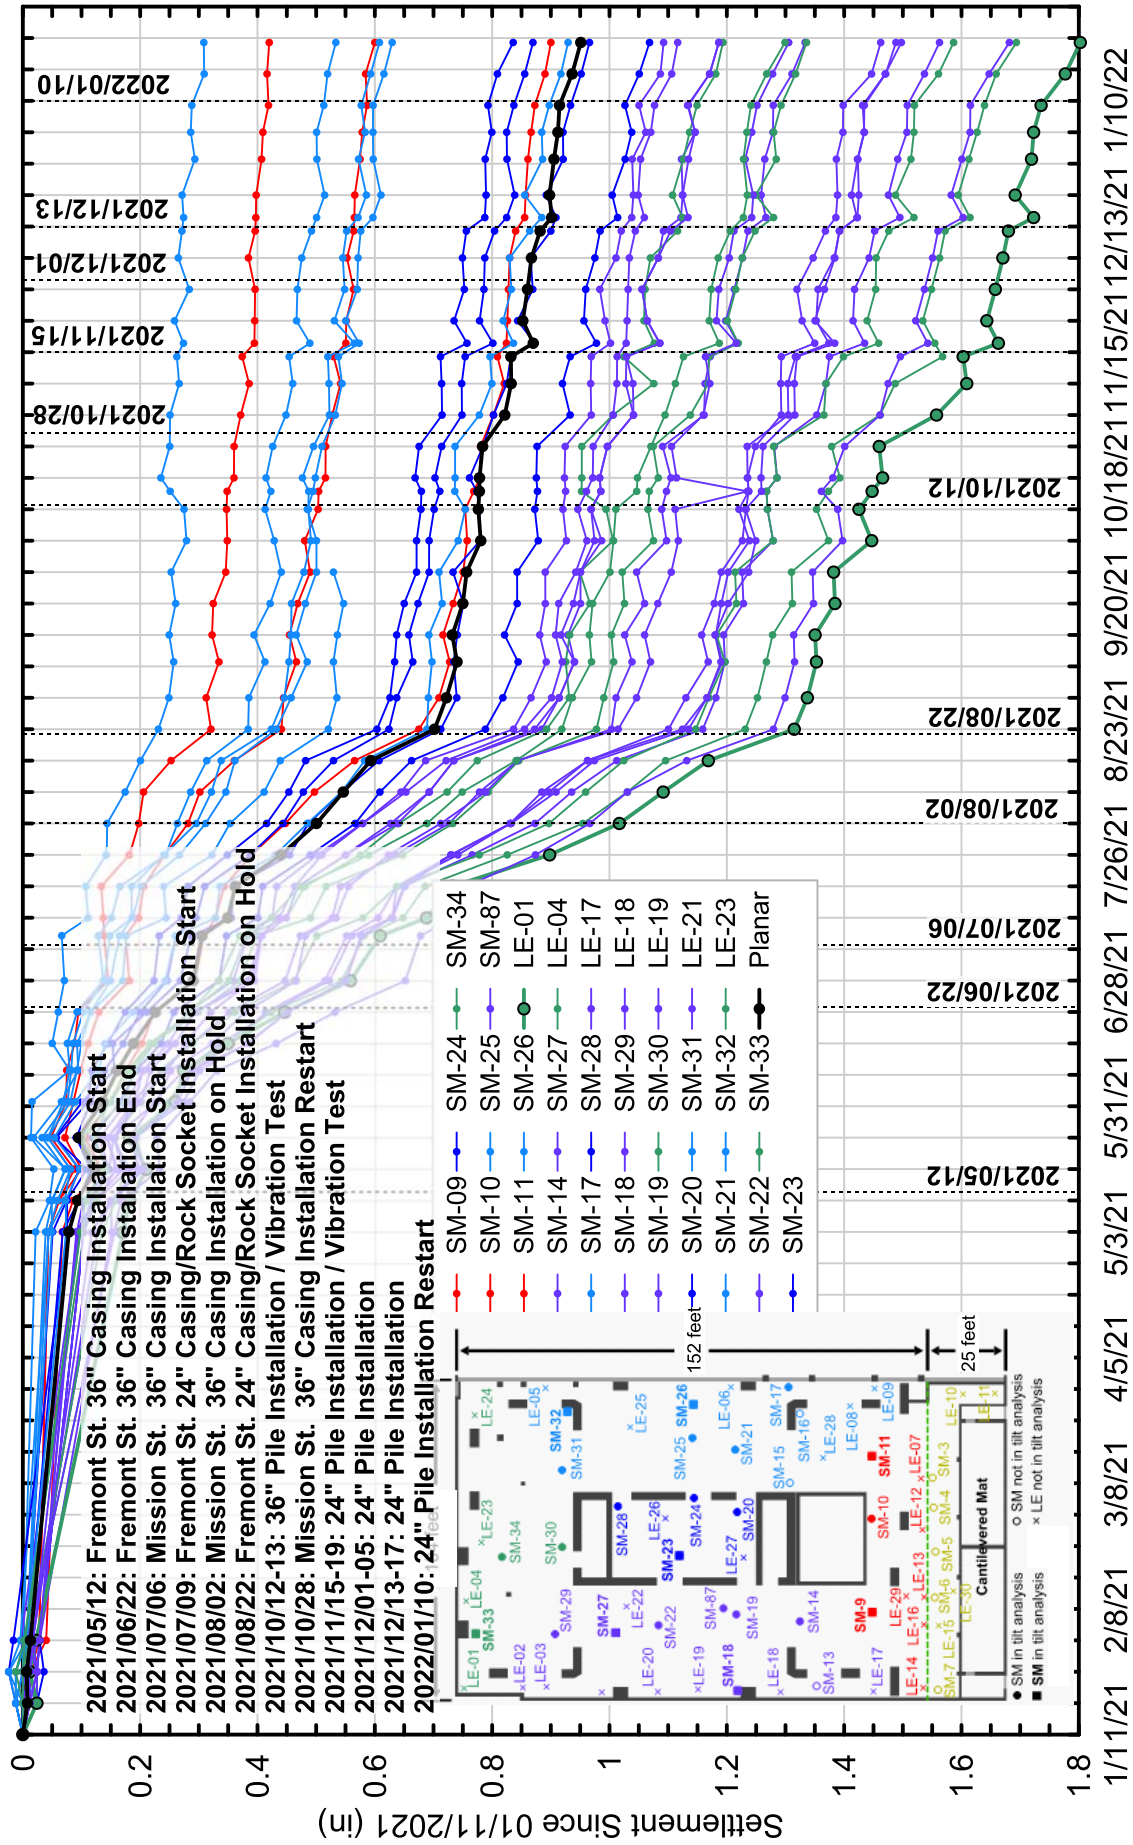
Project No: 19-009.00	Date: 1/24/2022	Created By: NBW	Checked By: DGM	Figure No: 038-03B

SETTLEMENT MARKER DATA SINCE 01/11/2021 THROUGH 01/23/2022				
Millennium Tower Perimeter Pile Upgrade: Instrumentation Monitoring Data City and County of San Francisco, California

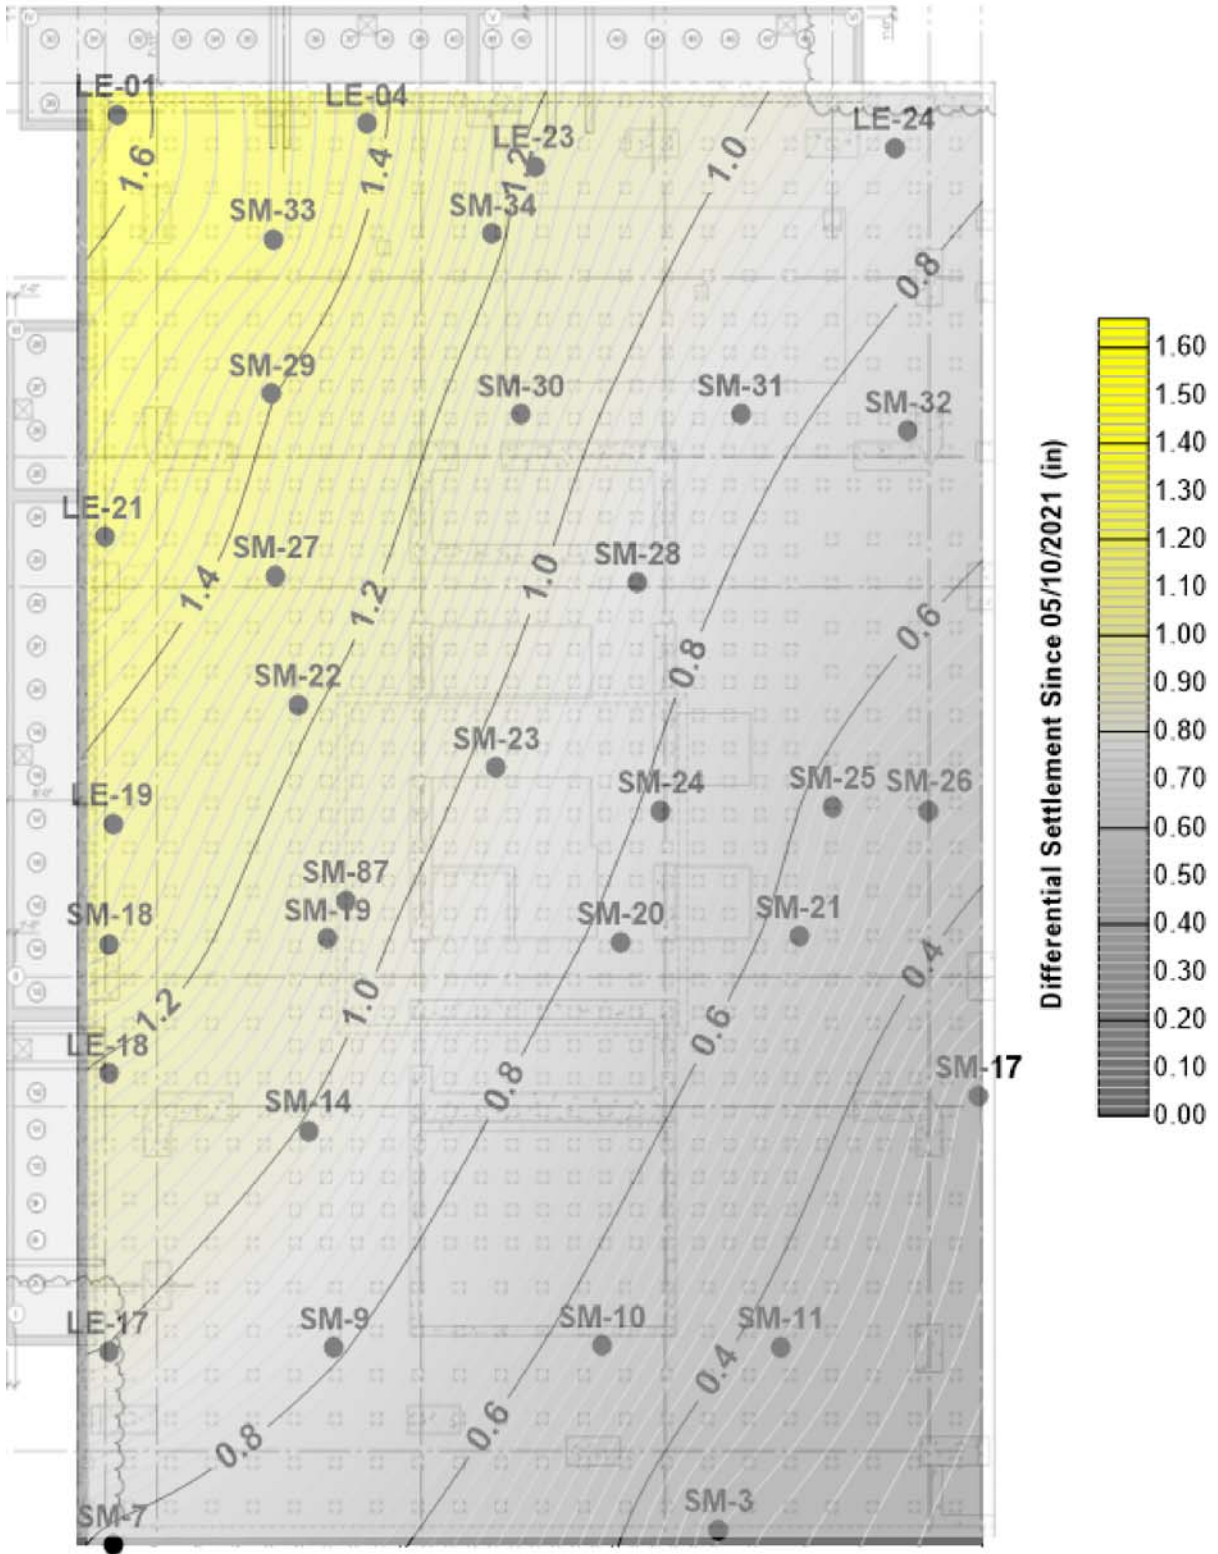
Figure No: **038-04**

SETTLEMENT CONTOURS
SINCE 05/10/2021 THROUGH 01/23/2022

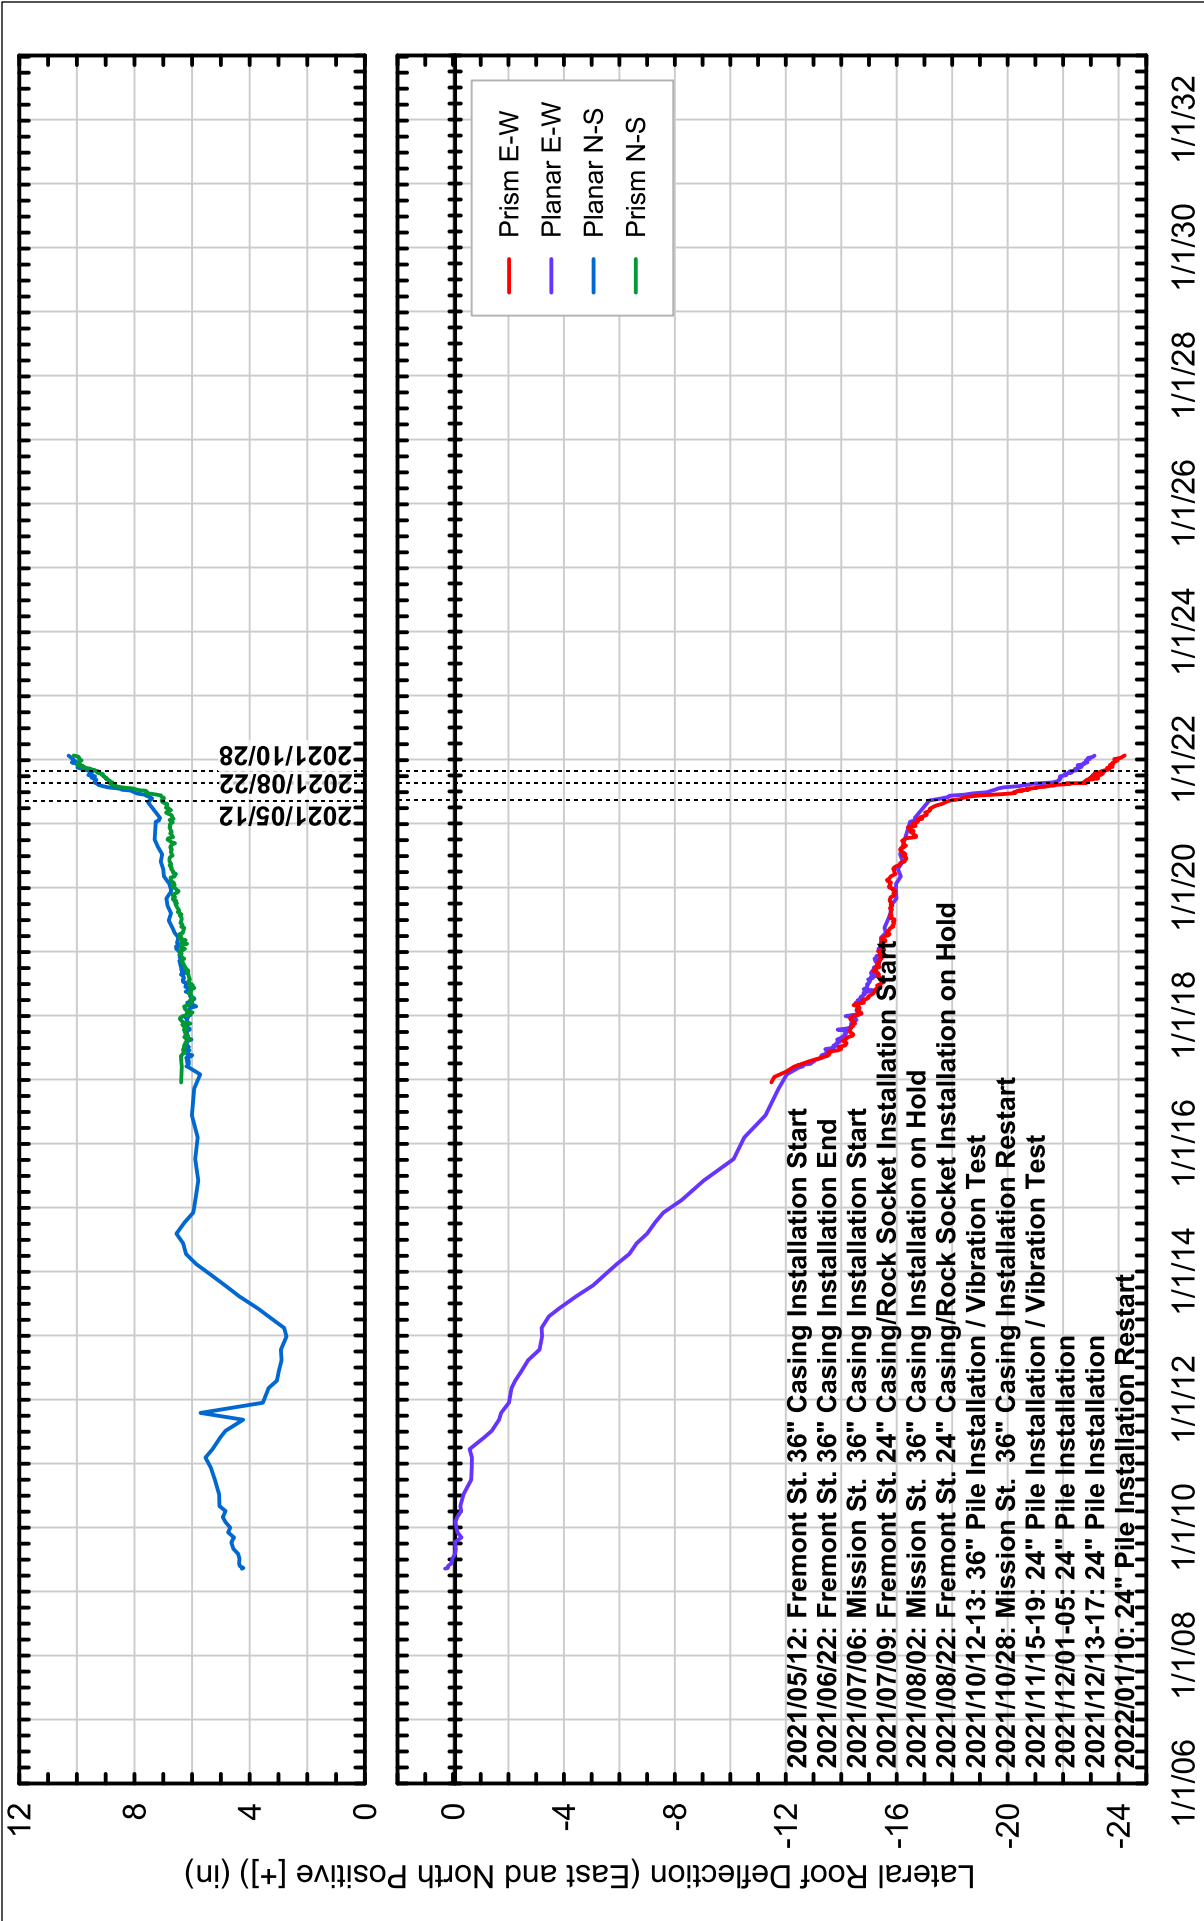
Figure 05 presents historical lateral roof deflections in the project north-south and project east-west directions interpreted from survey prisms mounted on the exterior of the Tower, from InSAR data, and from a planar fit of the settlement marker data. In addition, data from surveys performed during the retrofit are included. Figure 06A presents lateral roof deflection data from a planar fit of the settlement marker data and from survey prisms mounted on the exterior of the Tower since the start of production pile installation (May 12, 2021; baseline readings on May 10 and 13, 2021, respectively) through January 24, 2022. Figure 06B presents lateral roof deflection data from a planar fit of the settlement marker data and from survey prisms mounted on the exterior of the Tower since January 11, 2021, through January 24, 2022.

Project No: 19-009.00	Date: 1/25/2022	Created By: NBW	Checked By: DGM
HISTORICAL LATERAL ROOF DEFLECTION DATA

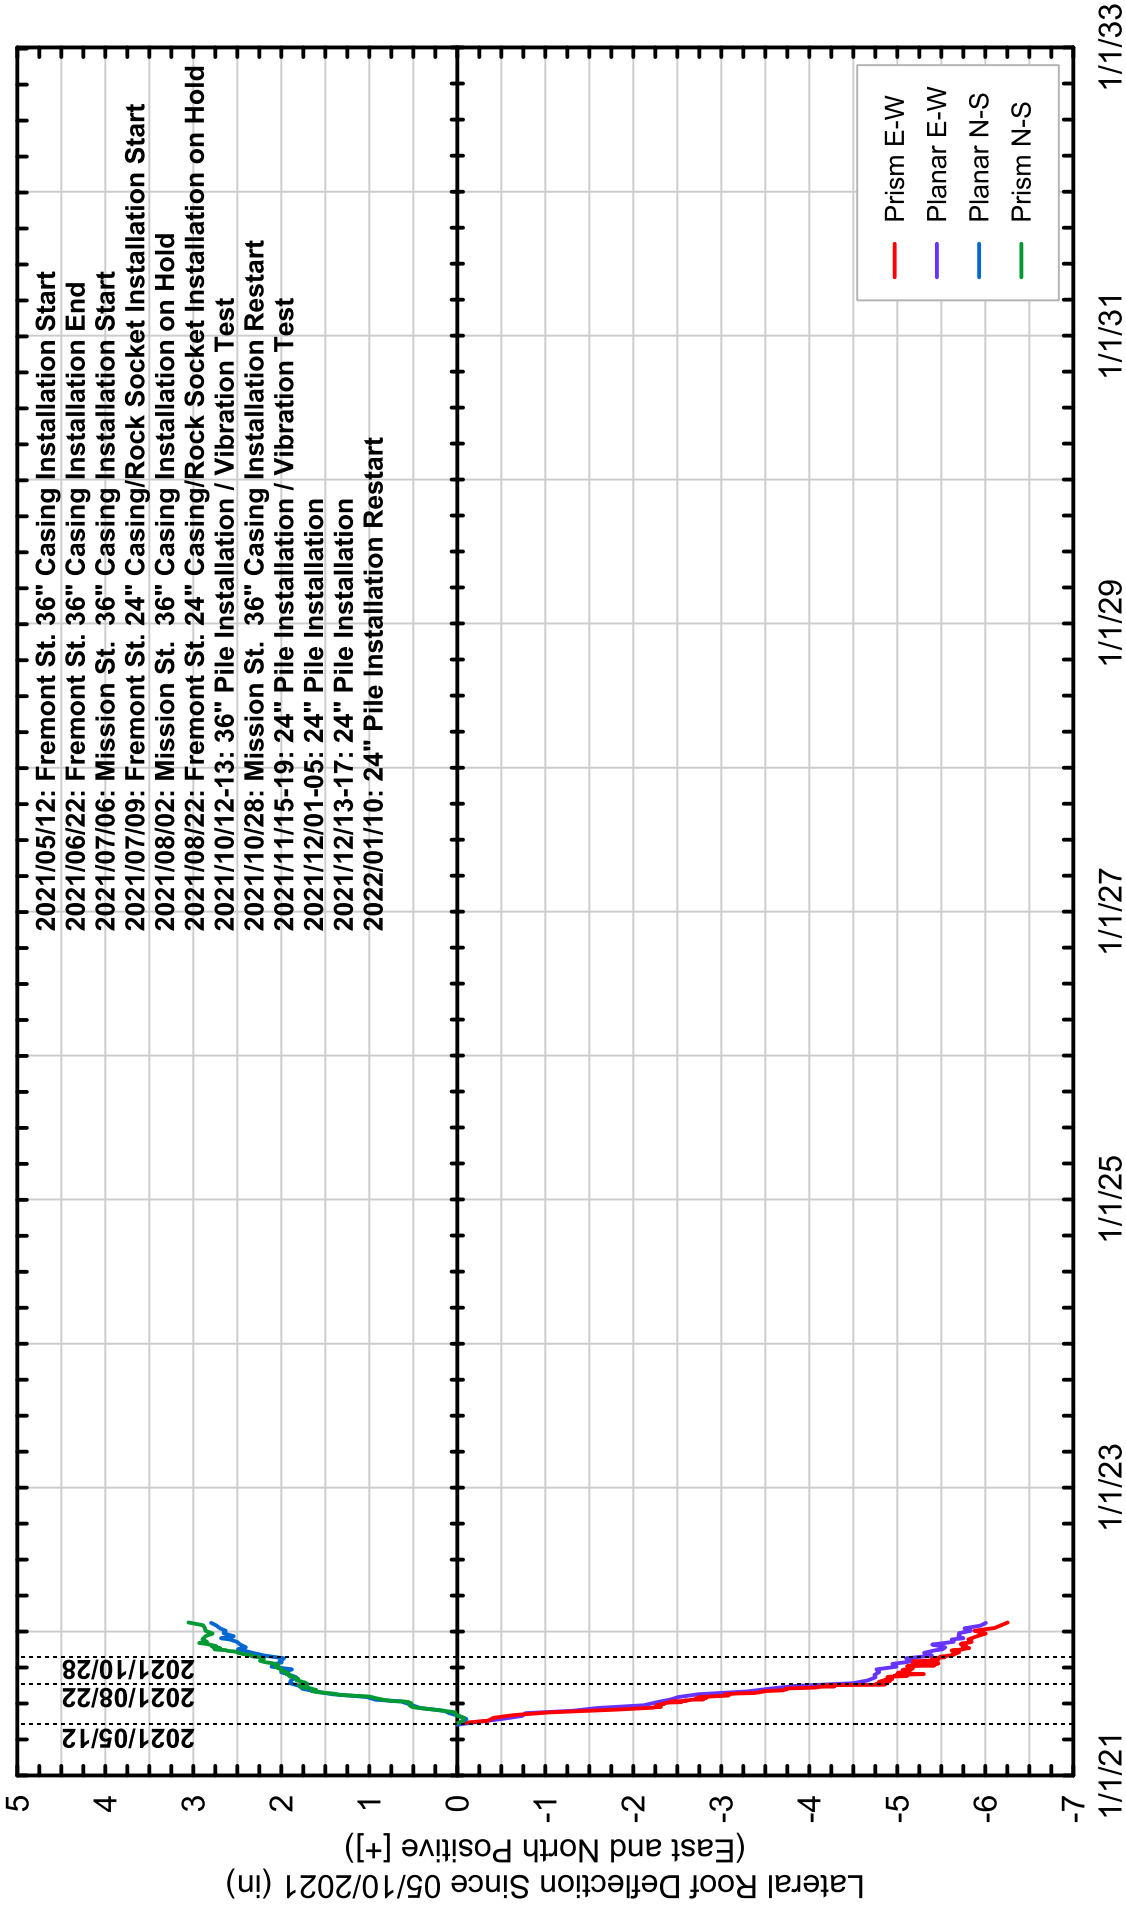
Project No: 19-009.00	Date: 1/25/2022	Created By: NBW	Checked By: DGM	Figure No: 038-06A
SLATE GEOTECHNICAL CONSULTANTS				
LATERAL ROOF DEFLECTION DATA SINCE 05/10/2021 THROUGH 01/24/2022				
Millennium Tower Perimeter Pile Upgrade: Instrumentation Monitoring Data City and County of San Francisco, California

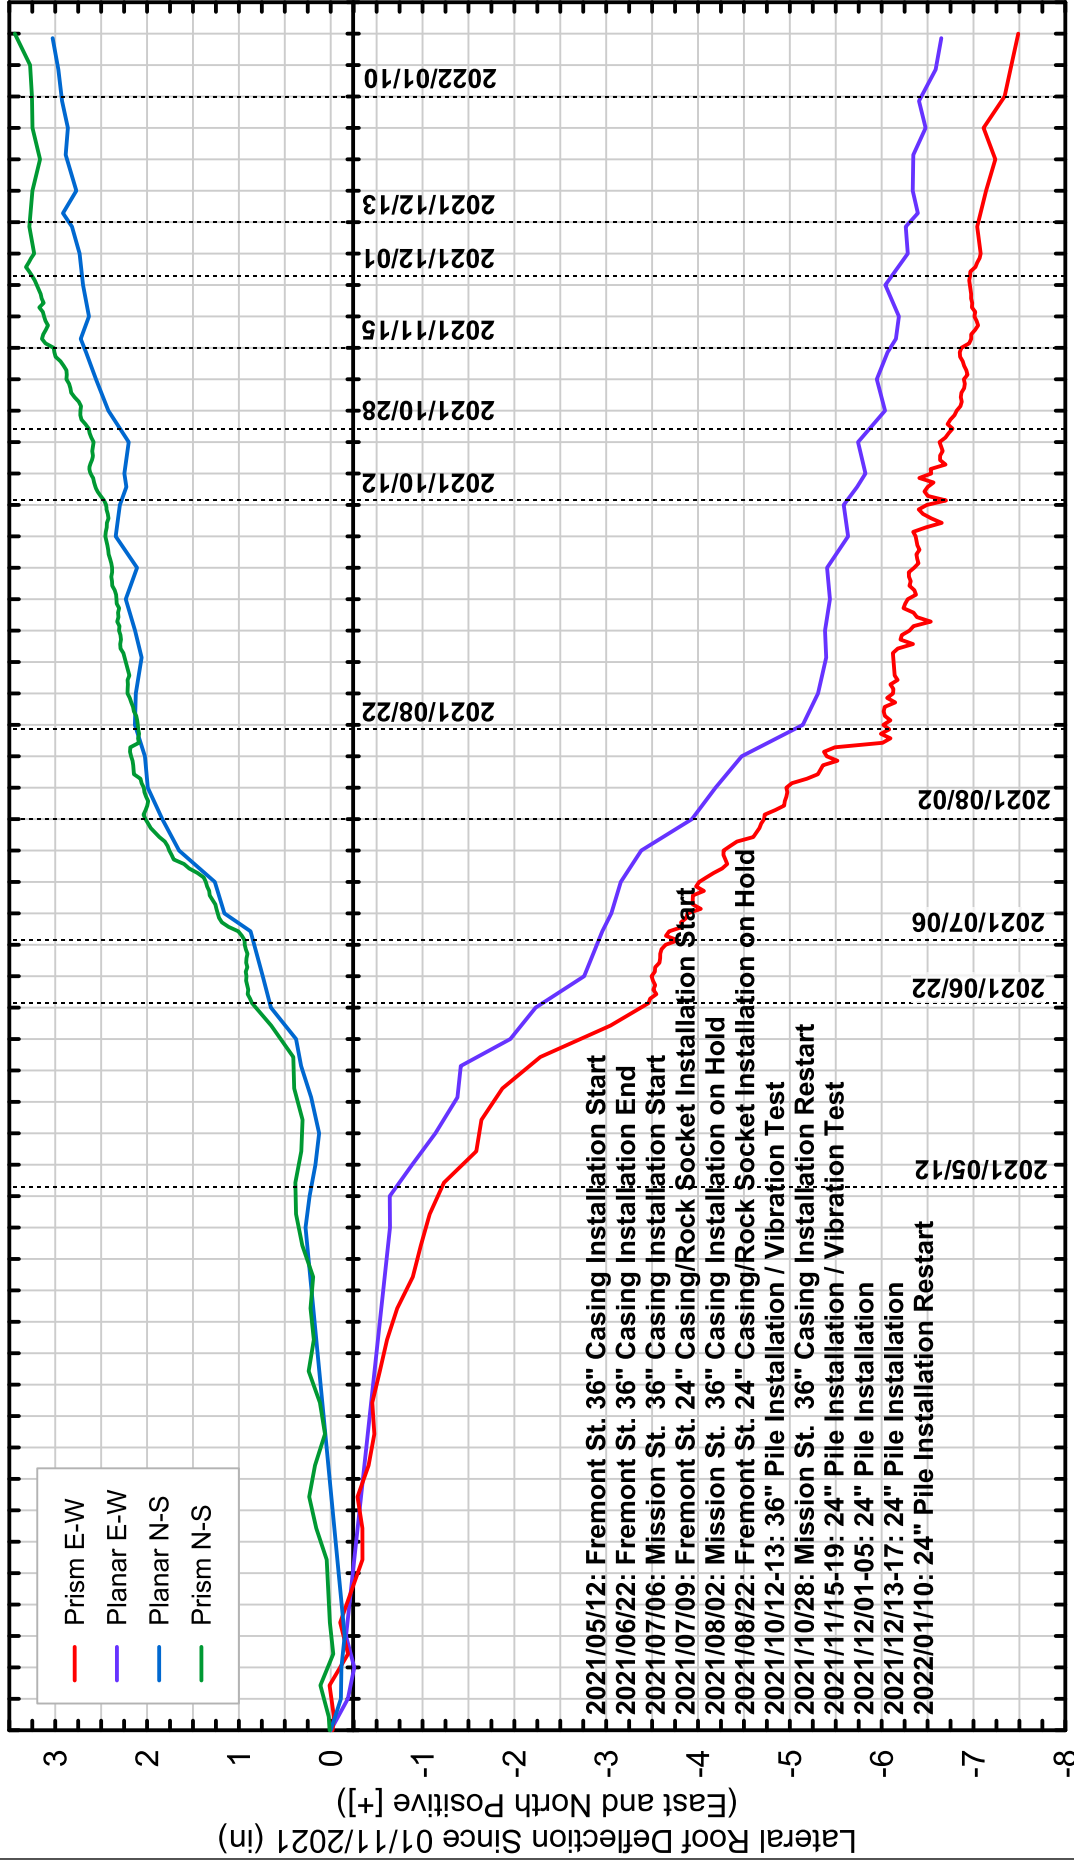
Project No: 19-009.00	Date: 1/25/2022	Created By: NBW	Checked By: DGM	Figure No: 038-06B
<p>SLATE GEOTECHNICAL CONSULTANTS</p> <p>LATERAL ROOF DEFLECTION DATA SINCE 01/11/2021 THROUGH 01/24/2022</p> <p>Millennium Tower Perimeter Pile Upgrade: Instrumentation Monitoring Data City and County of San Francisco, California</p>

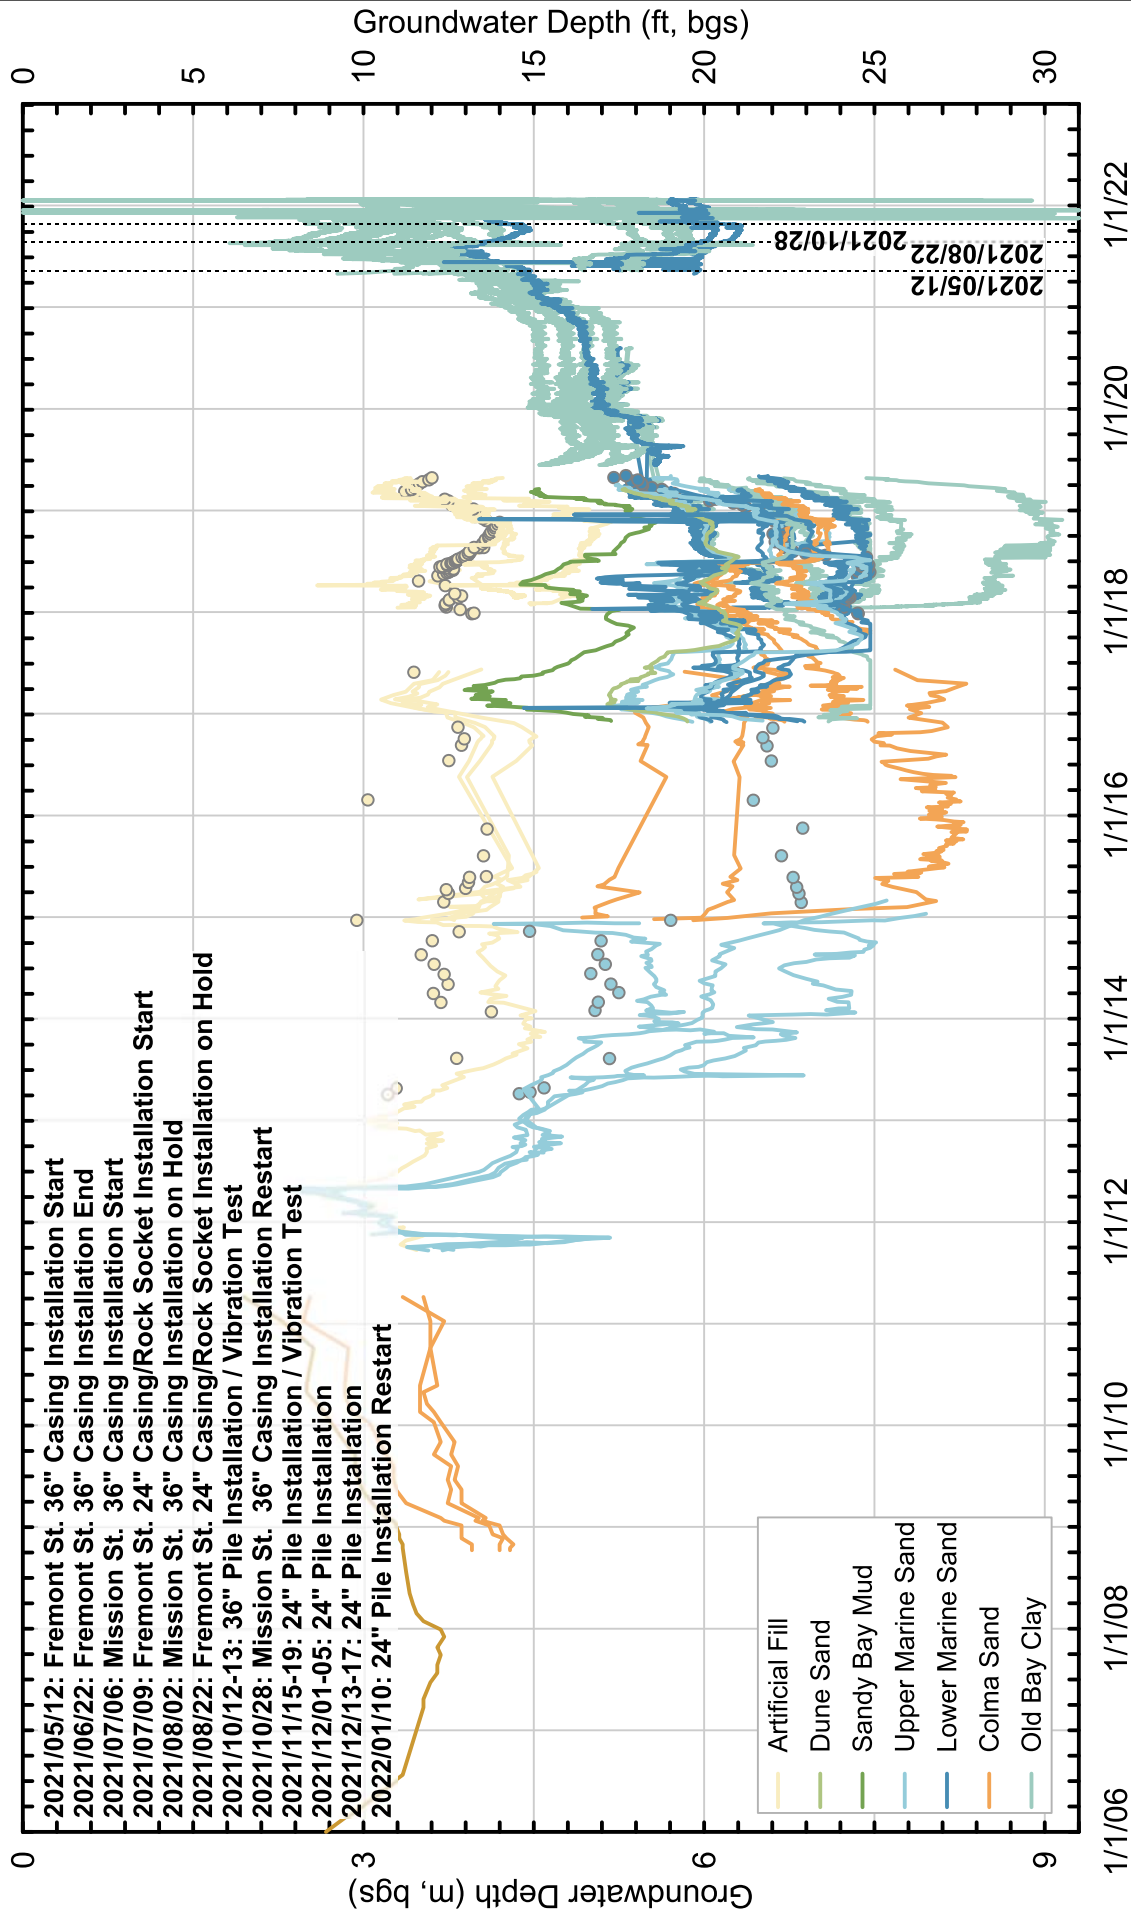
Figure 07 presents the historical groundwater elevation interpreted from piezometer readings at locations near 301 Mission. In addition, data from piezometers installed to monitor groundwater elevation during the retrofit are included. Figures 08 and 09 present groundwater elevation interpreted from piezometer readings in the Marine/Colma Sand and the Old Bay Clay, respectively, for the time period prior to the start of production pile installation (January 1, 2021) through January 24, 2022.

Project No: 19-009.00	Date: 1/24/2022	Created By: NBW	Checked By: DGM	Figure No: 038-07
HISTORICAL GROUNDWATER ELEVATION MEASUREMENTS AT LOCATIONS NEAR 301 MISSION				
Millennium Tower Perimeter Pile Upgrade: Instrumentation Monitoring Data City and County of San Francisco, California
