Project Number: 19-009

Subject: 301 Mission Retrofit Monitoring Report 038: Results as of January 24, 2022

Millennium Tower Perimeter Pile Upgrade: Instrumentation Monitoring Data
City and County of San Francisco, California

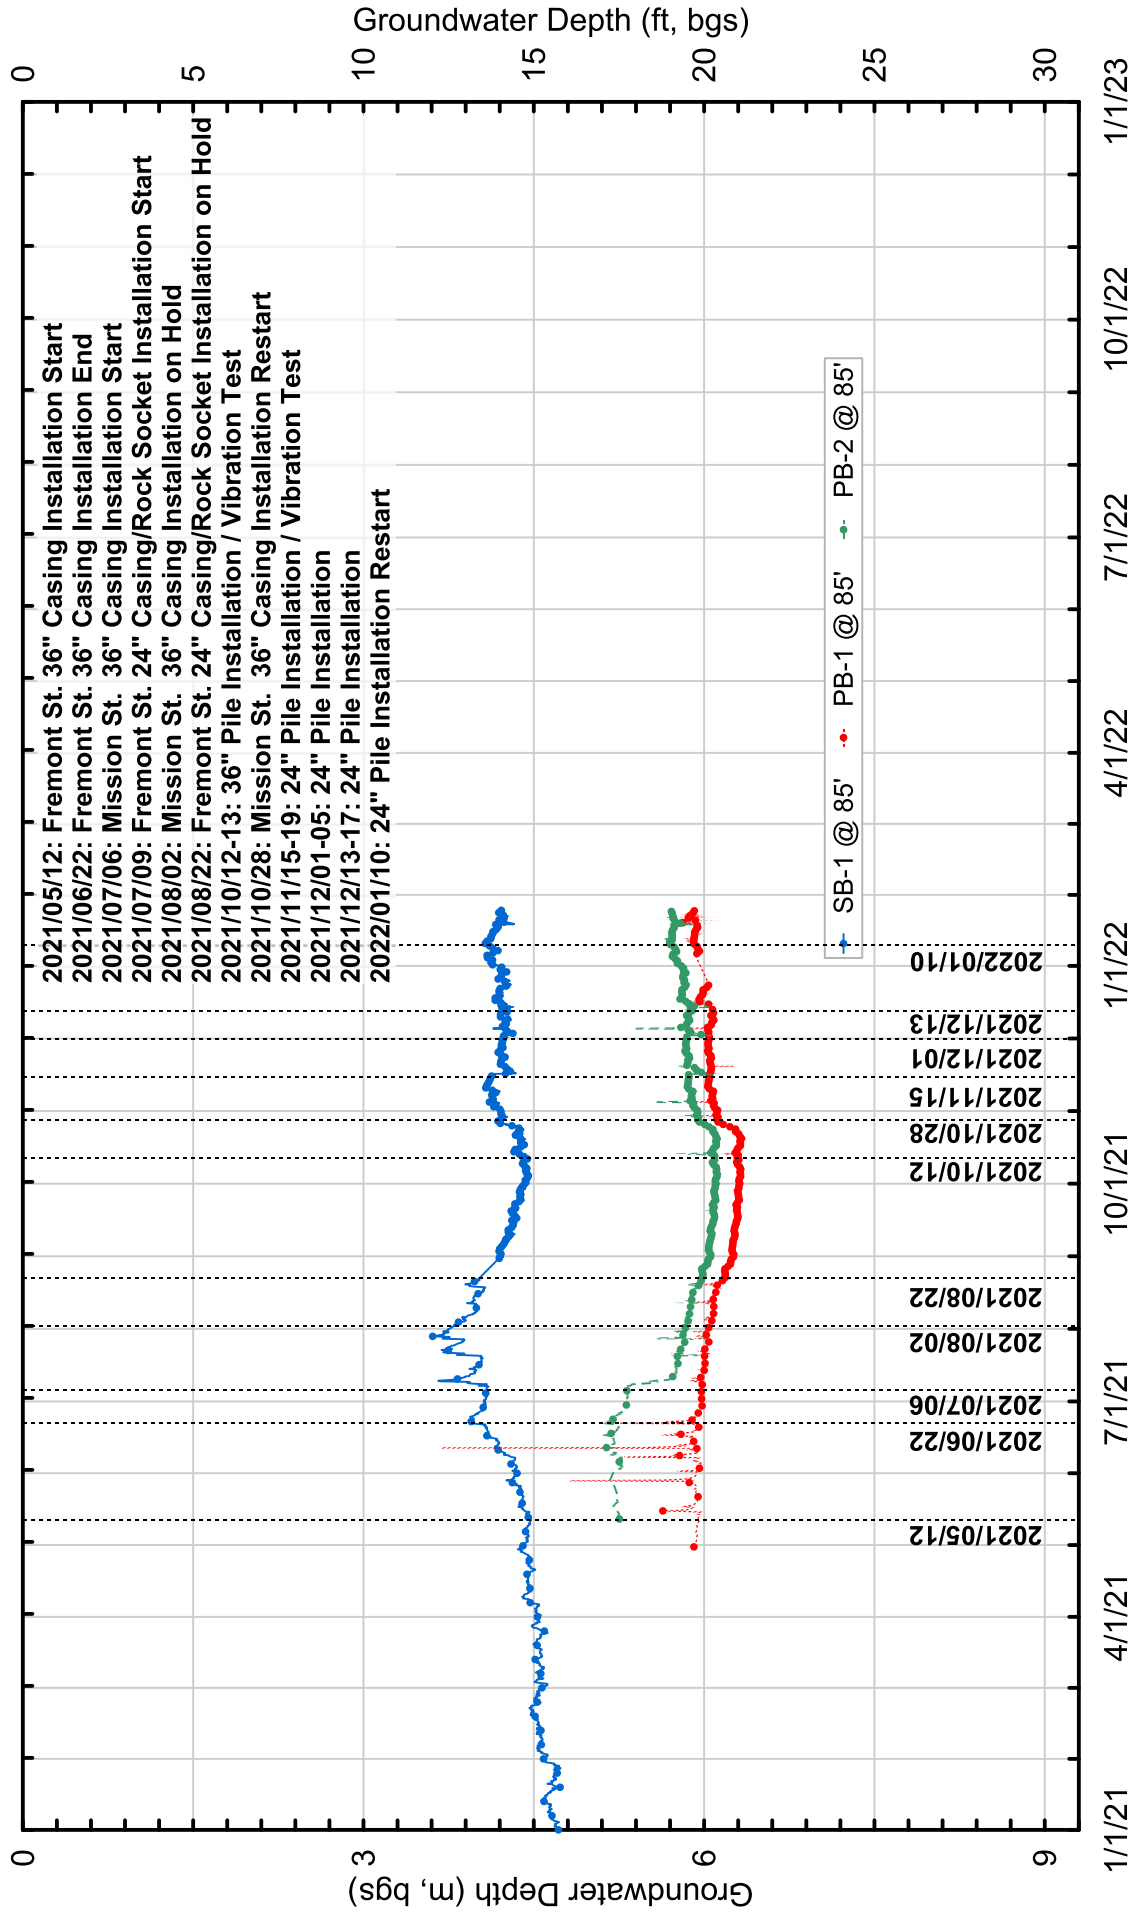
Project No: 19-009.00	Date: 1/24/2022	Created By: NBW	Checked By: DGM	Figure No: 038-08A
-----------------------	-----------------	-----------------	-----------------	--------------------

GROUNDWATER ELEVATION MEASUREMENTS IN MARINE AND COLMA SAND
 SINCE 01/01/2021 THROUGH 01/24/2022

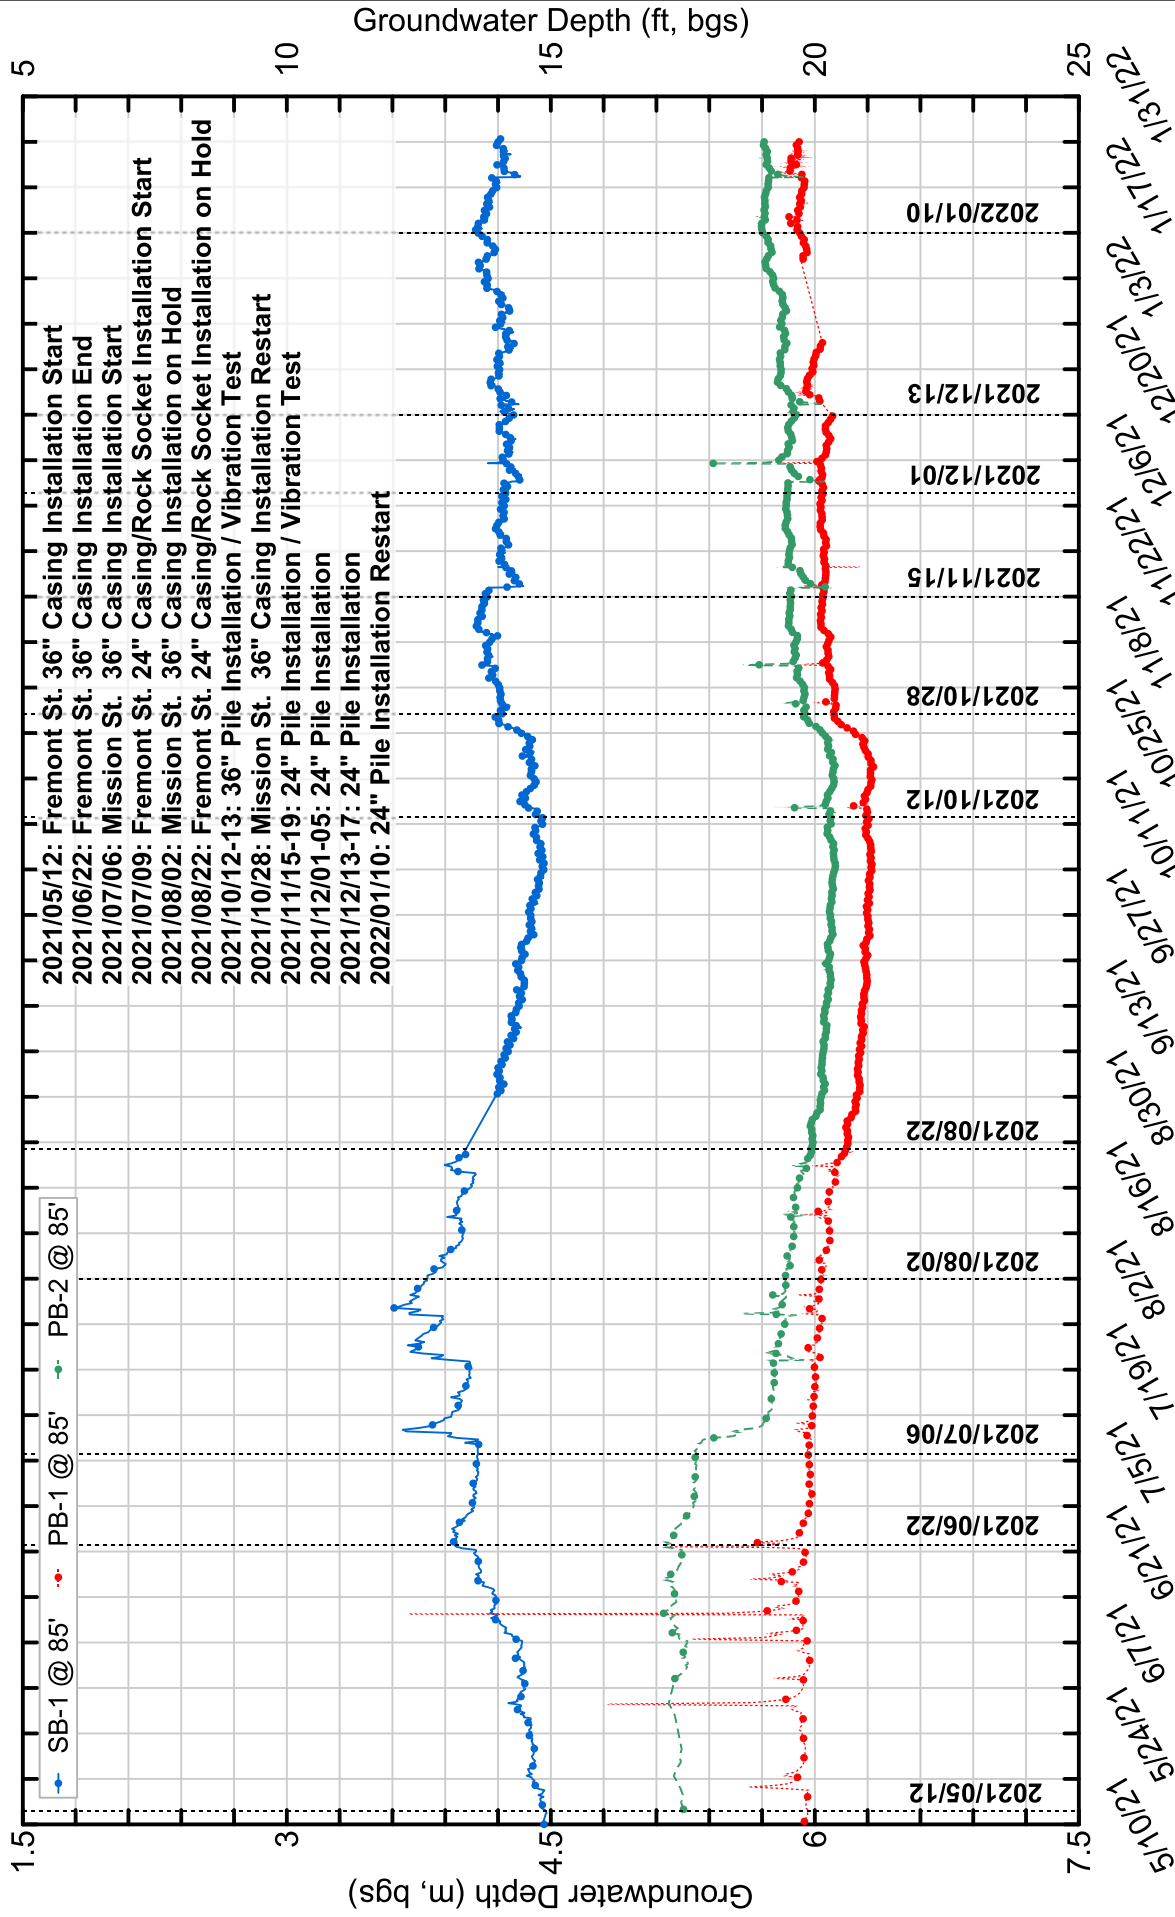
Project No: 19-009.00	Date: 1/24/2022	Created By: NBW	Checked By: DGM	Figure No: 038-08B
-----------------------	-----------------	-----------------	-----------------	--------------------

GROUNDWATER ELEVATION MEASUREMENTS IN MARINE AND COLMA SAND
 SINCE 05/10/2021 THROUGH 01/24/2022

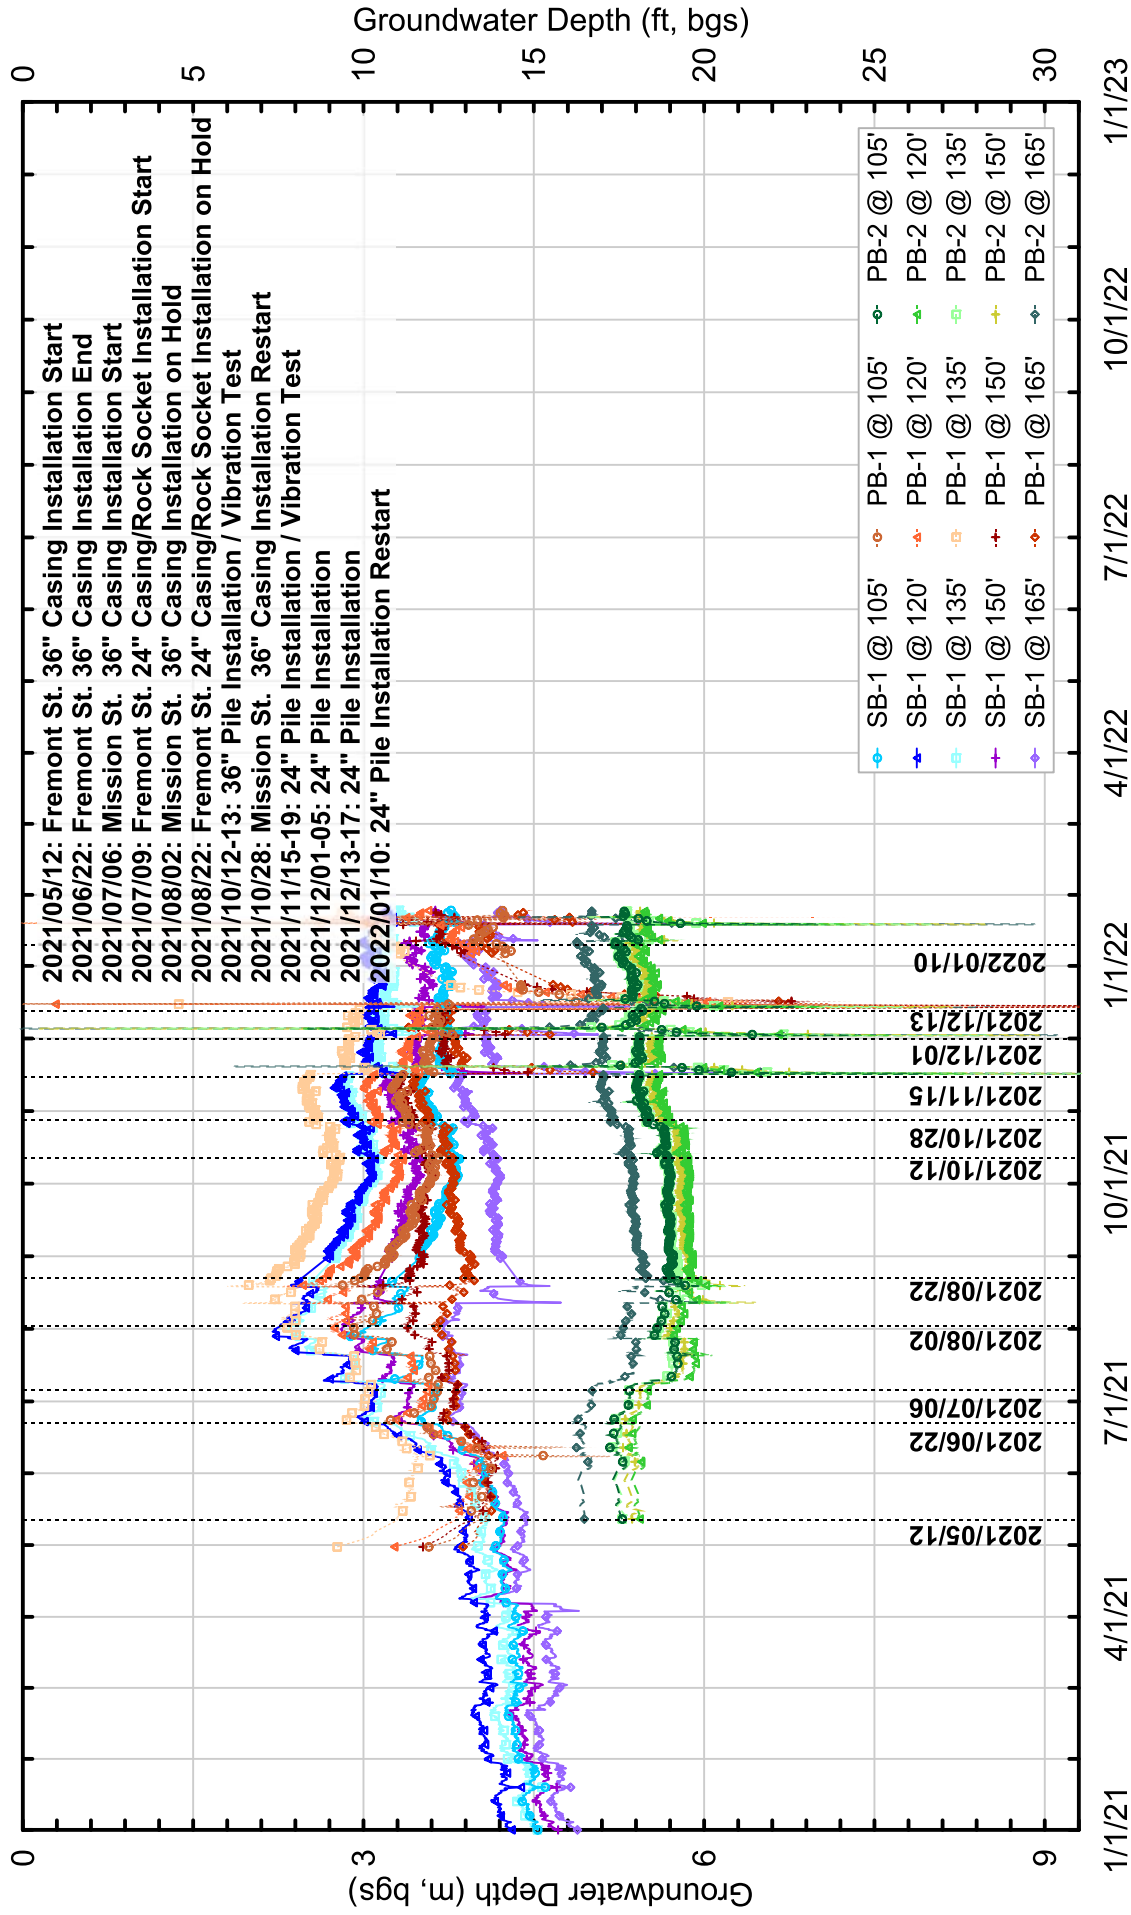
Project No: 19-009.00	Date: 1/24/2022	Created By: NBW	Checked By: DGM	Figure No: 038-09A

GROUNDWATER ELEVATION MEASUREMENTS IN OLD BAY CLAY SINCE 01/01/2021 THROUGH 01/24/2022				
Millennium Tower Perimeter Pile Upgrade: Instrumentation Monitoring Data City and County of San Francisco, California

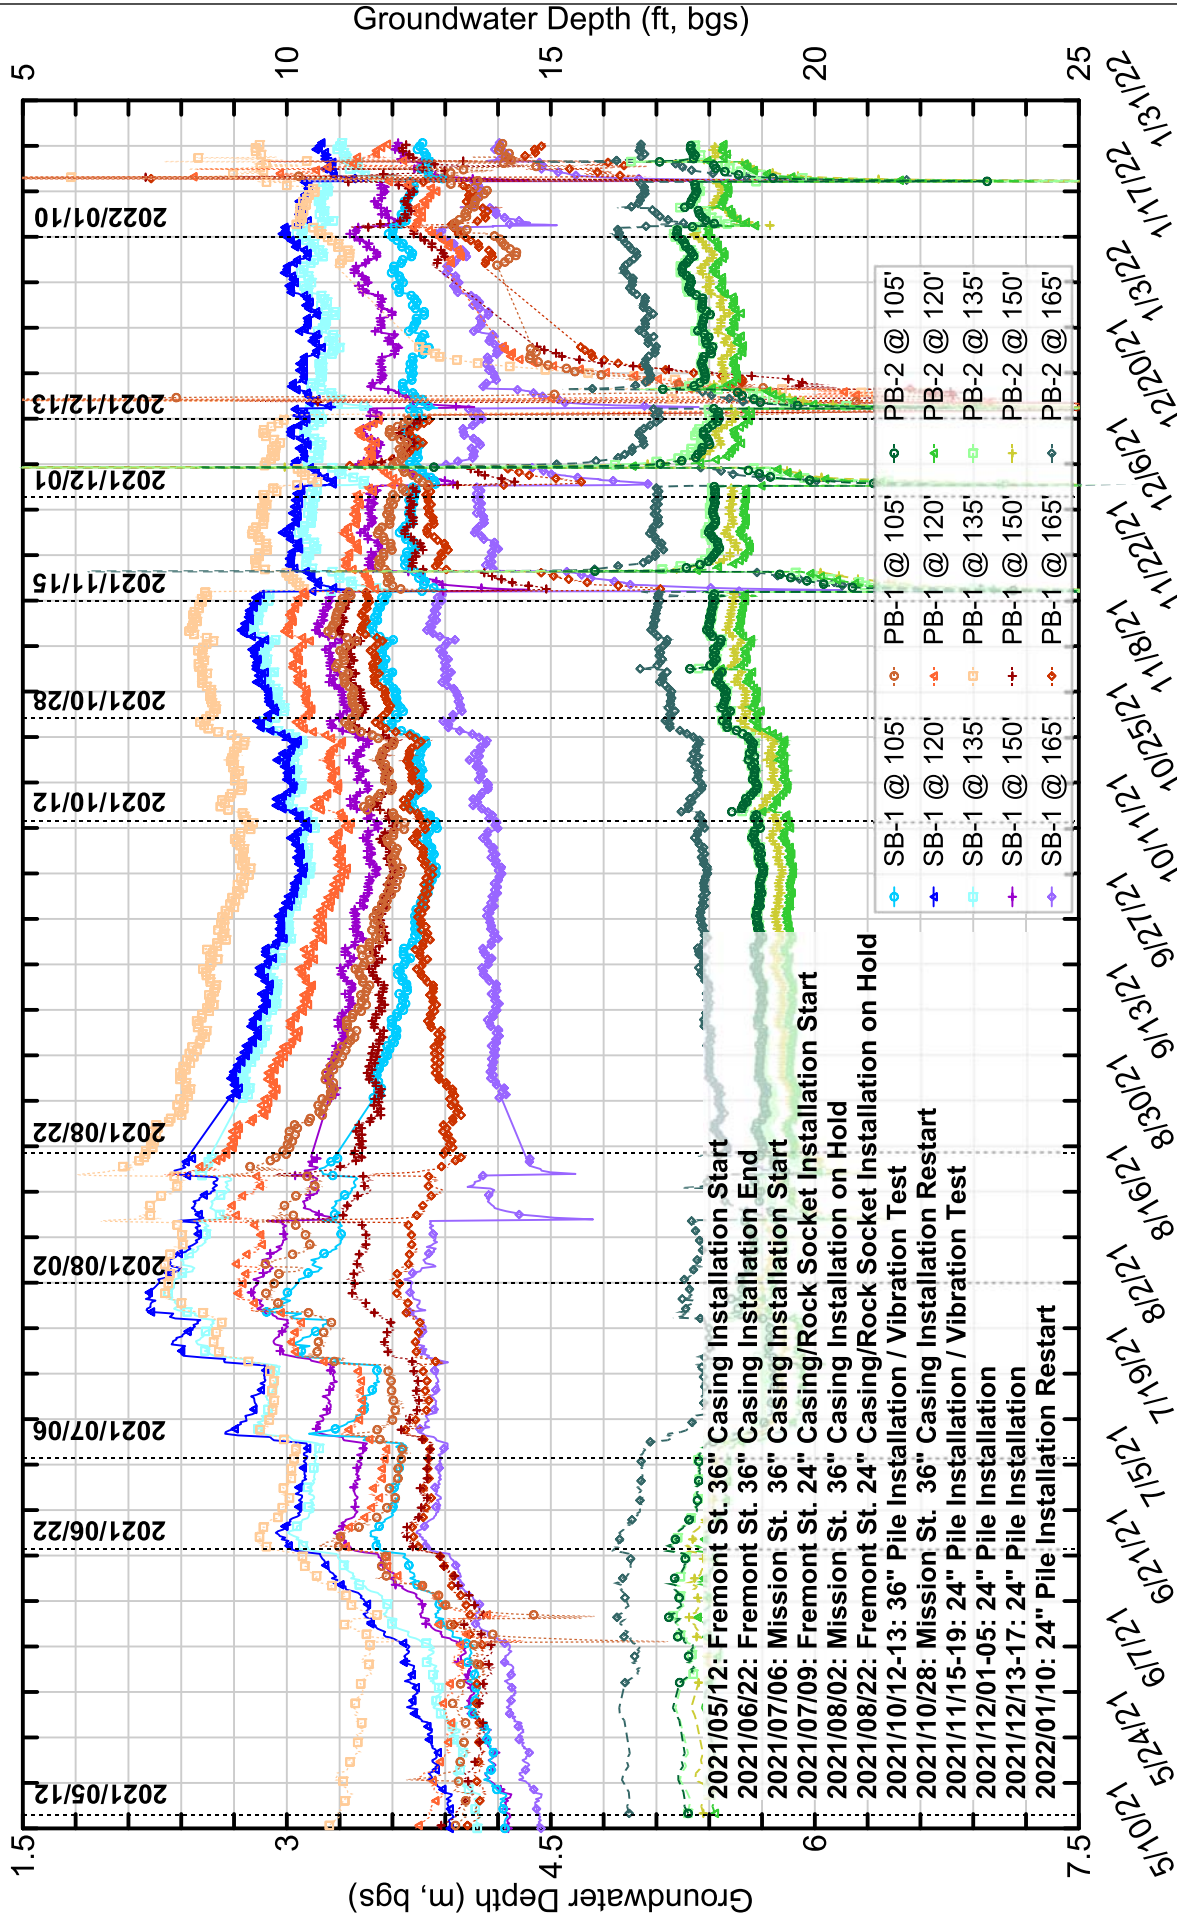
Project No: 19-009.00	Date: 1/24/2022	Created By: NBW	Checked By: DGM	Figure No: 038-09B

GROUNDWATER ELEVATION MEASUREMENTS IN OLD BAY CLAY SINCE 05/10/2021 THROUGH 01/24/2022				
Millennium Tower Perimeter Pile Upgrade: Instrumentation Monitoring Data City and County of San Francisco, California

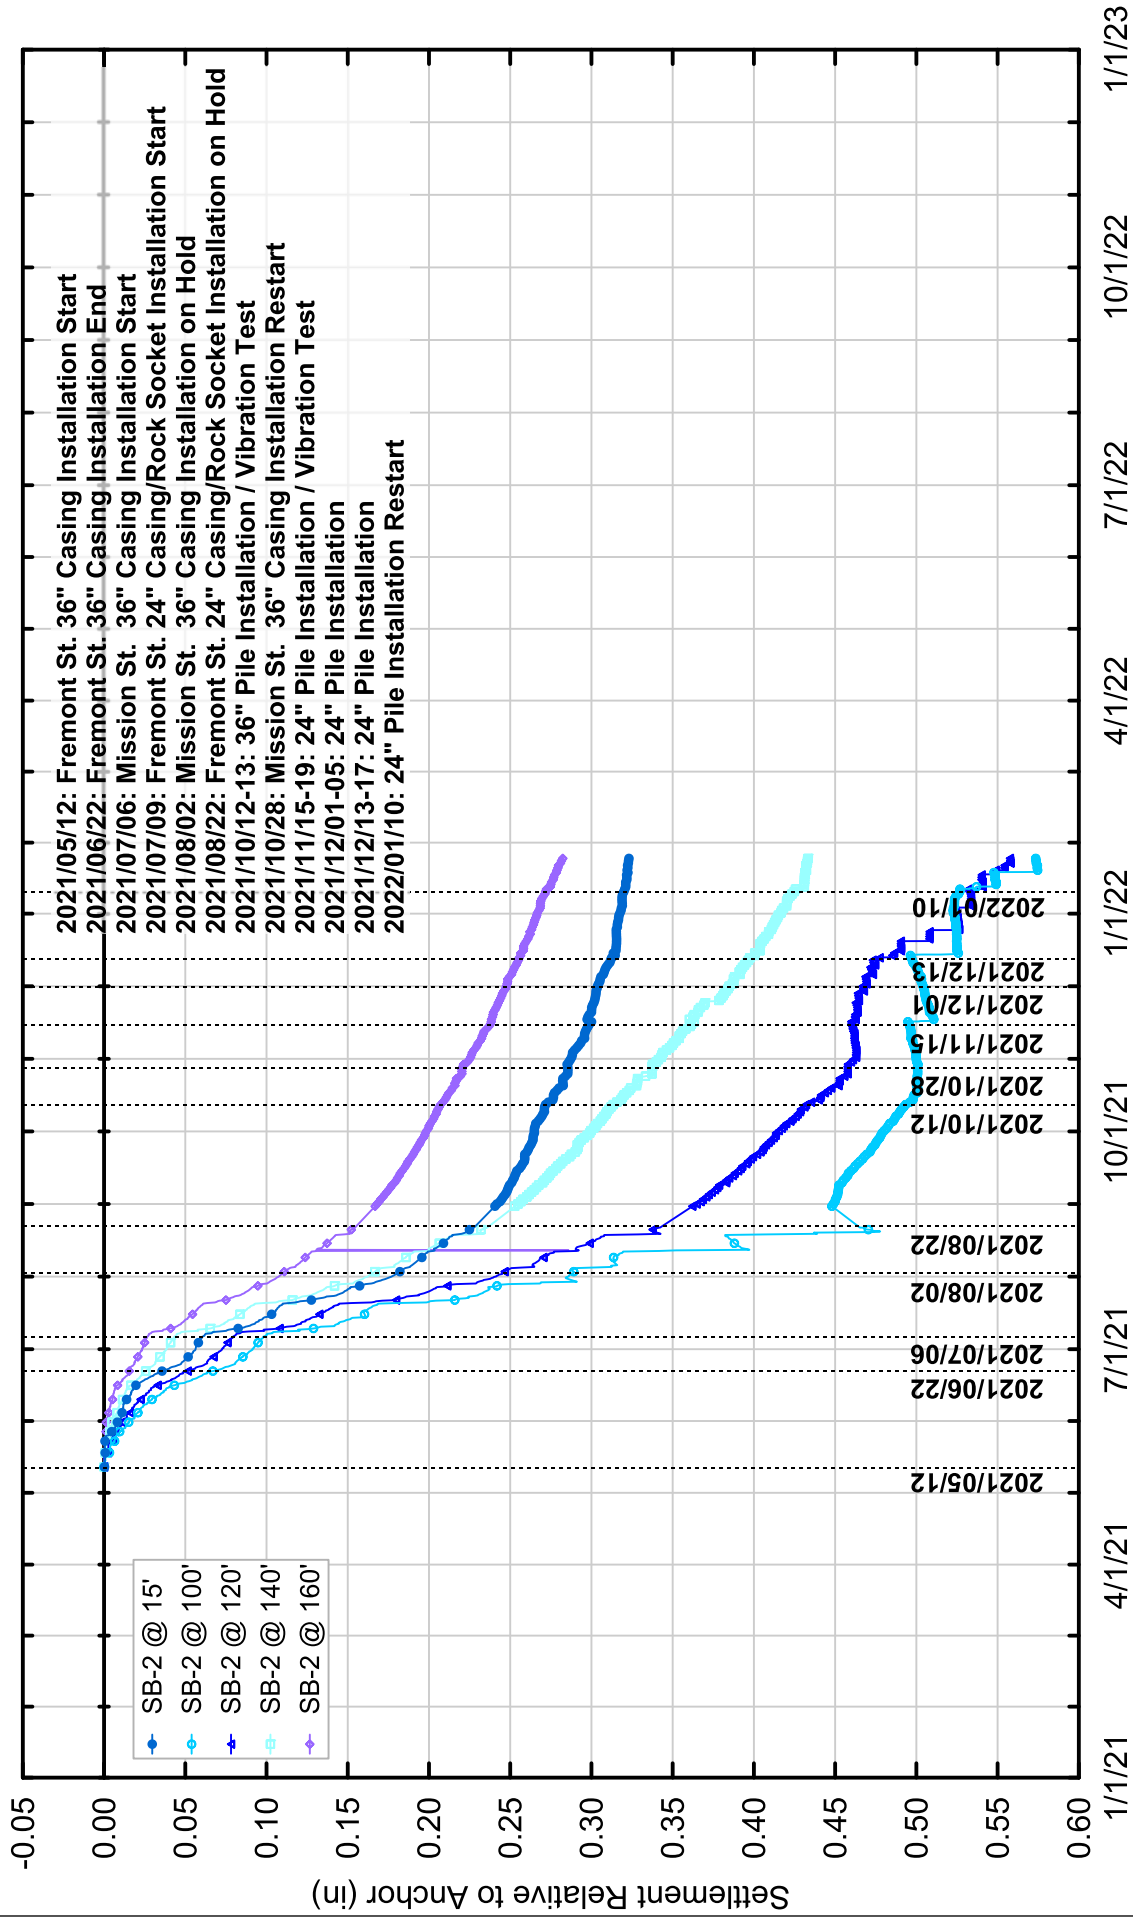
Project No: 19-009.00	Date: 1/24/2022	Created By: NBW	Checked By: DGM	Figure No: 038-10A

Figure 10 presents extensometer data from within the Tower basement since the start of production pile installation (May 12, 2021) through January 24, 2022. Figure 11 presents extensometer data from Fremont

EXTENSOMETER DATA FROM WITHIN TOWER BASEMENT SINCE 01/01/2021 THROUGH 01/24/2022				
Millennium Tower Perimeter Pile Upgrade: Instrumentation Monitoring Data City and County of San Francisco, California

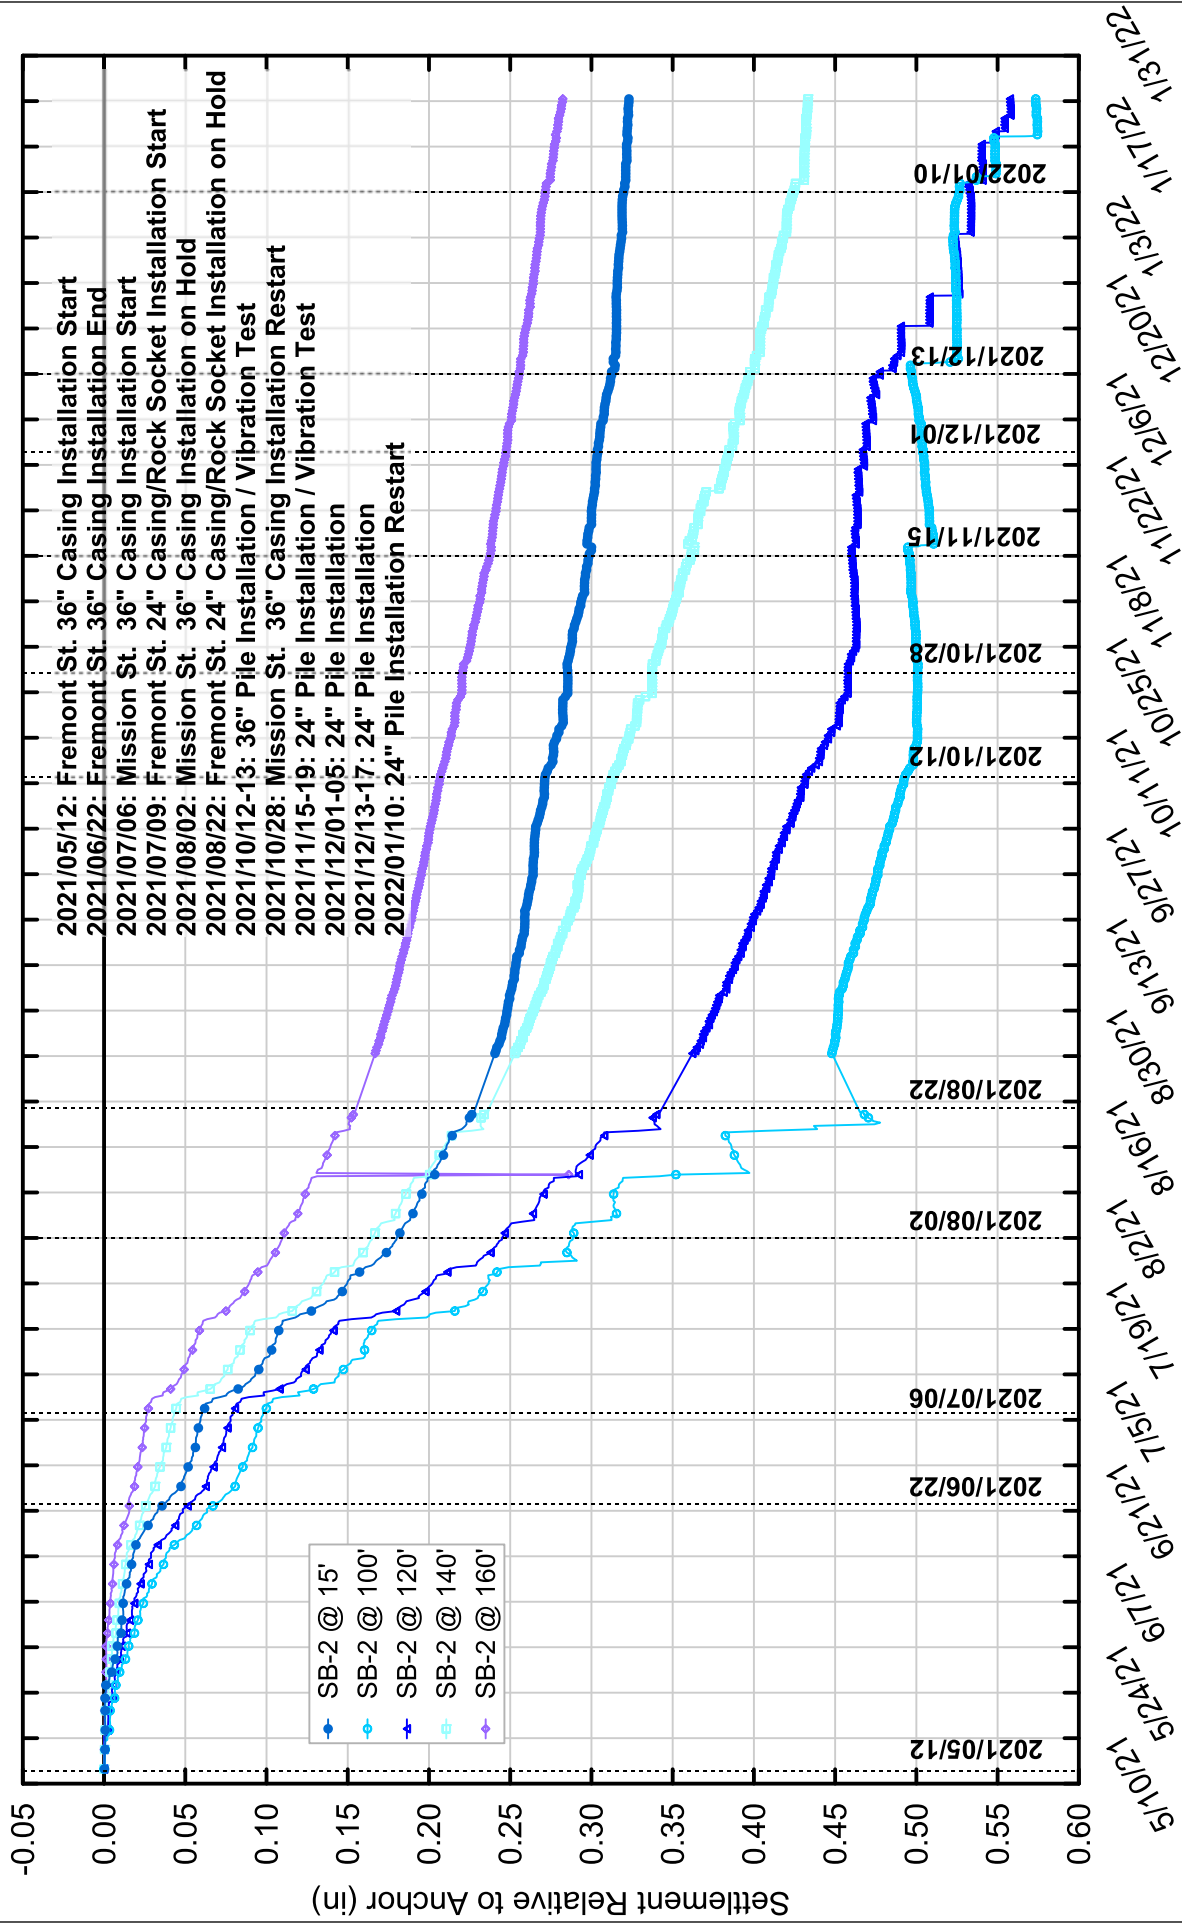
Project No: 19-009.00	Date: 1/24/2022	Created By: NBW	Checked By: DGM	Figure No: 038-10B
-----------------------	-----------------	-----------------	-----------------	--------------------

EXTENSOMETER DATA FROM WITHIN TOWER BASEMENT
 SINCE 05/10/2021 THROUGH 01/24/2022

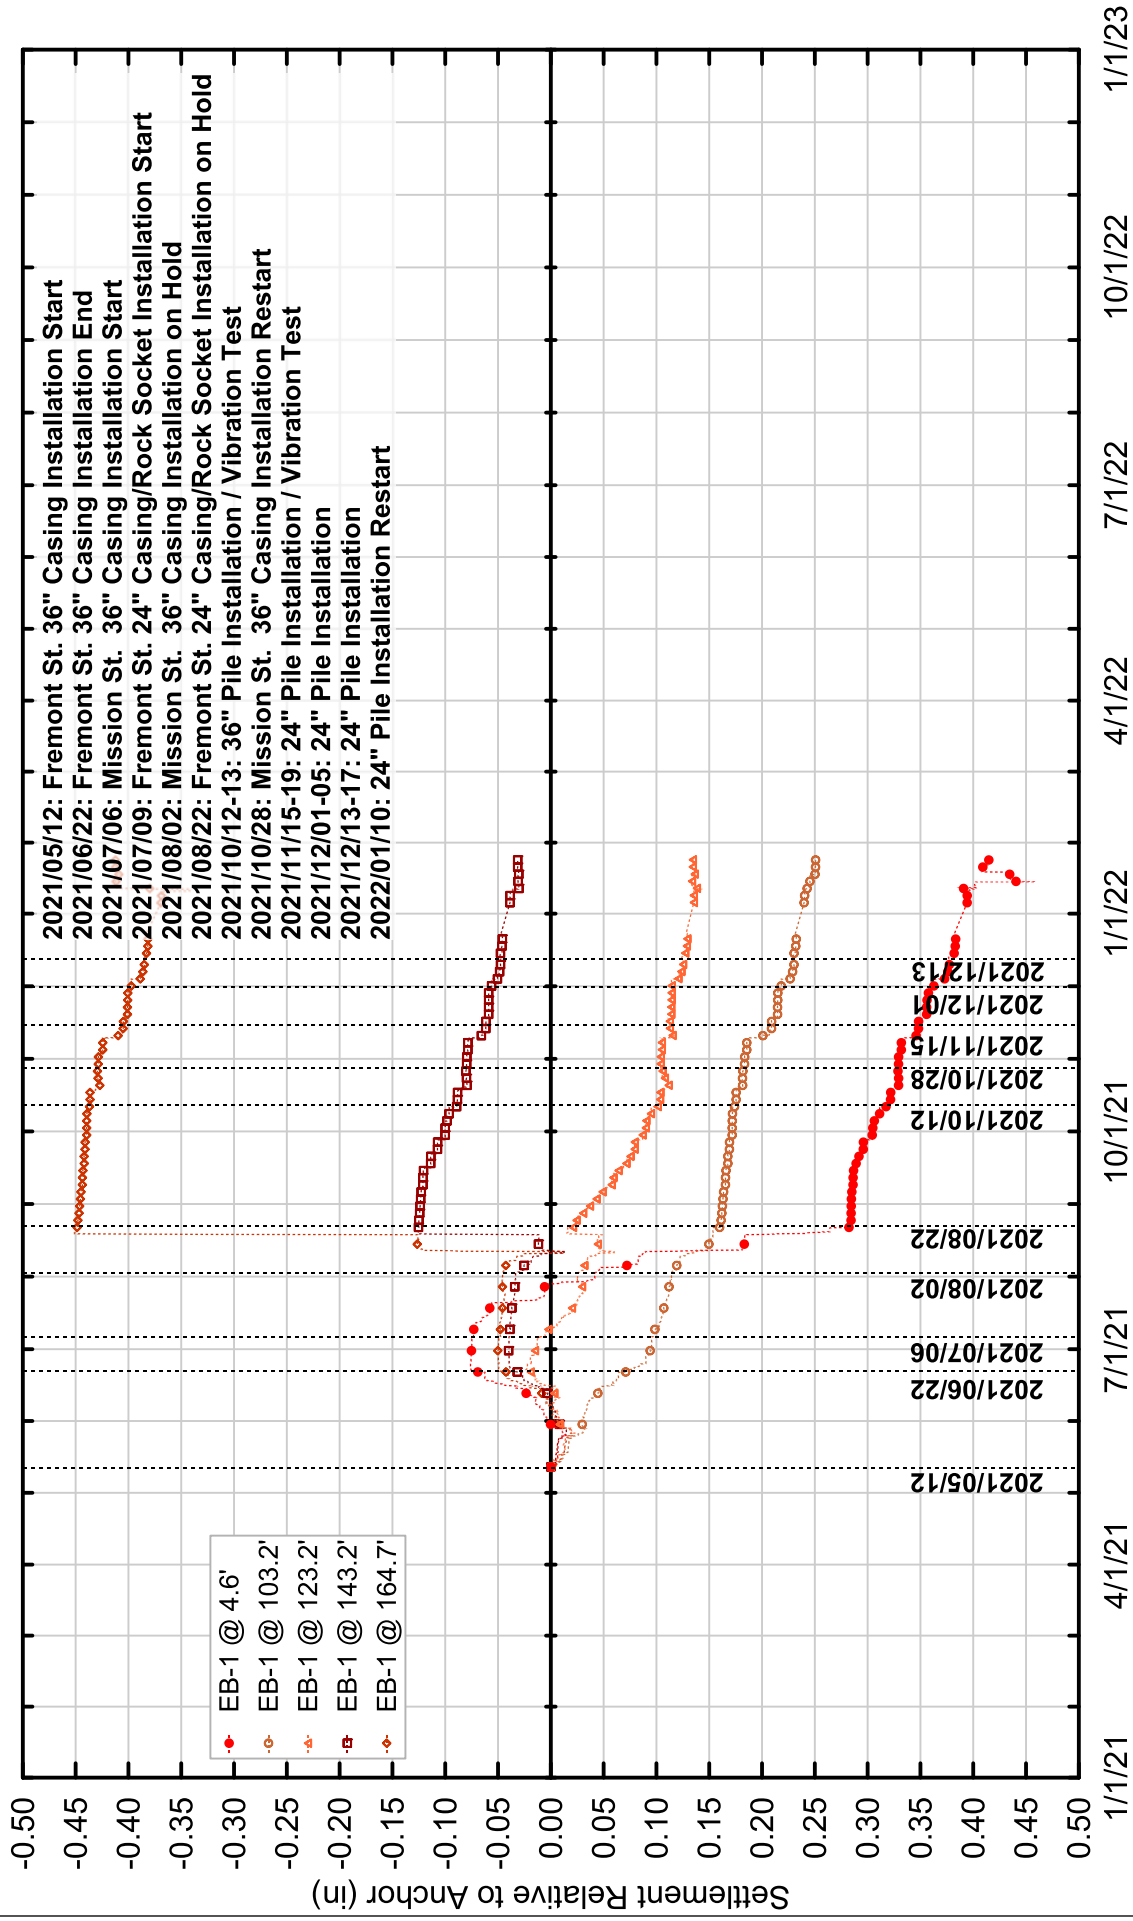
Project No: 19-009.00	Date: 1/24/2022	Created By: NBW	Checked By: DGM	Figure No: 038-11A
-----------------------	-----------------	-----------------	-----------------	--------------------

Street since the start of production pile installation (May 12, 2021) through January 24, 2022. Figure 12 presents extensometer data from Mission Street since the start of production pile installation (May 12, 2021) through January 24, 2022.

EXTENSOMETER DATA FROM FREMONT STREET
SINCE 01/01/2021 THROUGH 01/24/2022

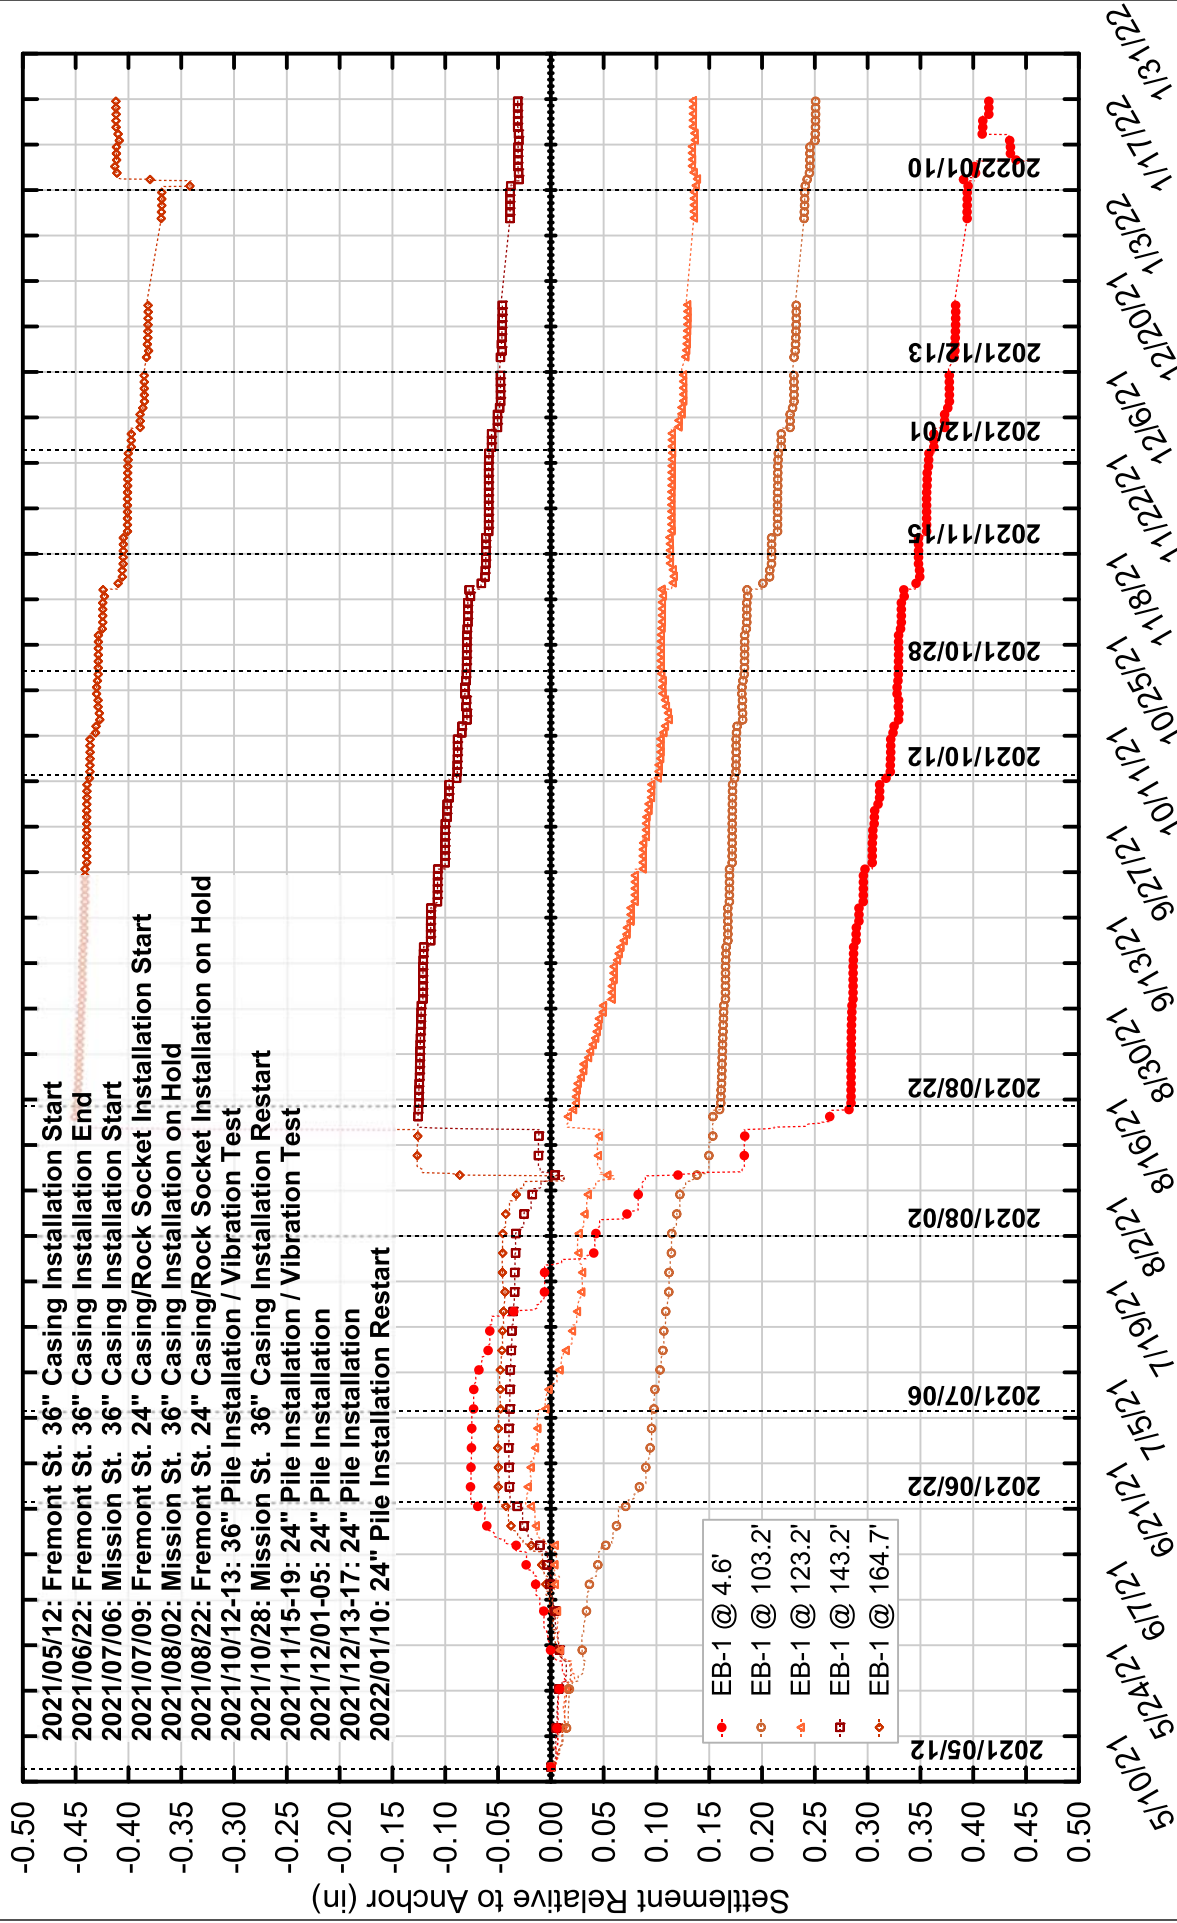
Project No: 19-009.00	Date: 1/24/2022	Created By: NBW	Checked By: DGM	Figure No: 038-11B
-----------------------	-----------------	-----------------	-----------------	--------------------

**EXTENSOMETER DATA FROM FREMONT STREET
SINCE 05/10/2021 THROUGH 01/24/2022**

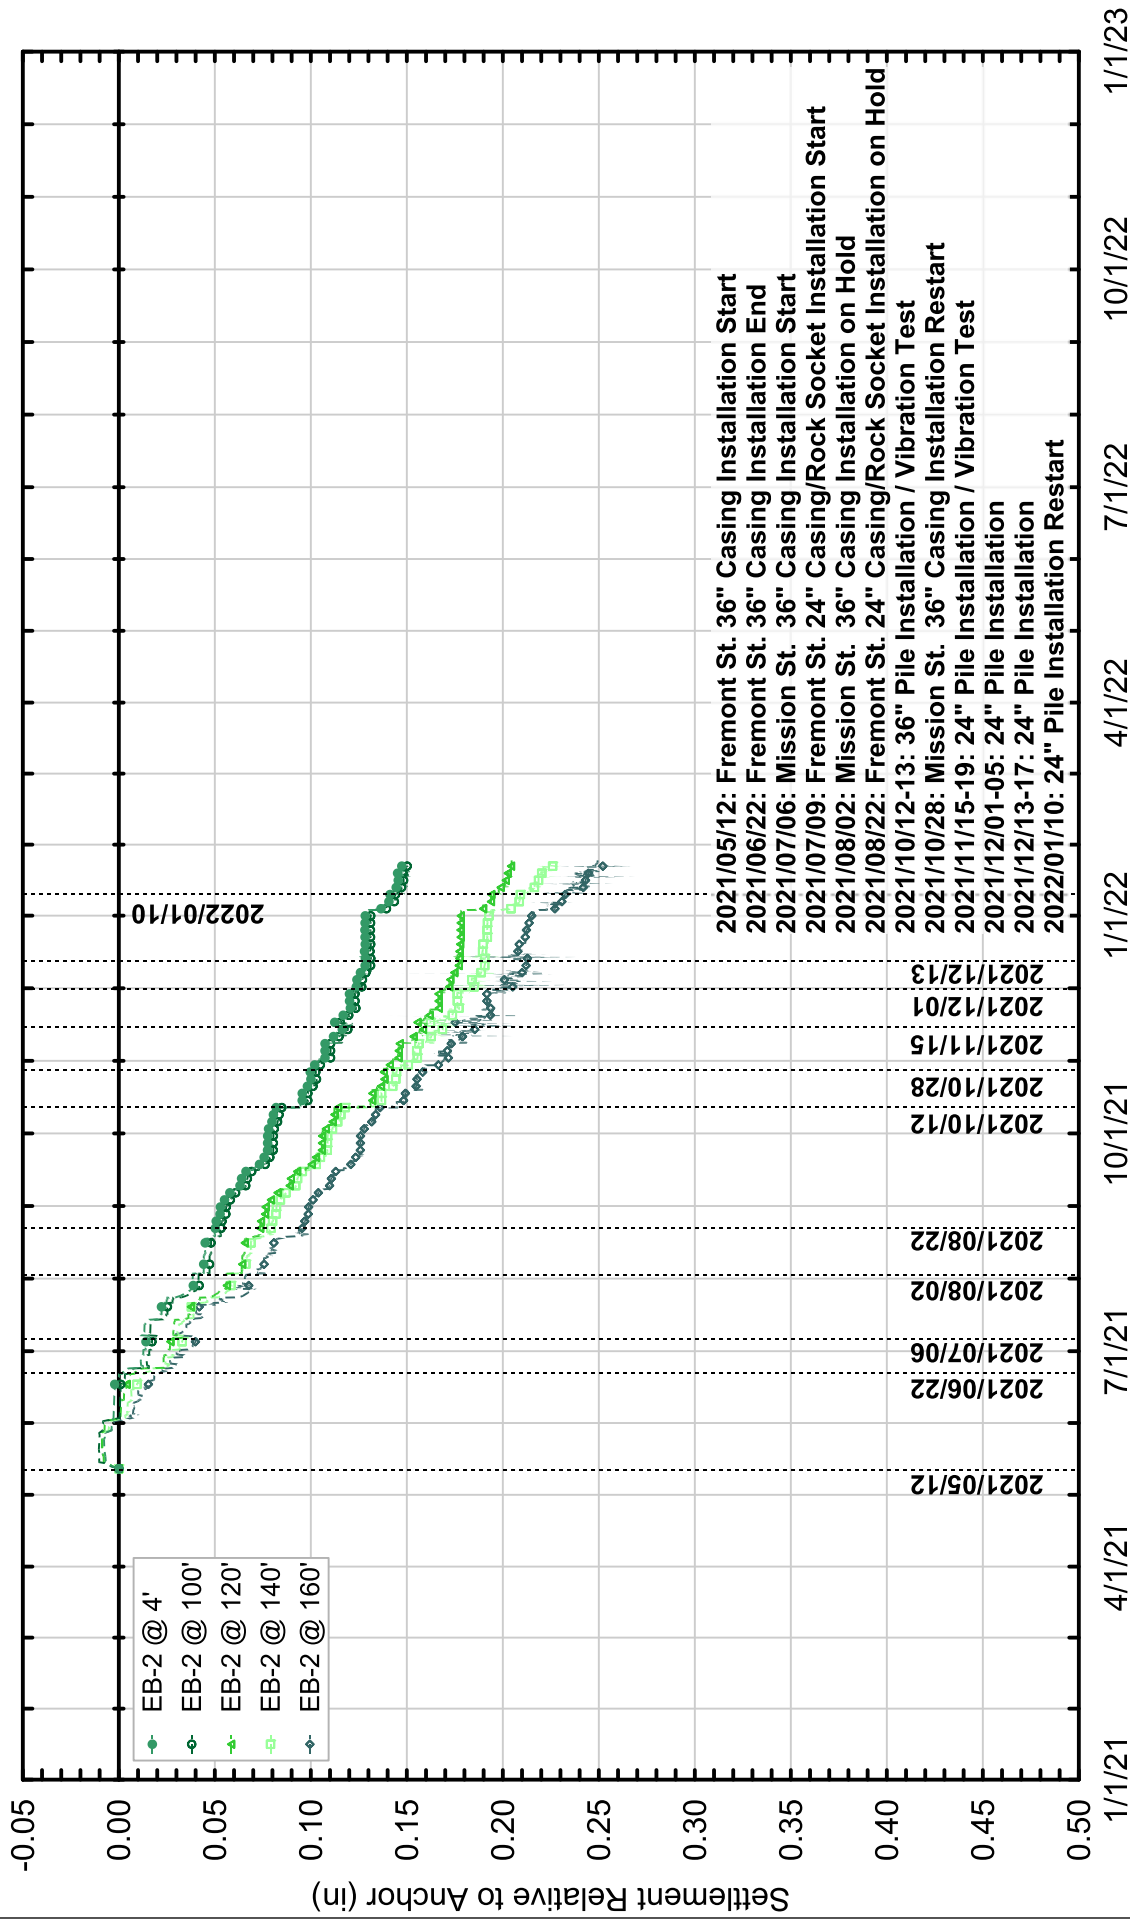
Project No: 19-009.00	Date: 1/24/2022	Created By: NBW	Checked By: DGM	Figure No: 038-12A
-----------------------	-----------------	-----------------	-----------------	--------------------

EXTENSOMETER DATA FROM MISSION STREET
SINCE 01/01/2021 THROUGH 01/24/2022

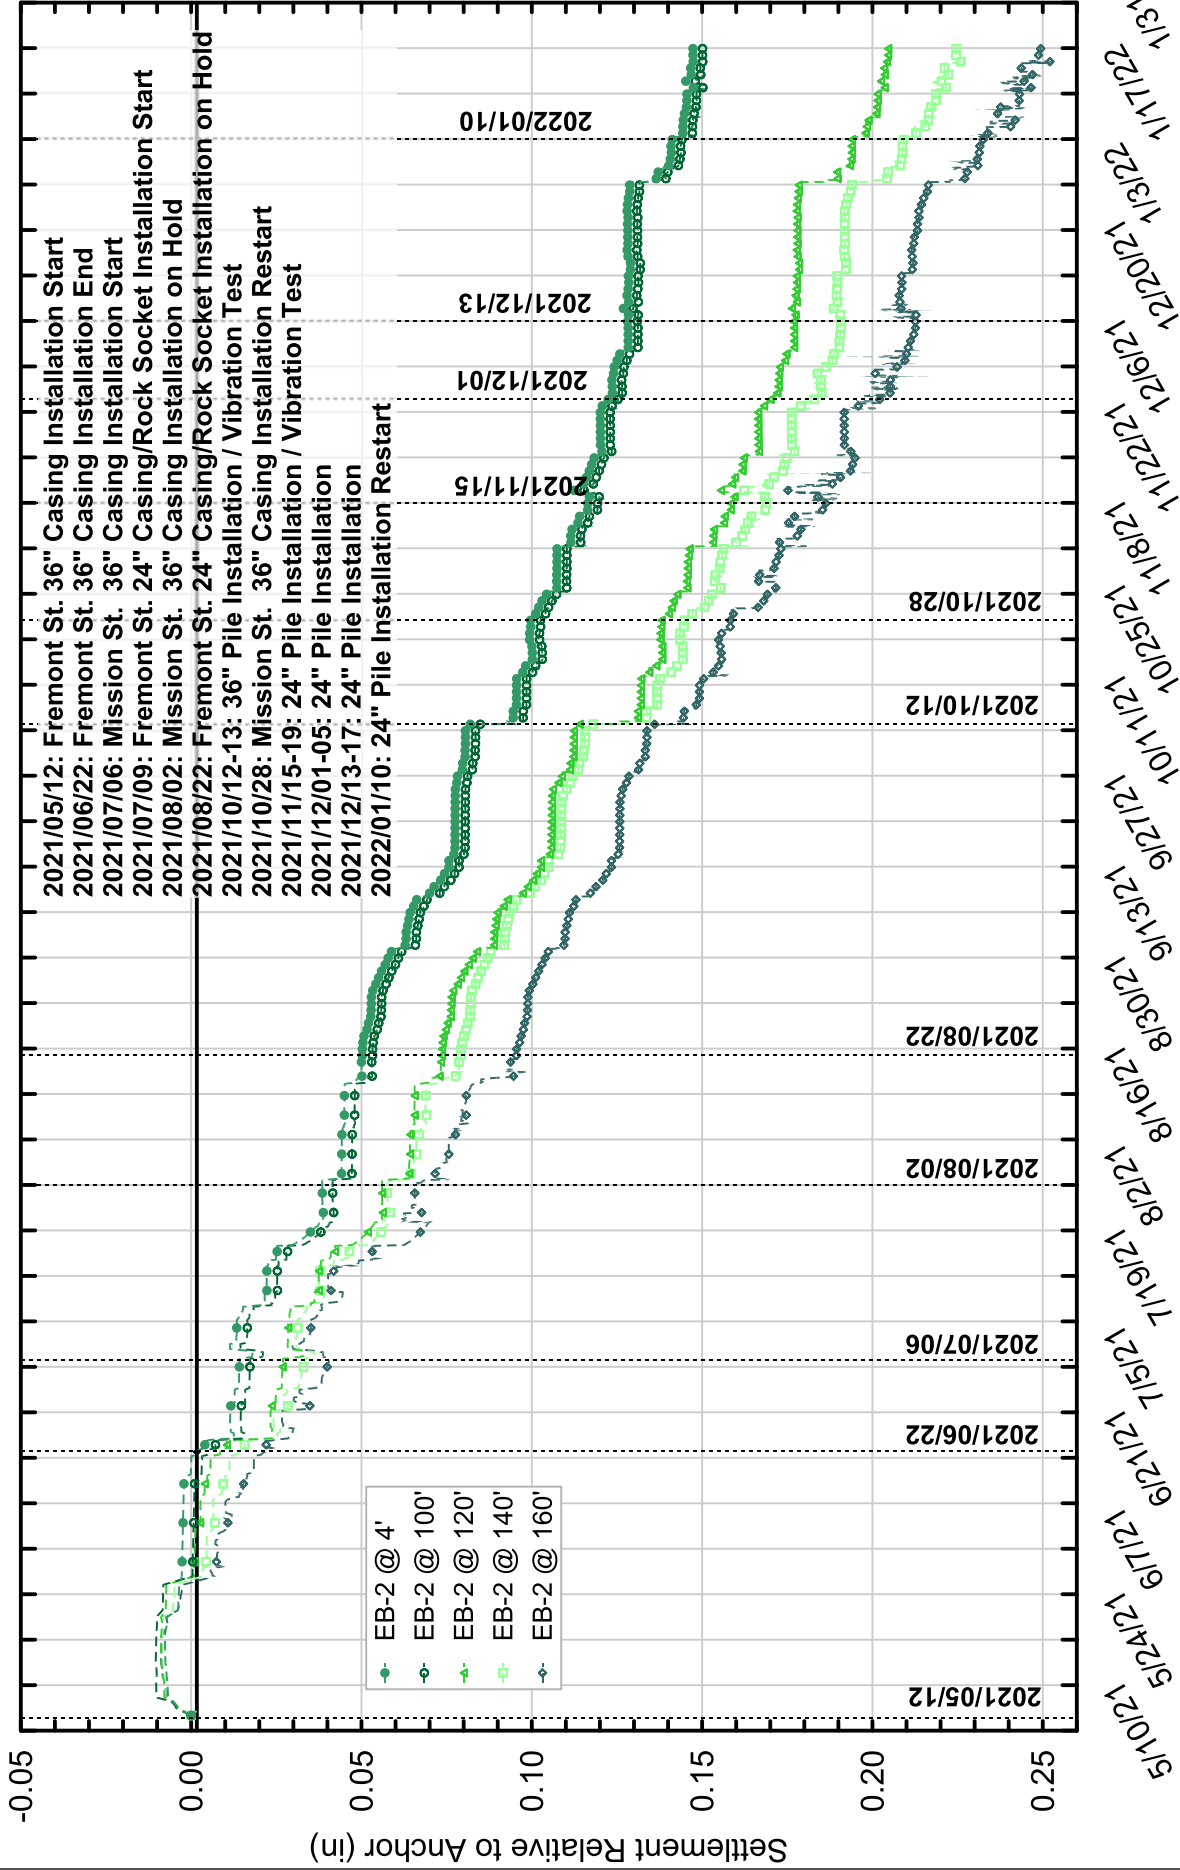
Project No: 19-009.00	Date: 1/24/2022	Created By: NBW	Checked By: DGM	Figure No: 038-12B
-----------------------	-----------------	-----------------	-----------------	--------------------

EXTENSOMETER DATA FROM MISSION STREET
SINCE 05/10/2021 THROUGH 01/24/2022
