Project Number: 19-009

Subject: 301 Mission Retrofit Supplemental Monitoring Report 059S: Results as of June 21, 2022

Millennium Tower Perimeter Pile Upgrade: Instrumentation Monitoring Data  
 City and County of San Francisco, California

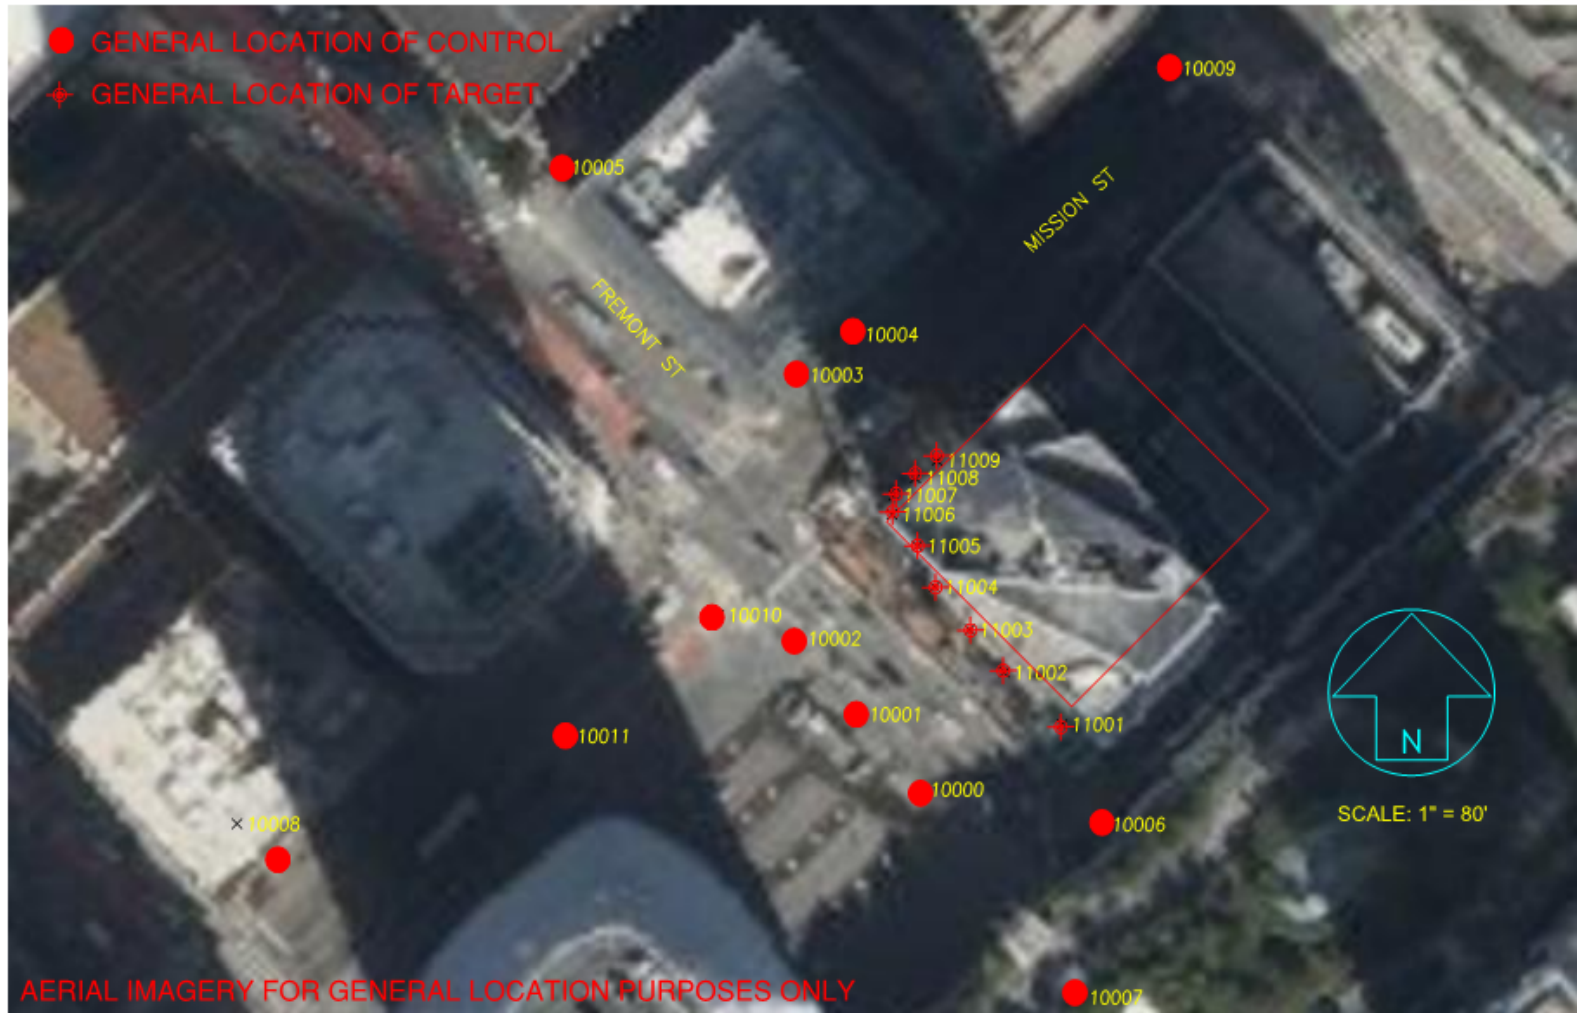
Project No: 19-009.00	Date: 5/3/2022	Created By: NBW	Checked By: DGM	Figure No: <b>059S-01</b>
-----------------------	----------------	-----------------	-----------------	---------------------------

Figure S-01 presents the locations of the survey prisms (including both control and target prisms) as referenced in later figures.

INSTRUMENT LOCATION MAP  
 HORIZONTAL SURVEY CONTROL AND TARGET POINTS AT FIRST LEVEL

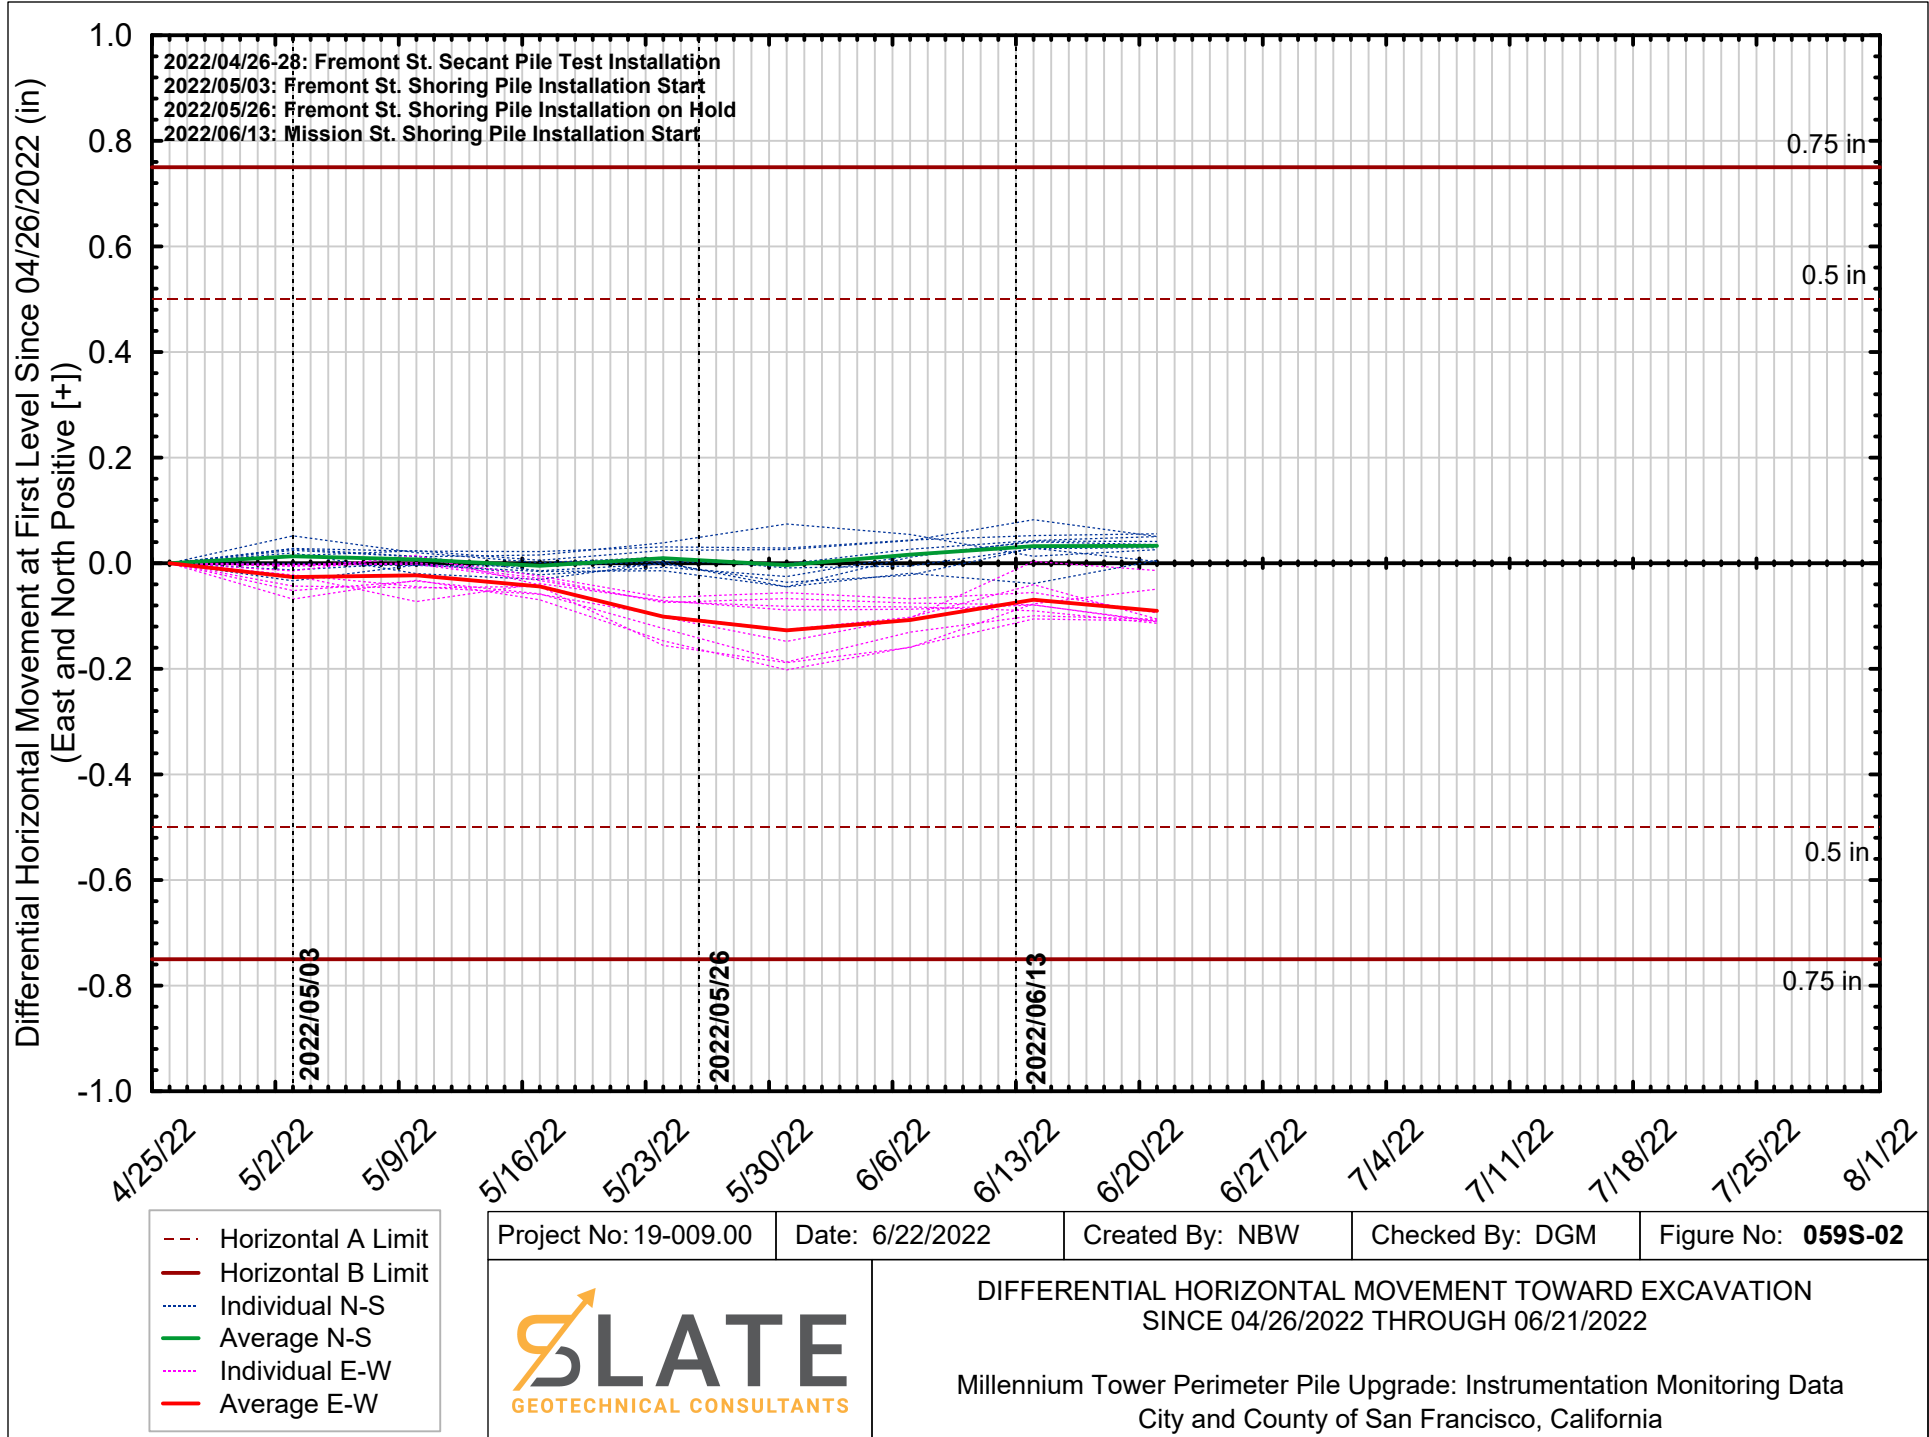
Figure S-02 presents the differential horizontal movement toward the excavation at survey prisms installed at approximately one floor level above grade on the exterior of the building, as well as the average in each of the project north-south and east-west direction, since April 26, 2022, through June 21, 2022. Limits established in the aforementioned letter are included for reference.

Figure S-02 – Differential Horizontal Movement Toward Excavation Since 04/26/2022 through 06/21/2022

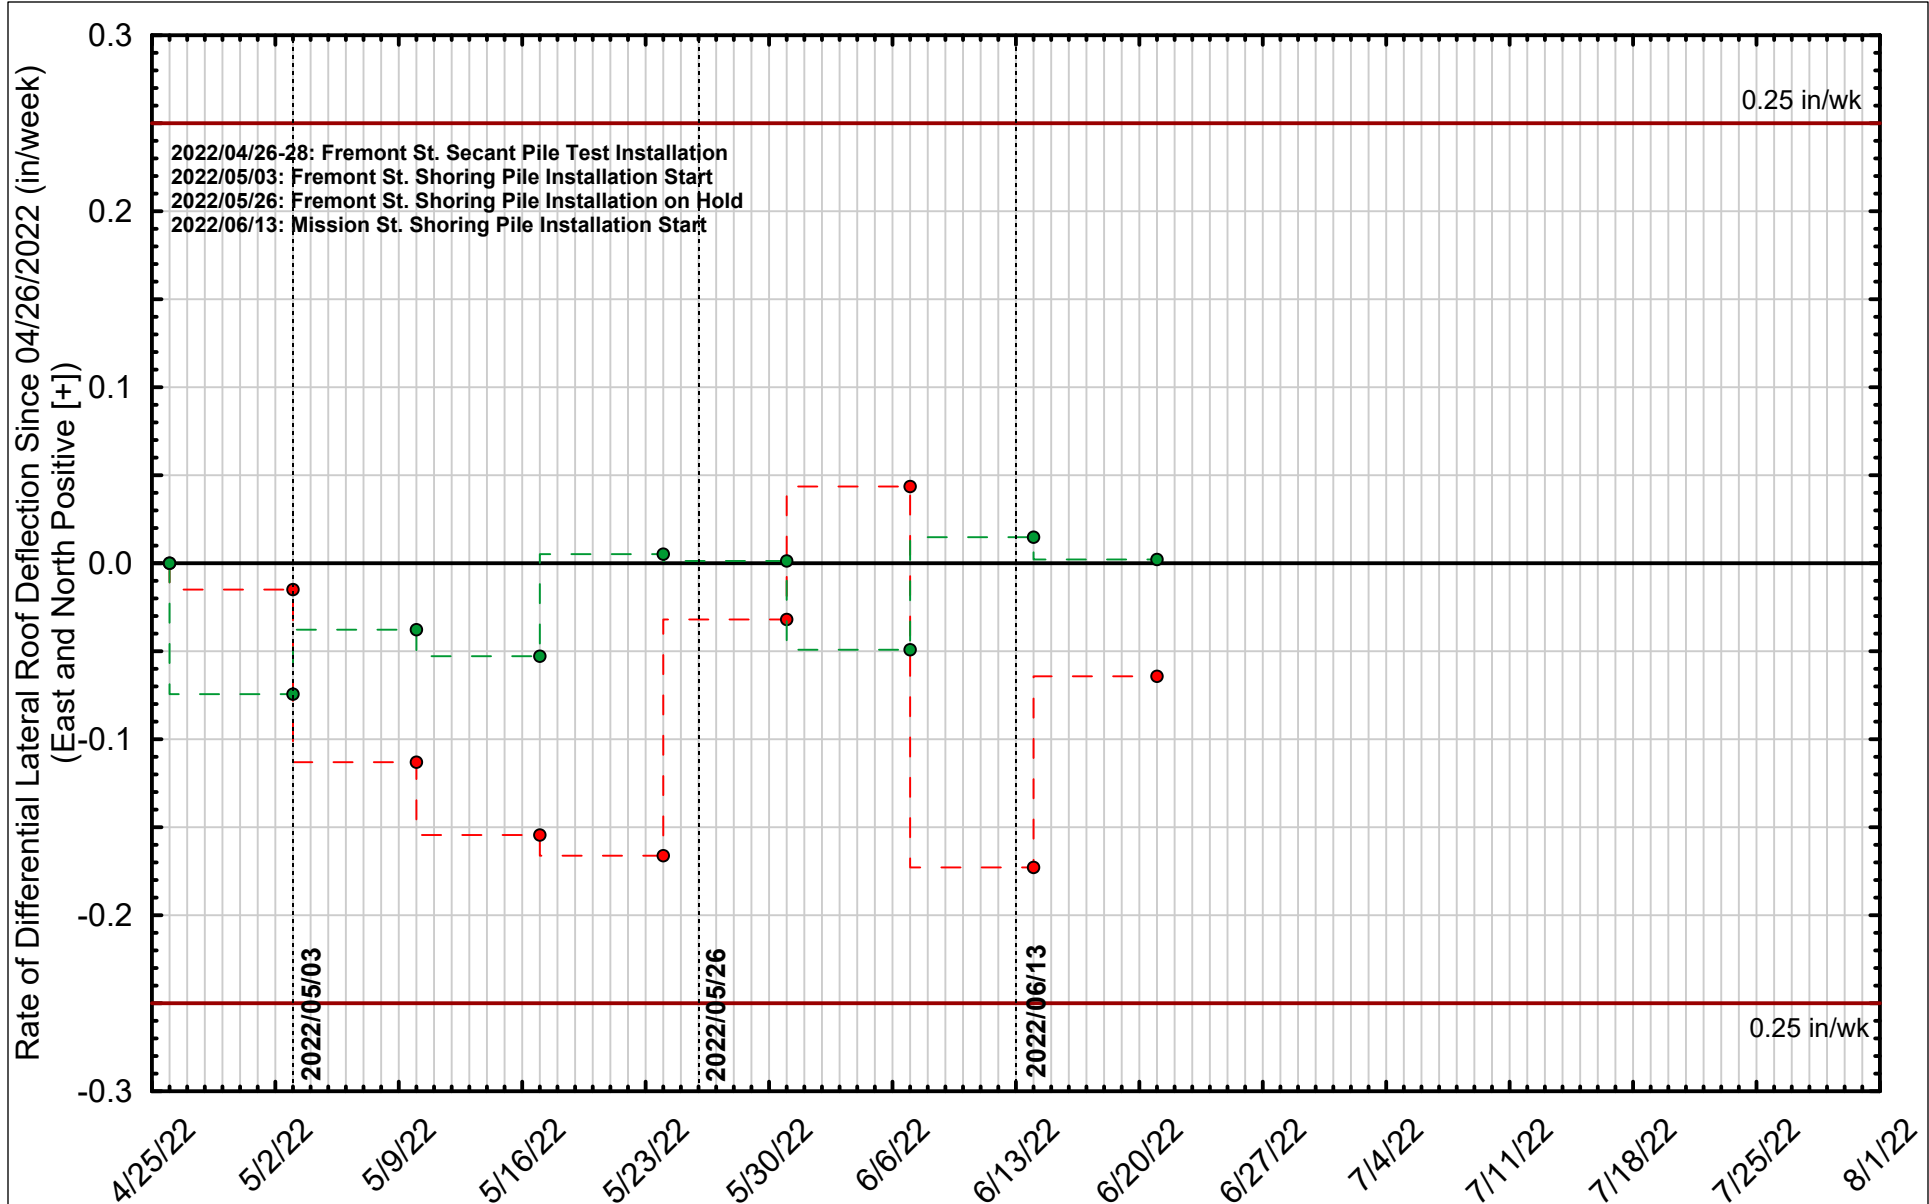
Project No: 19-009.00	Date: 6/22/2022	Created By: NBW	Checked By: DGM	Figure No: <b>059S-04</b>
-----------------------	-----------------	-----------------	-----------------	---------------------------

Figure S-04 presents rates of differential lateral roof deflection data due to shoring wall installation and excavation since April 26, 2022, through June 21, 2022. Limits established in the aforementioned letter are included for reference. Note that the rates are calculated as:

$$\frac{d\Delta_R}{dT} \approx \frac{\Delta_{R,t} - \Delta_{R,t-1}}{T_t - T_{t-1}}$$

where:  $t$  is an index representing the current instance in time; and  
 $t - 1$  is an index representing the previous instance in time.

RATE OF DIFFERENTIAL LATERAL ROOF DEFLECTION DATA  
 DUE TO SHORING WALL INSTALLATION AND EXCAVATION  
 SINCE 04/26/2022 THROUGH 06/21/2022  
 Millennium Tower Perimeter Pile Upgrade: Instrumentation Monitoring Data  
 City and County of San Francisco, California
