Date: July 6, 2022

Project Number: 19-009

Subject: 301 Mission Retrofit Monitoring Report 061: Results as of July 5, 2022

Millennium Tower Perimeter Pile Upgrade: Instrumentation Monitoring Data
City and County of San Francisco, California

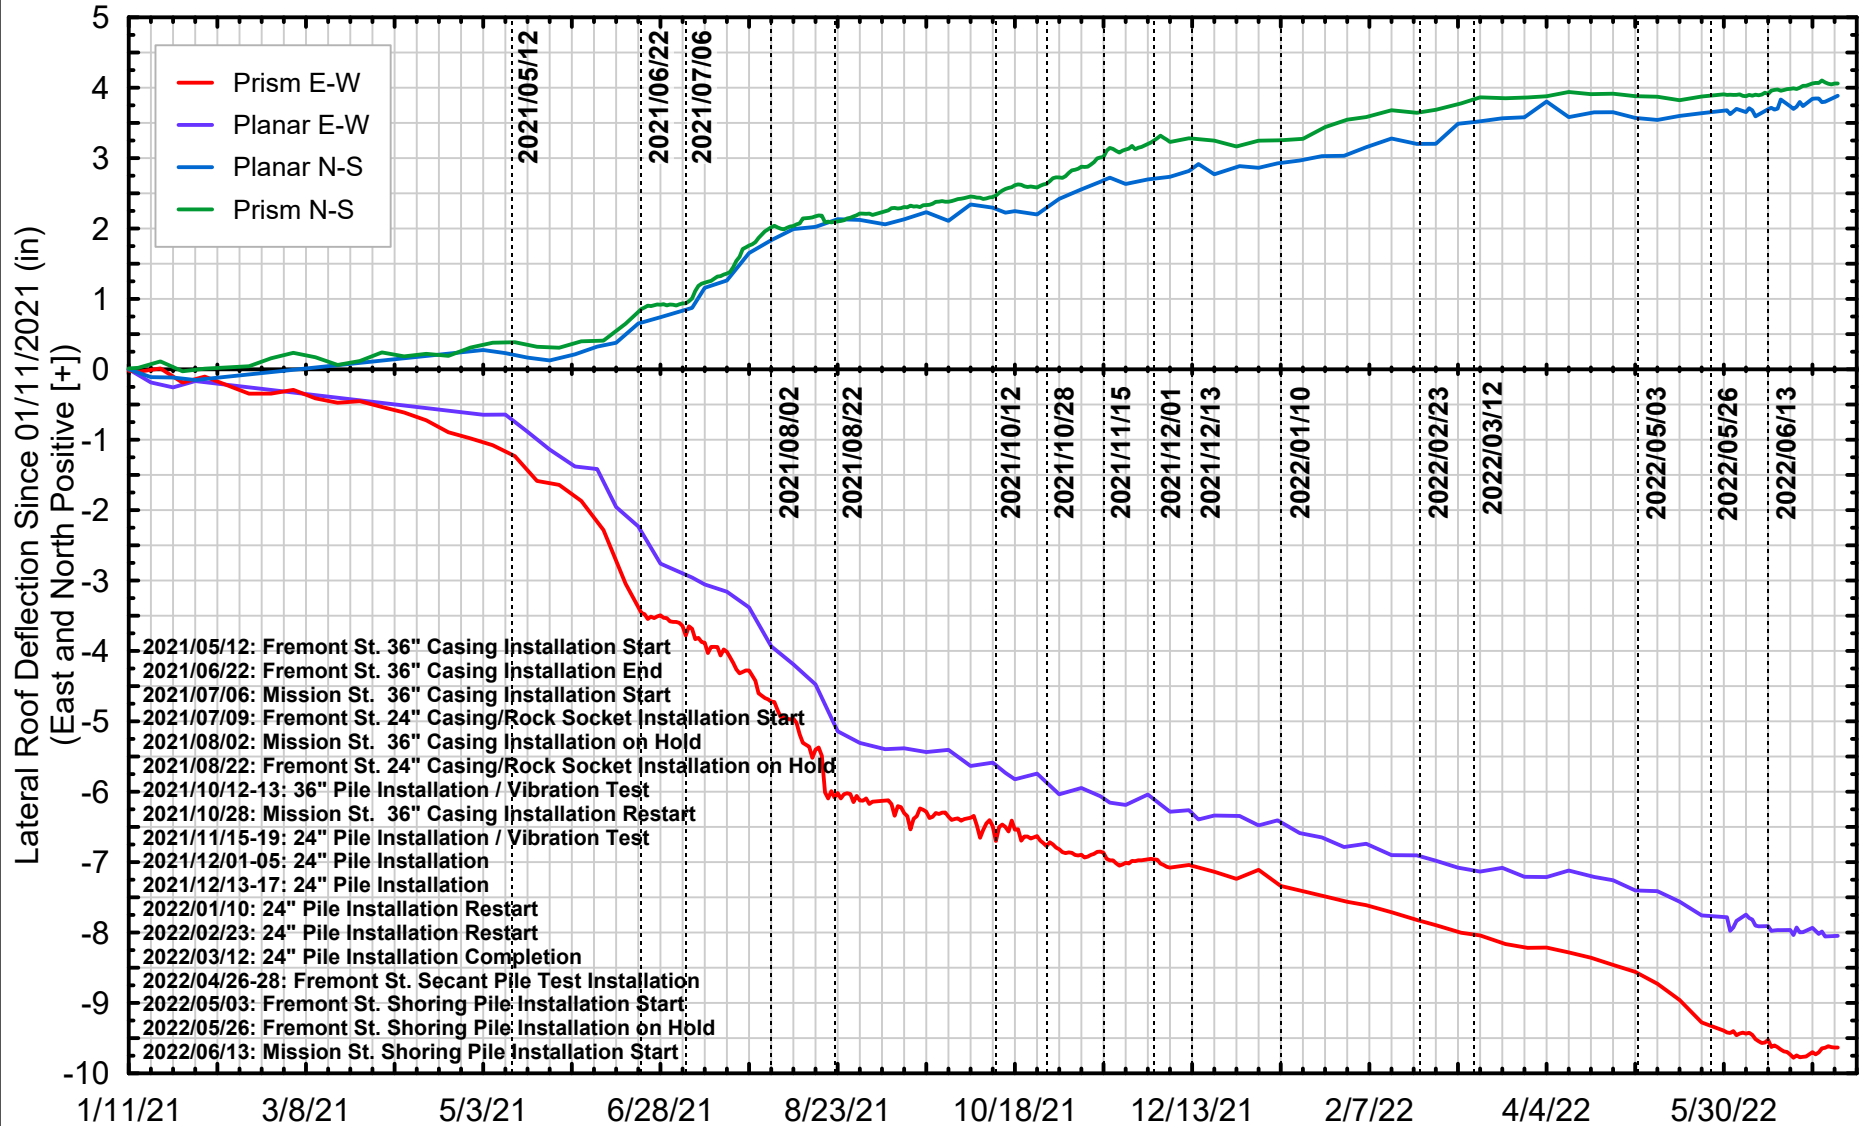
Project No: 19-009.00 Date: 7/6/2022 Created By: NBW Checked By: DGM Figure No: **061-06B**

LATERAL ROOF DEFLECTION DATA
SINCE 01/11/2021 THROUGH 07/05/2022

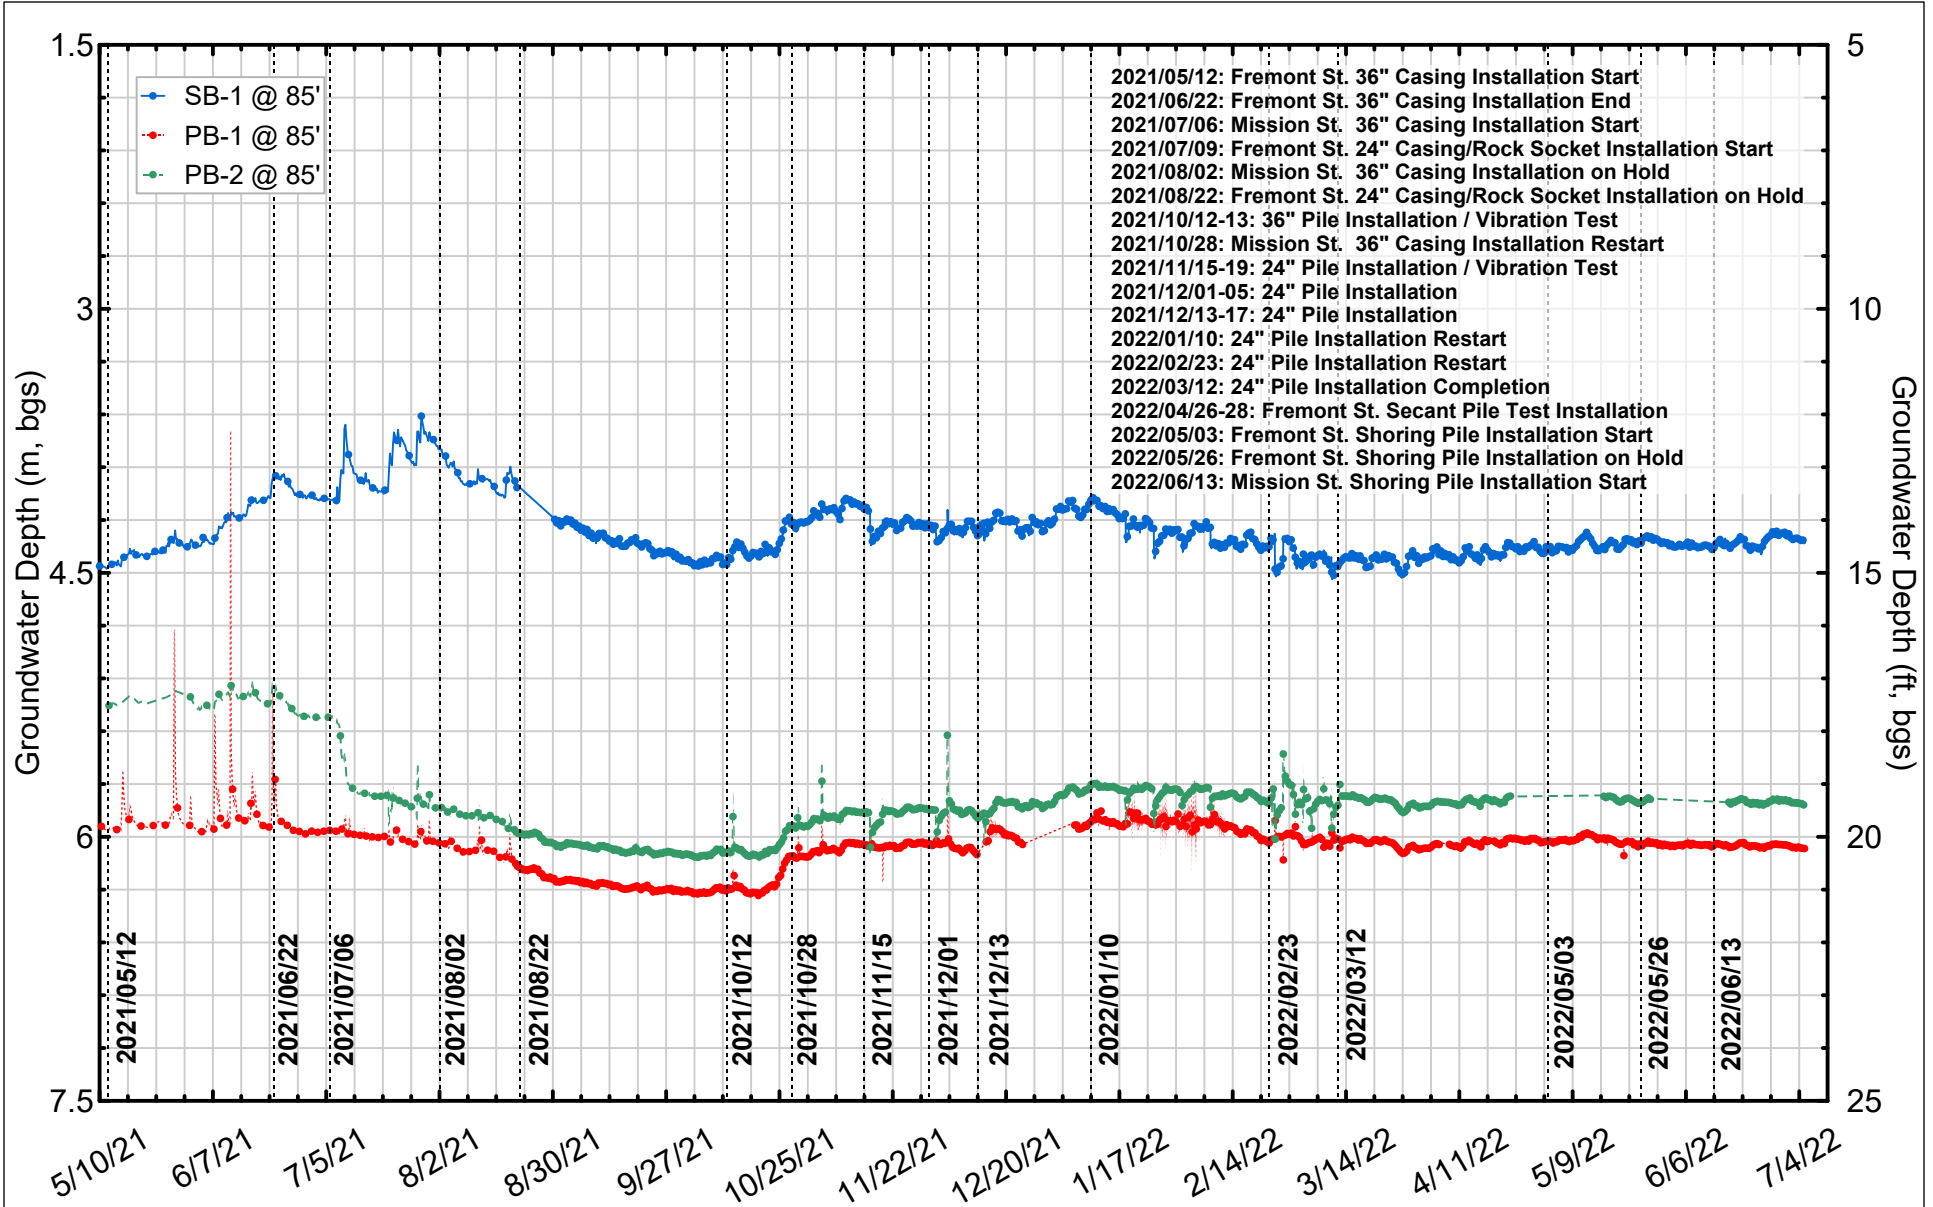
Project No: 19-009.00	Date: 7/6/2022	Created By: NBW	Checked By: DGM	Figure No: 061-08B
-----------------------	----------------	-----------------	-----------------	---------------------------

GROUNDWATER ELEVATION MEASUREMENTS IN MARINE AND COLMA SAND
SINCE 05/10/2021 THROUGH 07/05/2022

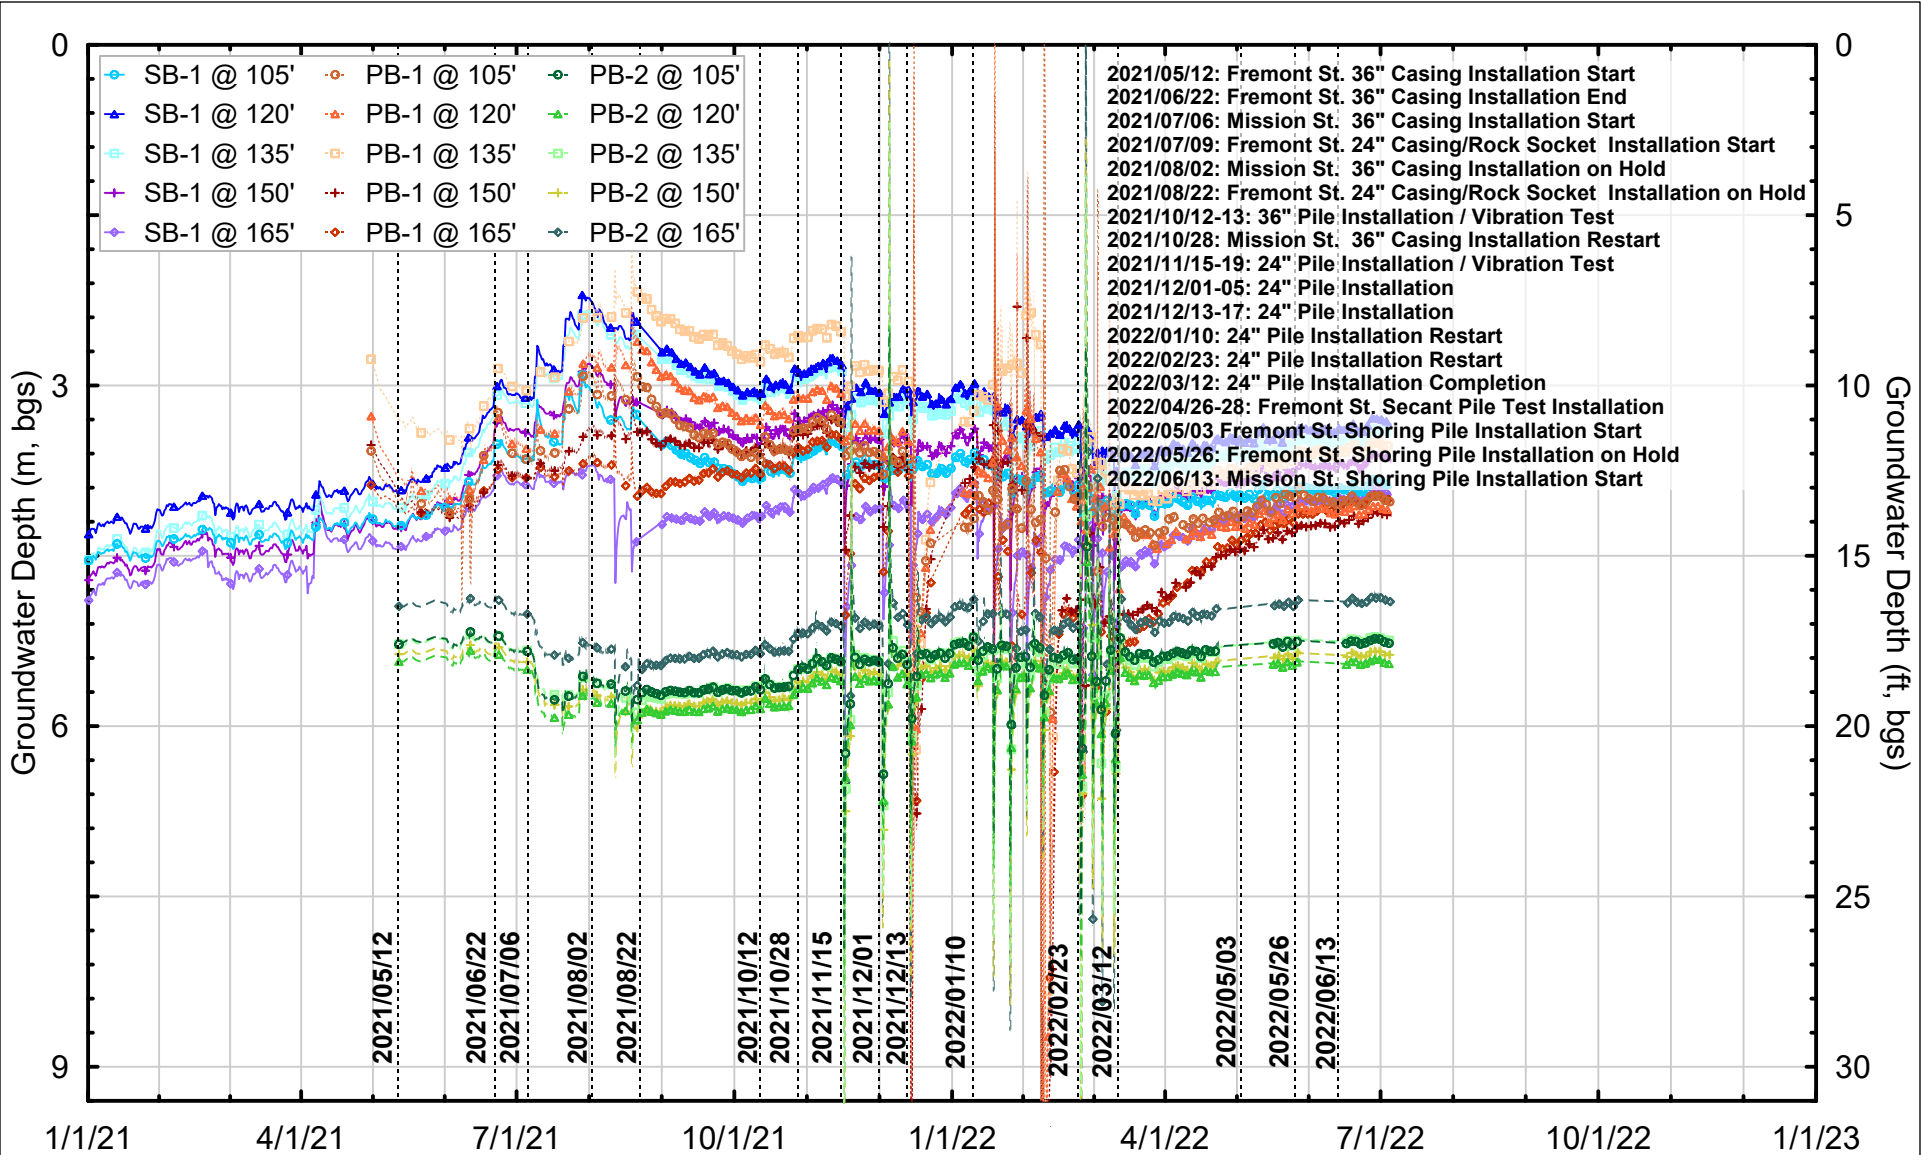
Project No: 19-009.00	Date: 7/6/2022	Created By: NBW	Checked By: DGM	Figure No: 061-09A
-----------------------	----------------	-----------------	-----------------	---------------------------

GROUNDWATER ELEVATION MEASUREMENTS IN OLD BAY CLAY
 SINCE 01/01/2021 THROUGH 07/05/2022

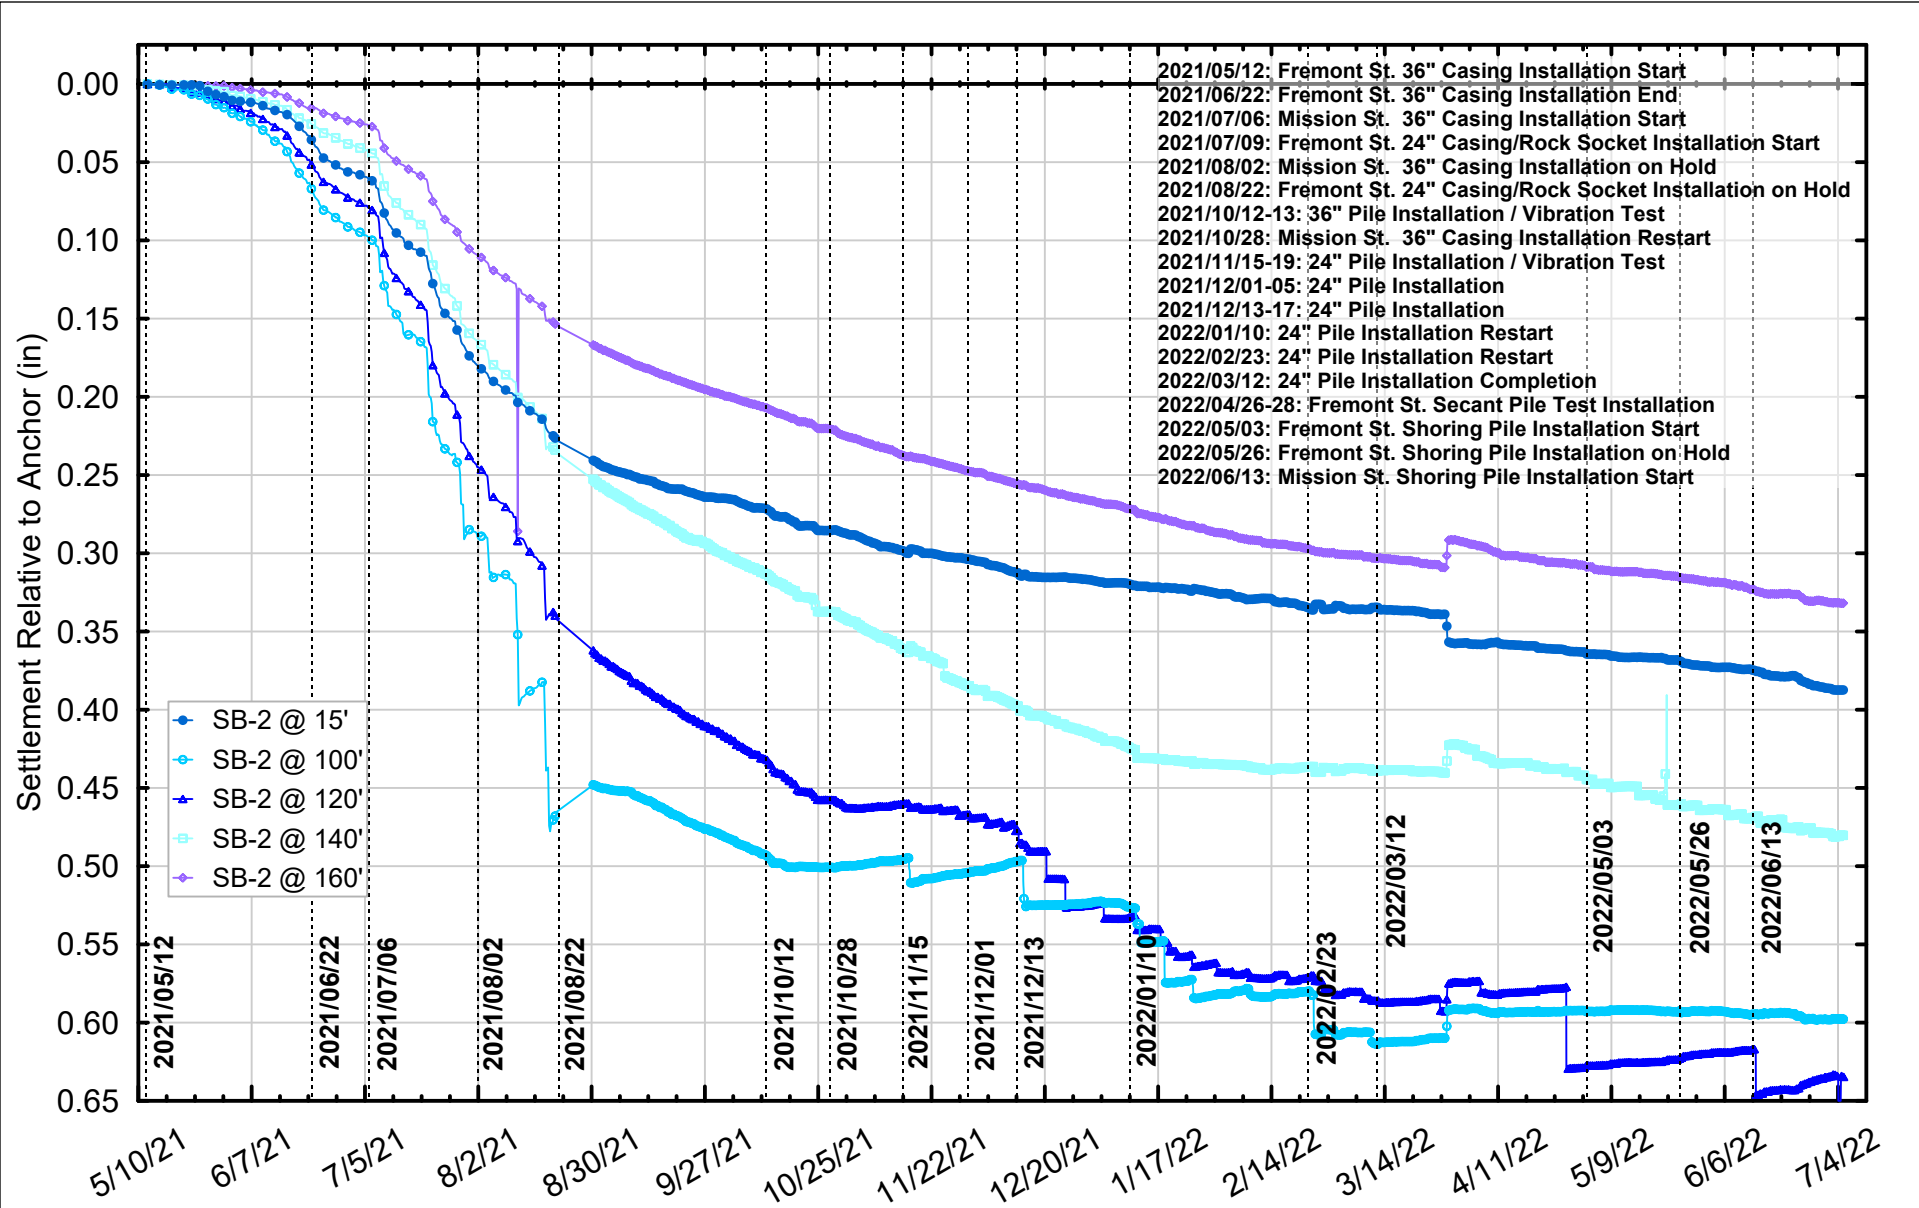
Project No: 19-009.00	Date: 7/6/2022	Created By: NBW	Checked By: DGM	Figure No: 061-10B
-----------------------	----------------	-----------------	-----------------	---------------------------

EXTENSOMETER DATA FROM WITHIN TOWER BASEMENT
SINCE 05/10/2021 THROUGH 07/05/2022
